CONSERVATION RESOURCE ALLIANCE

Little Manistee River Eroding Stream Bank Assessment

Carrieville (Kings Highway) Bridge to Old Stronach Rd. Bridge

12/31/2014

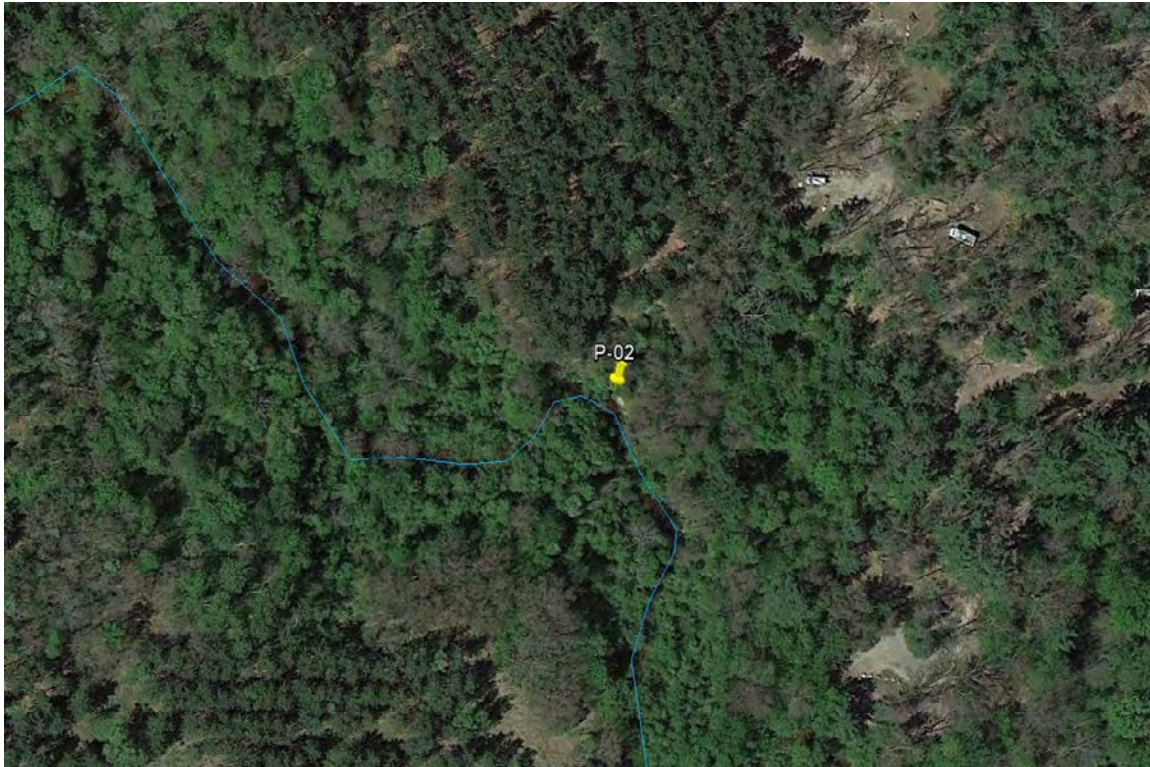
Site 2

Severity: Moderate

Notes: substrate sand, channel width 16', water depth 2.0-4.0' maximum

View straight on (2013)

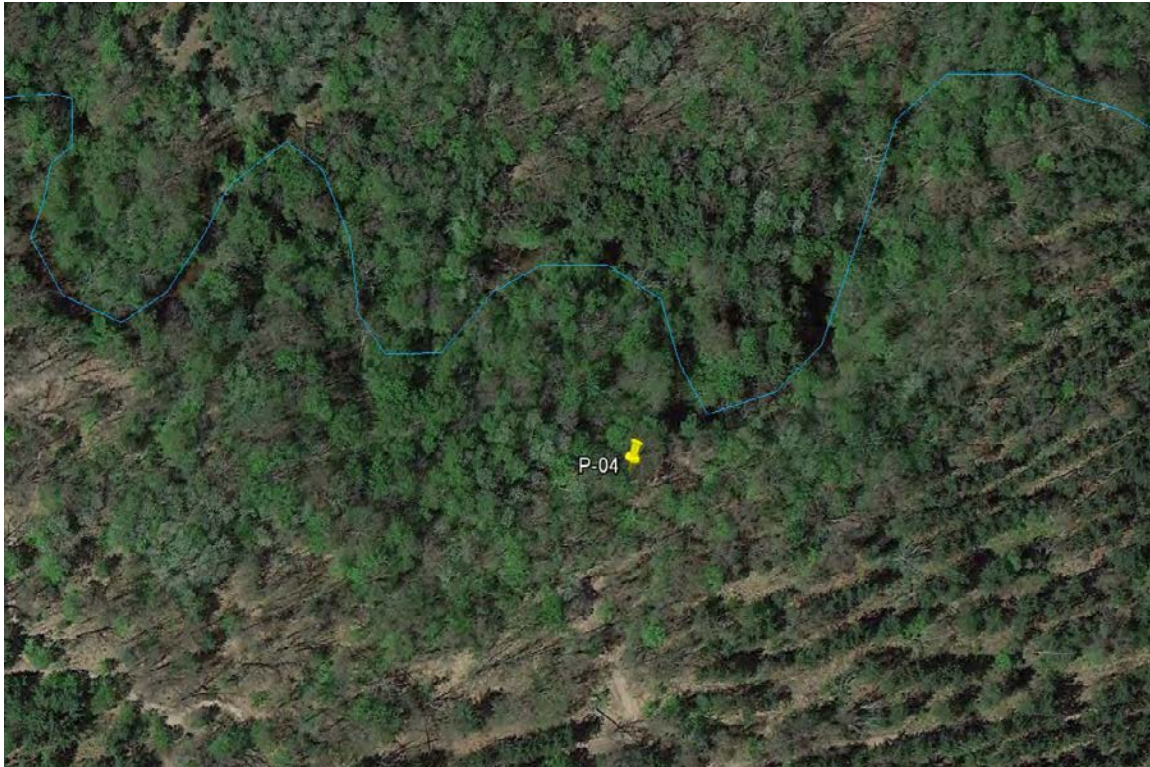
Site 4

Severity: Minor

Notes: water depth 3.0', channel width 12', substrate sand

View downstream (2013)

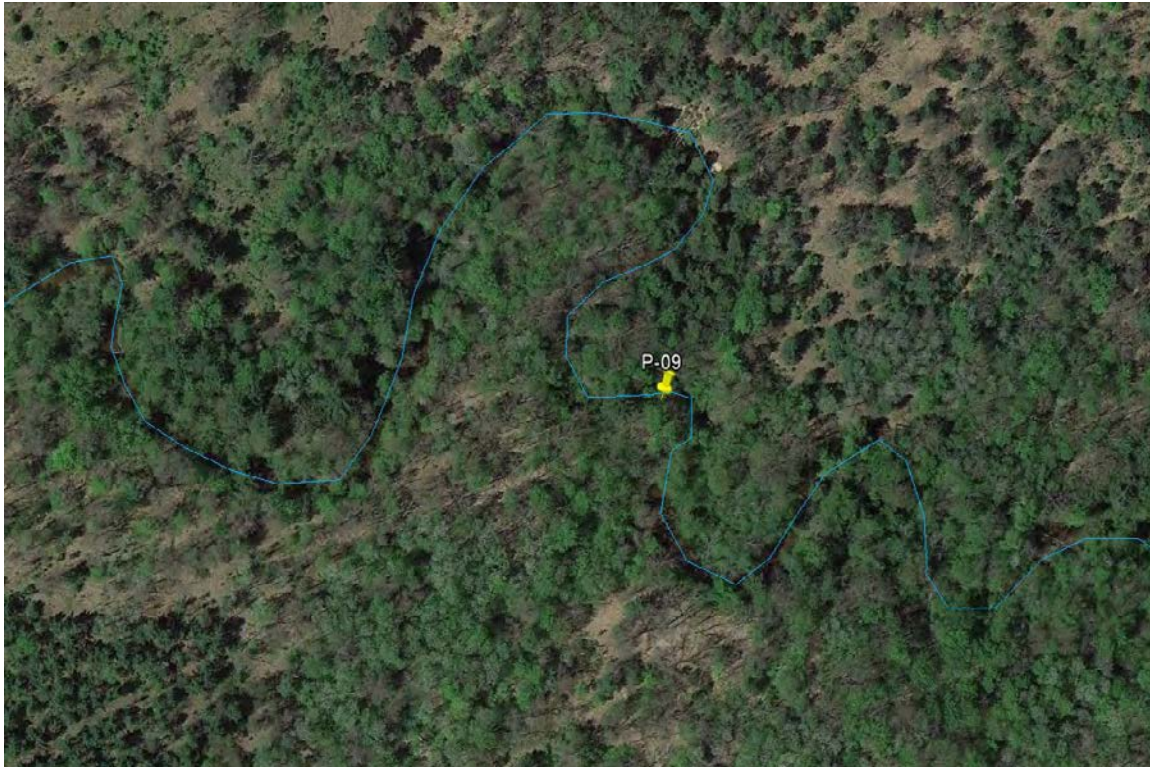
Site 9

Severity: Minor

Notes: channel width 20', water depth 1'-2.5', substrate sand/some gravel

View downstream (2013)

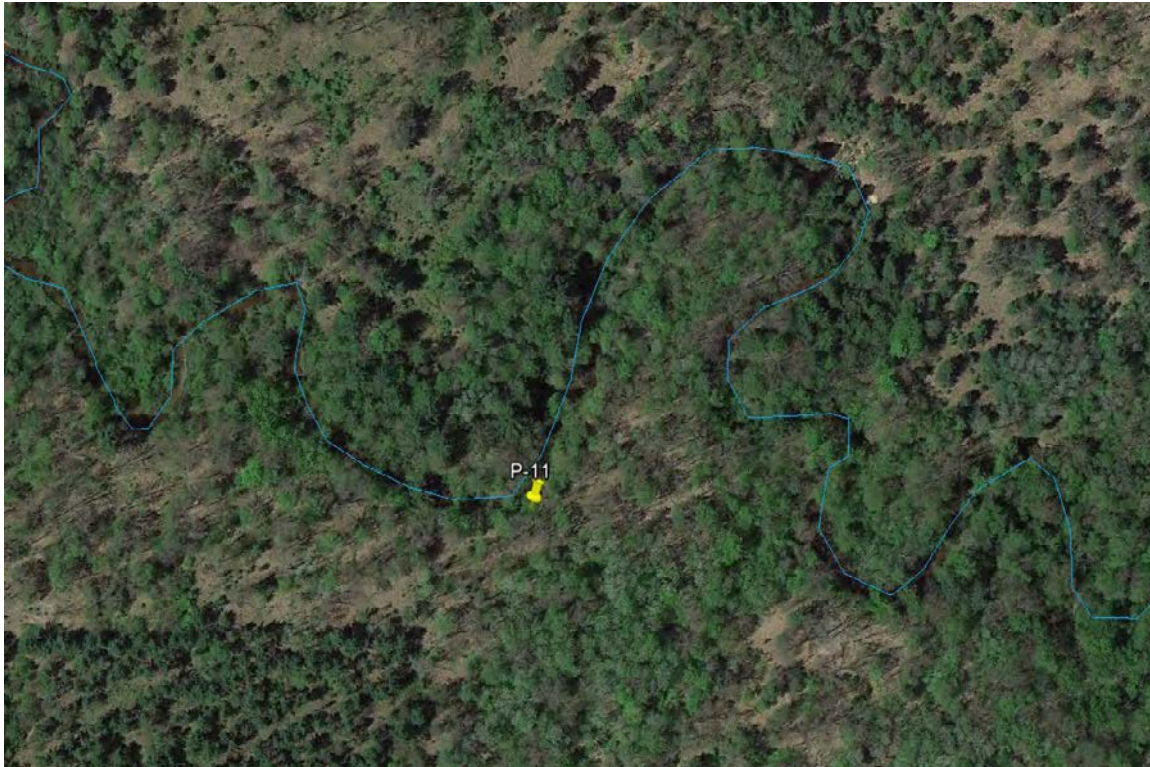
Site 11

Severity: Minor

Notes: water depth 1'-2.0', substrate sand/some gravel, channel width 24'

View straight on (2013)

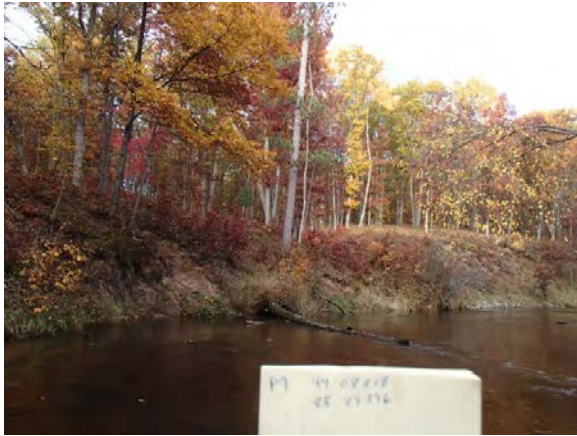
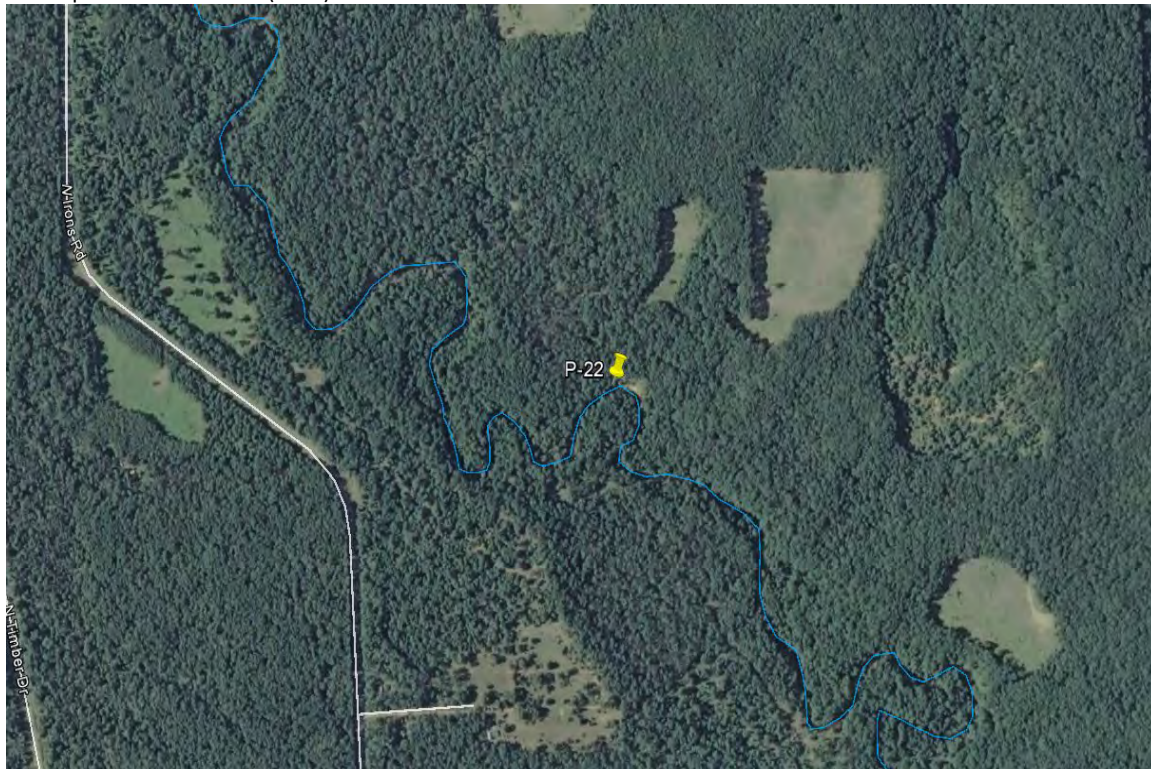
Site 22

Notes: cold upwelling observed at toe, water at toe 2.5'

View upstream and across (2014)

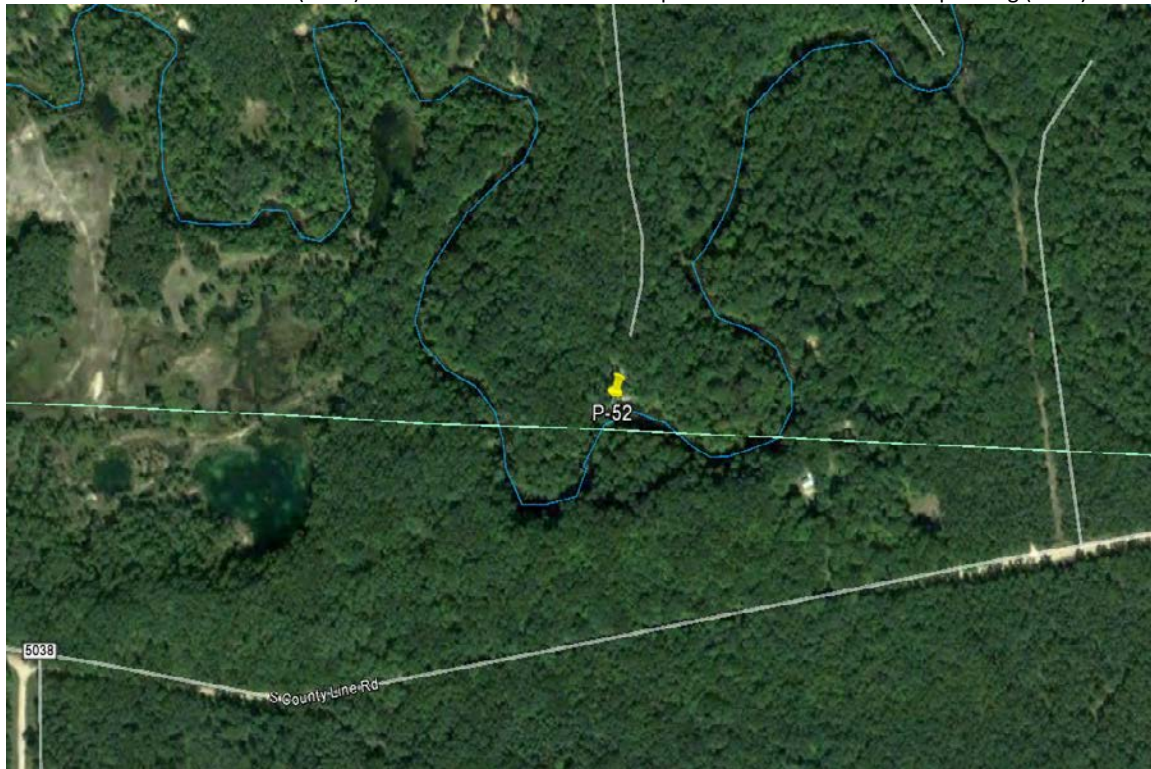
Site 52

View upstream and across-note maple snag (2014)

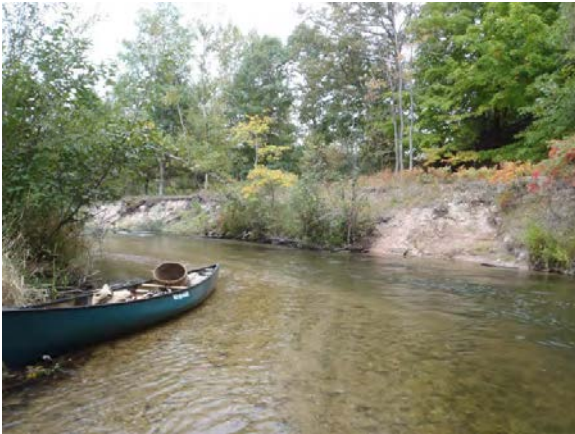
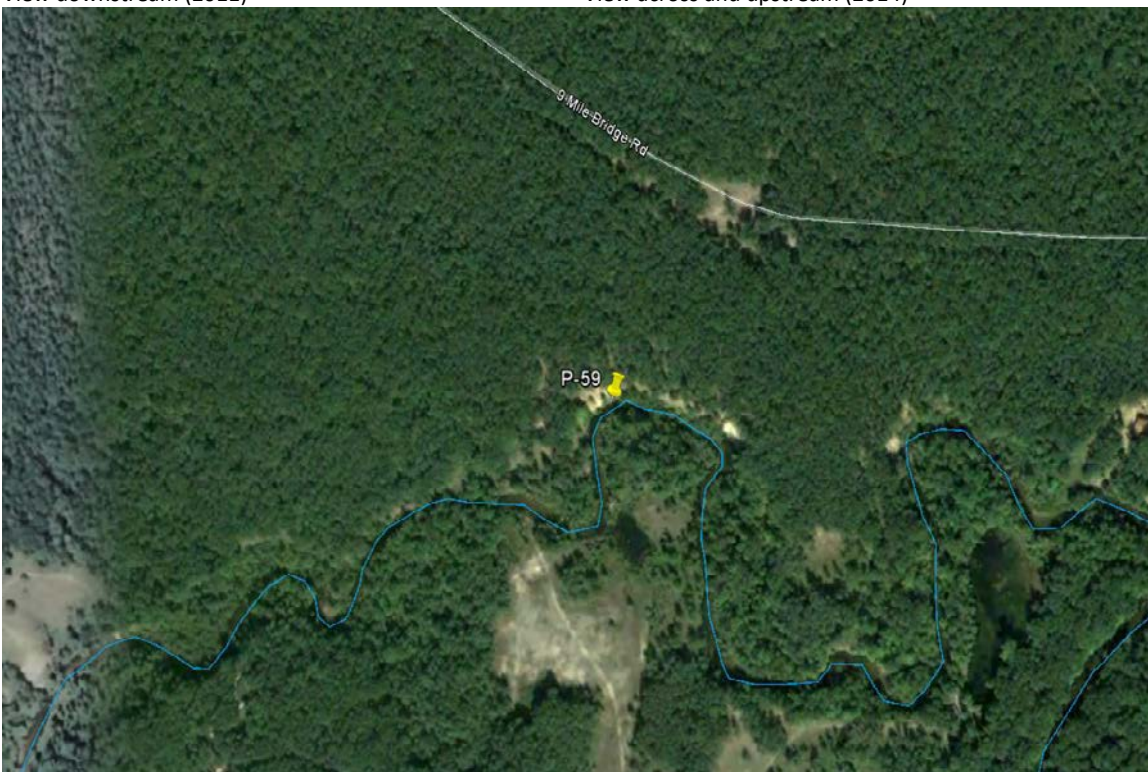
Site 59

Notes: angler access, continuation of prior site, clay exposed in bank, back eddies caused by debris jam, depth at toe 3'

View downstream (2011)

View across and upstream (2014)
