Date: December 18, 2019

Subject: Little Manistee River Private Lands Sites -Before, During, After Flooding

Author: Nate Winkler, Biologist

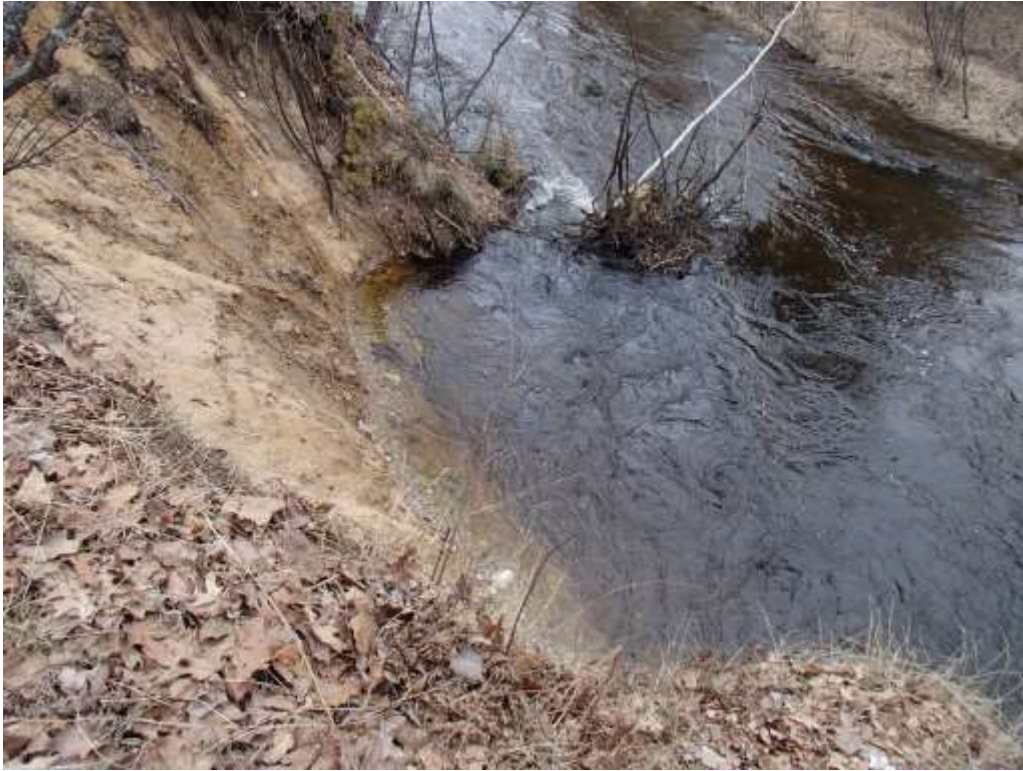
Site #56 (before)

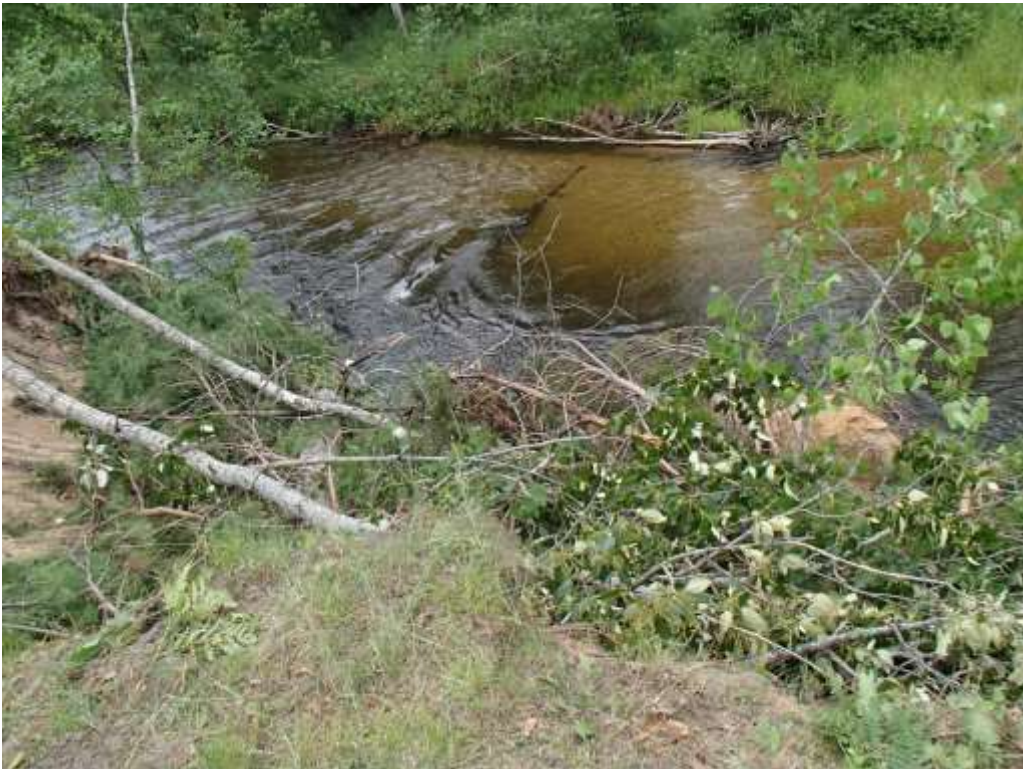
Site #56 (after 2017 wood placement)

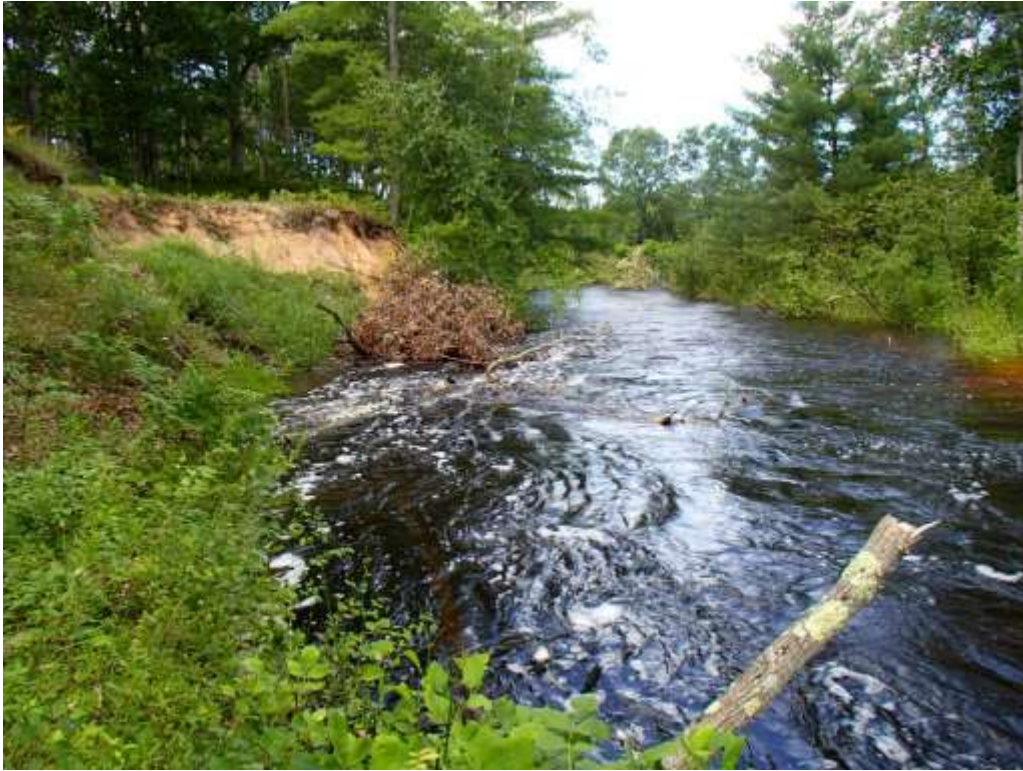
Site #56 (during 2019 high flow event)

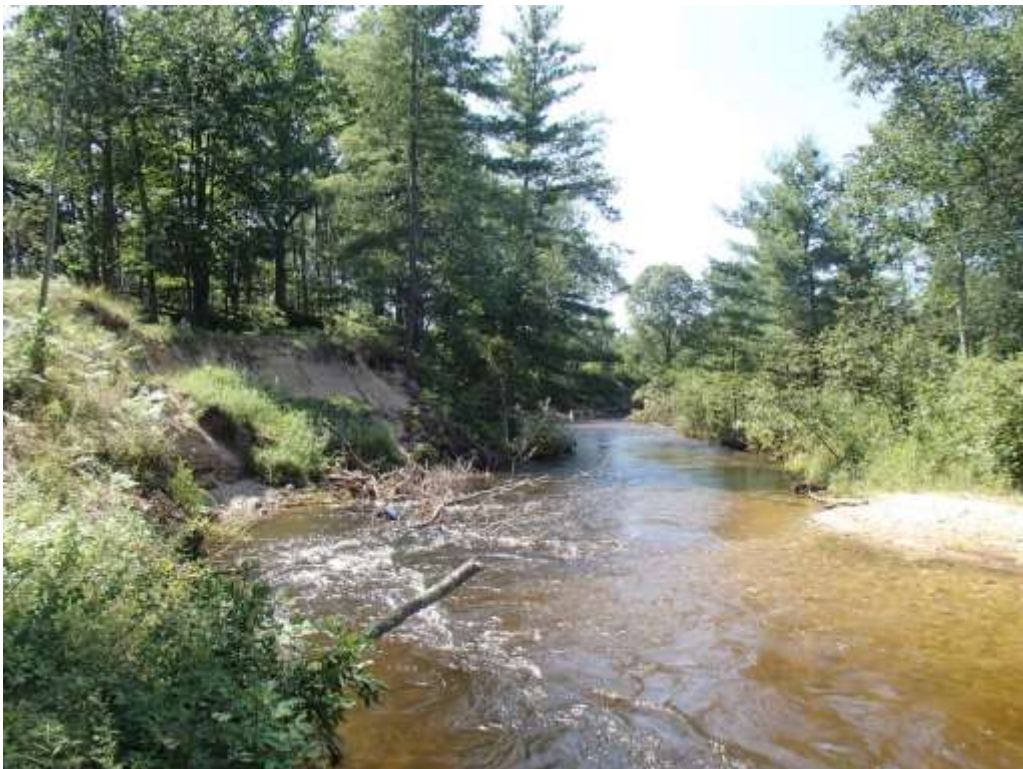
Site #56 (after 2019 high flow event)

The MDEQ (now "EGLE") permit for the Grooters-Latham site is still valid and will remain so until September 2021. If funds are available, CRA recommends going back in and shoring up #56 and replacing the material at #60 with larger diameter wood as well as the finer material originally installed. The level of flow, while not unprecedented, was obviously not expected so soon after installation. If #60 had more time to "season", the structure would, in all likelihood, have held.

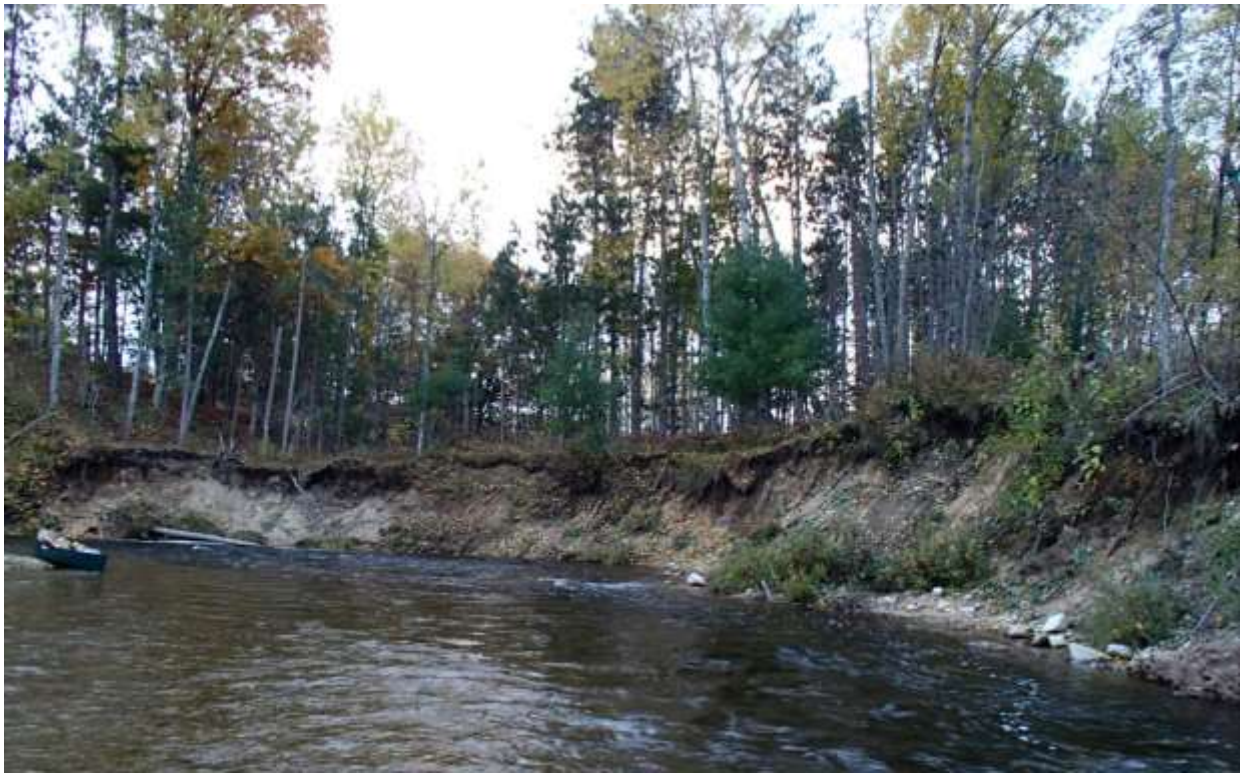
Site #57 (before) (view upstream)

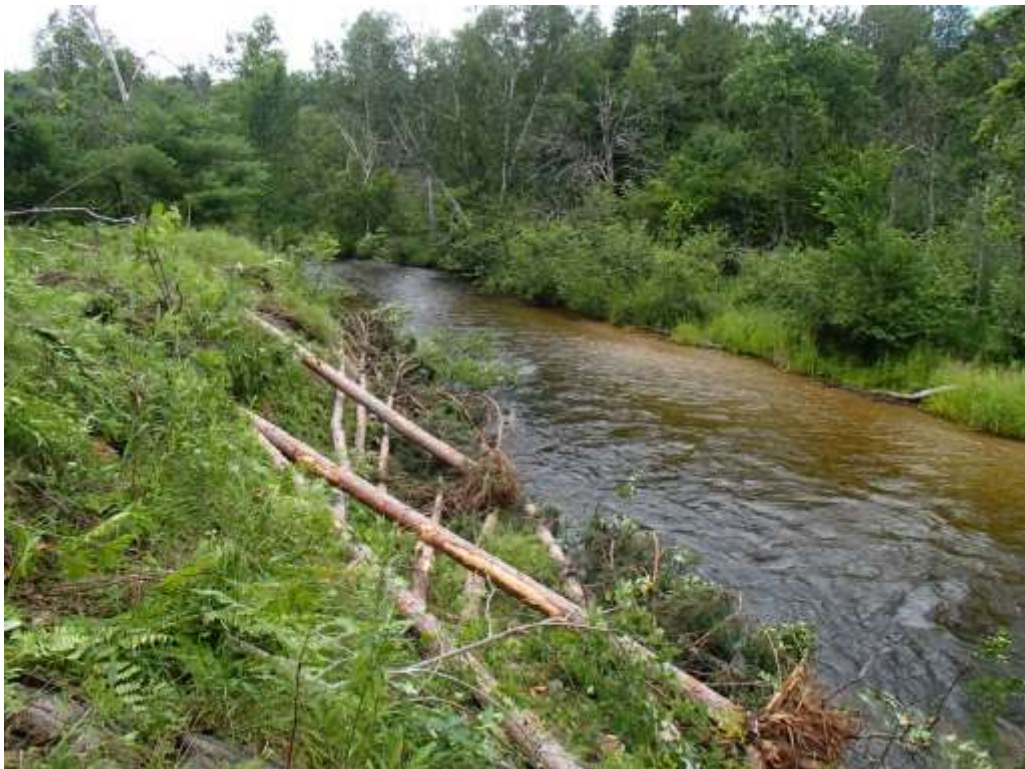
Site #57 (after wood placement) (view downstream from bluff top)

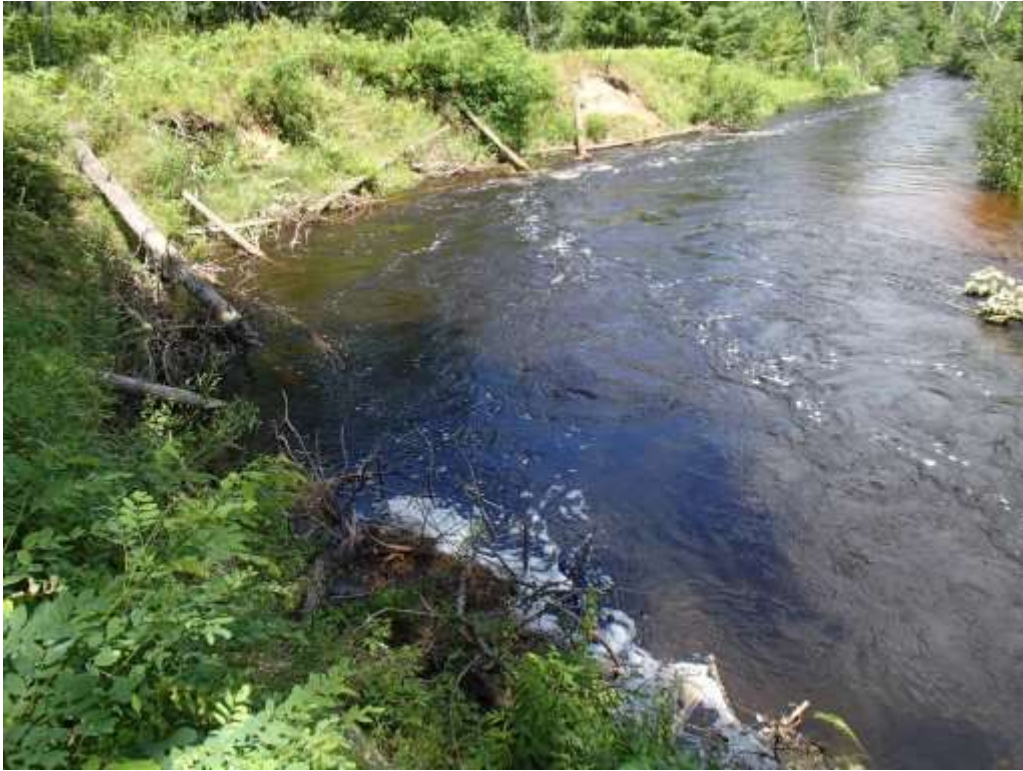
Site #57 (during 2019 high flow event) (view downstream from bluff top)

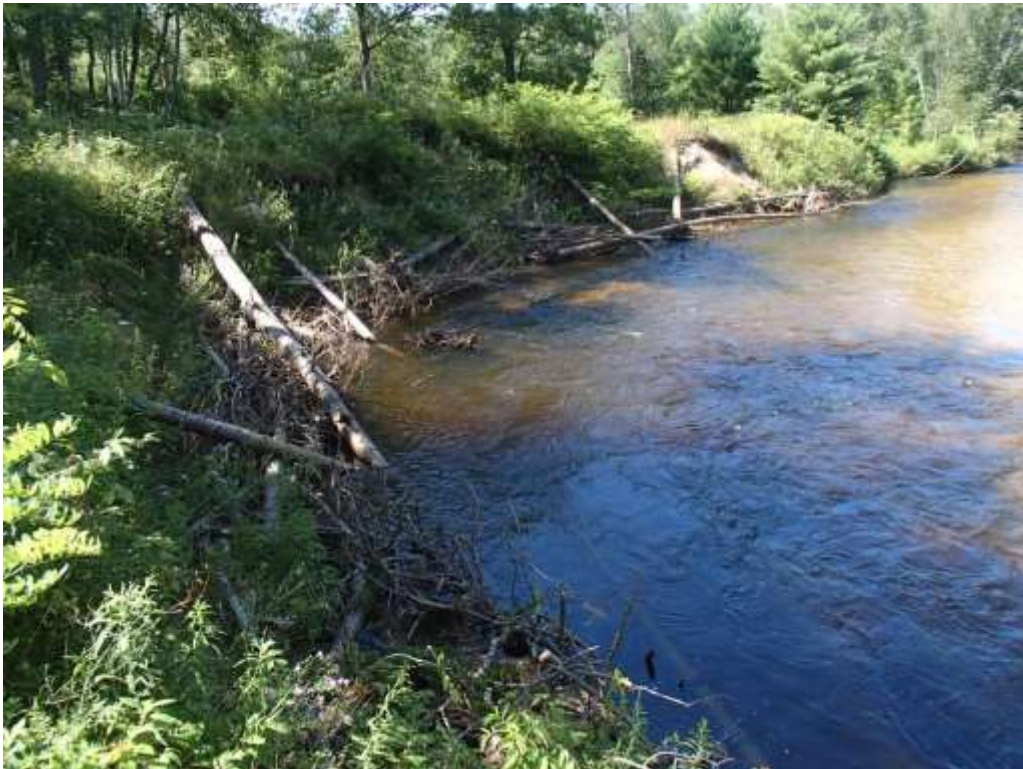
Site #57 (after 2019 high flow event) (view downstream from bluff top)

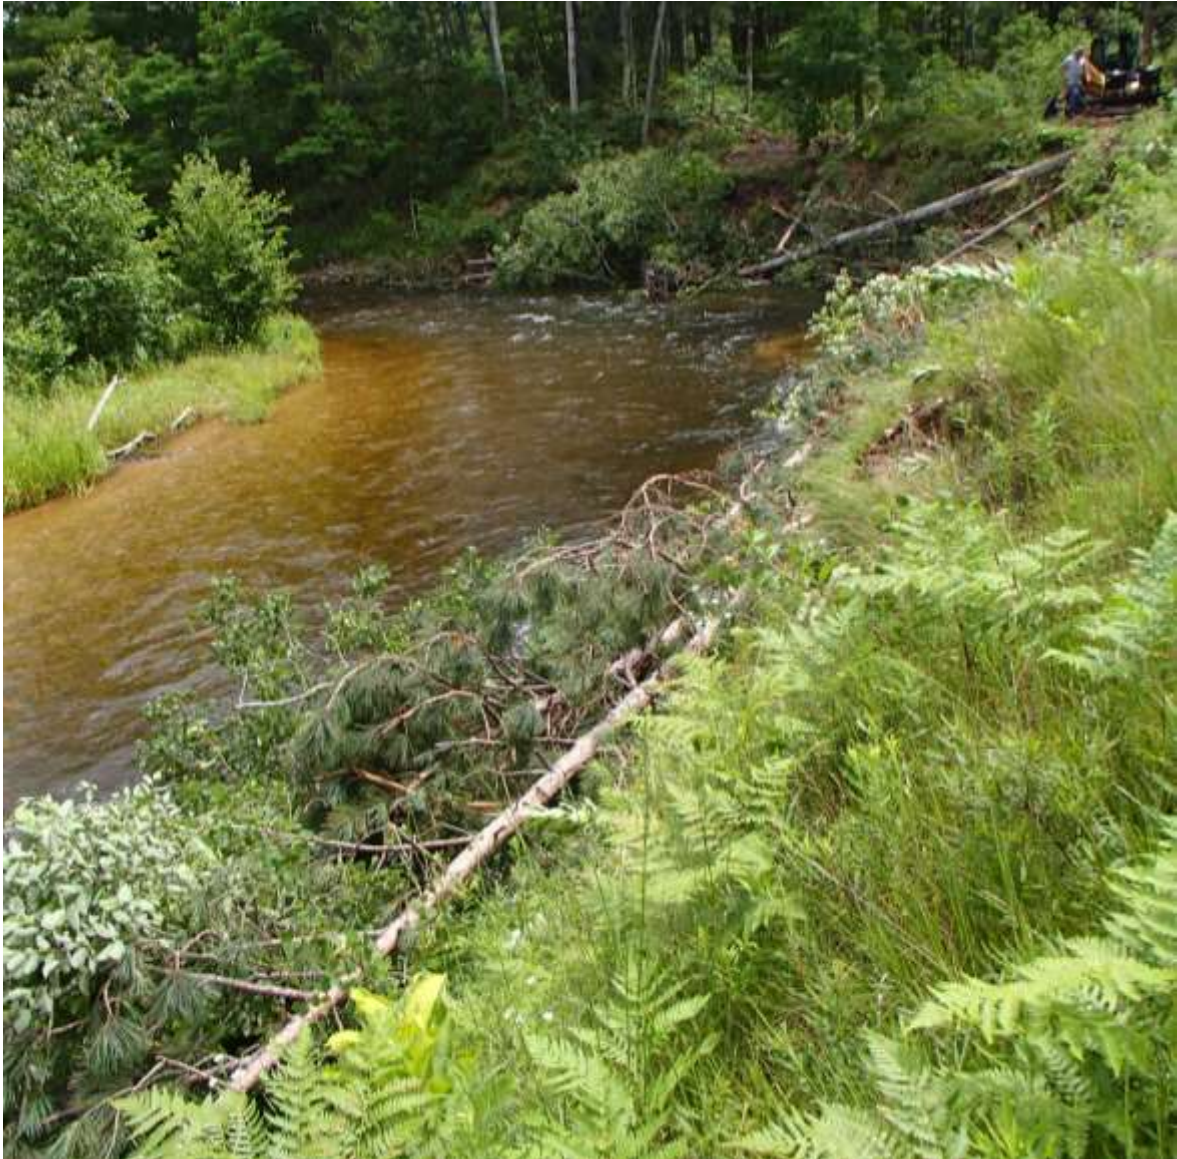
Site #57 (during wood placement) (view upstream from bluff top)

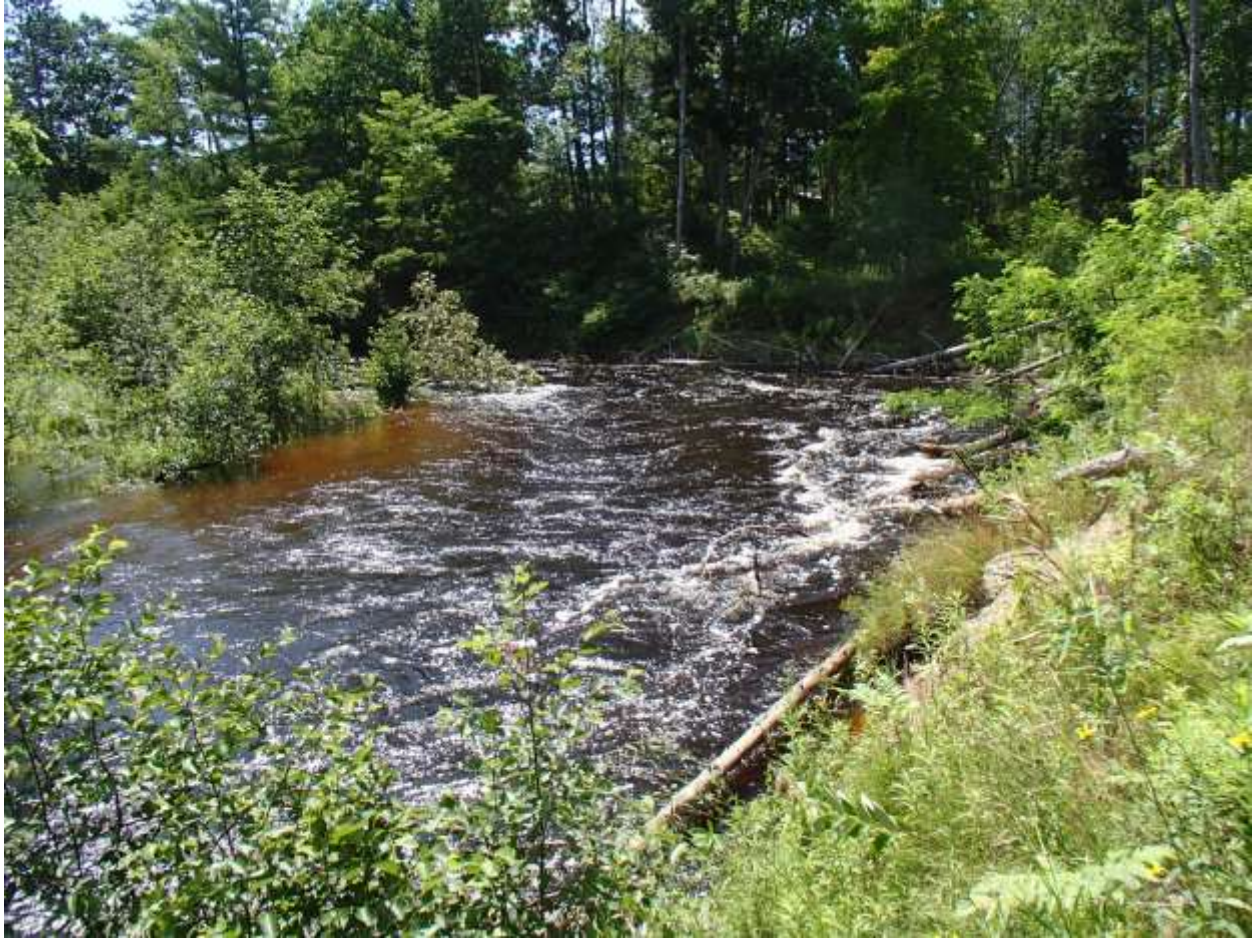
Site #57 (during 2019 high flow event) (view upstream from bluff top)

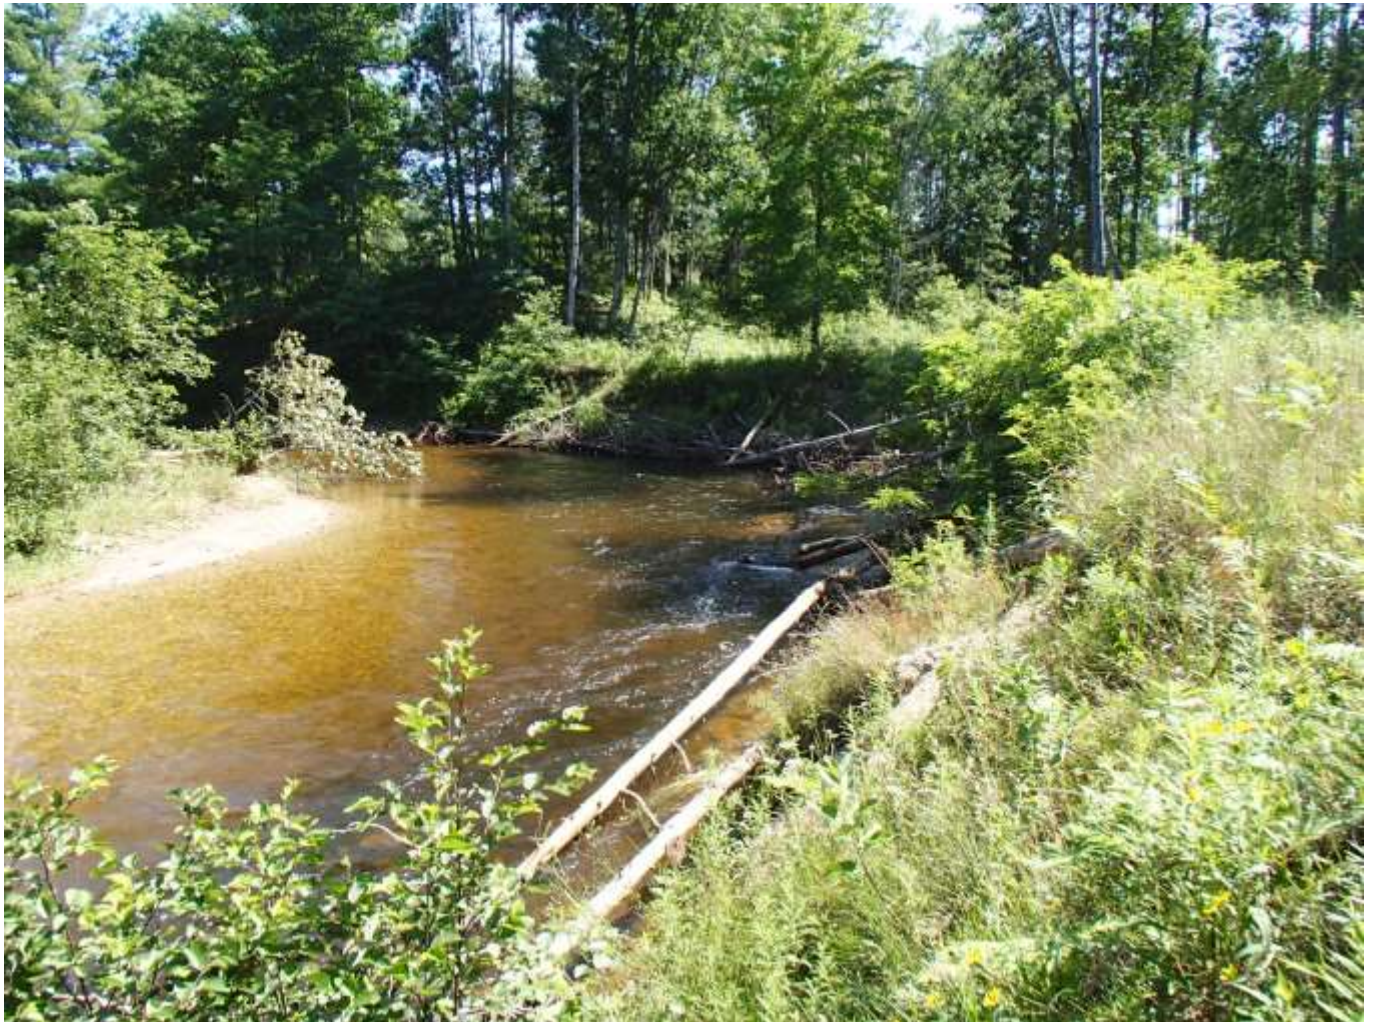
Site #57 (after 2019 high flow event) (view upstream from bluff top)

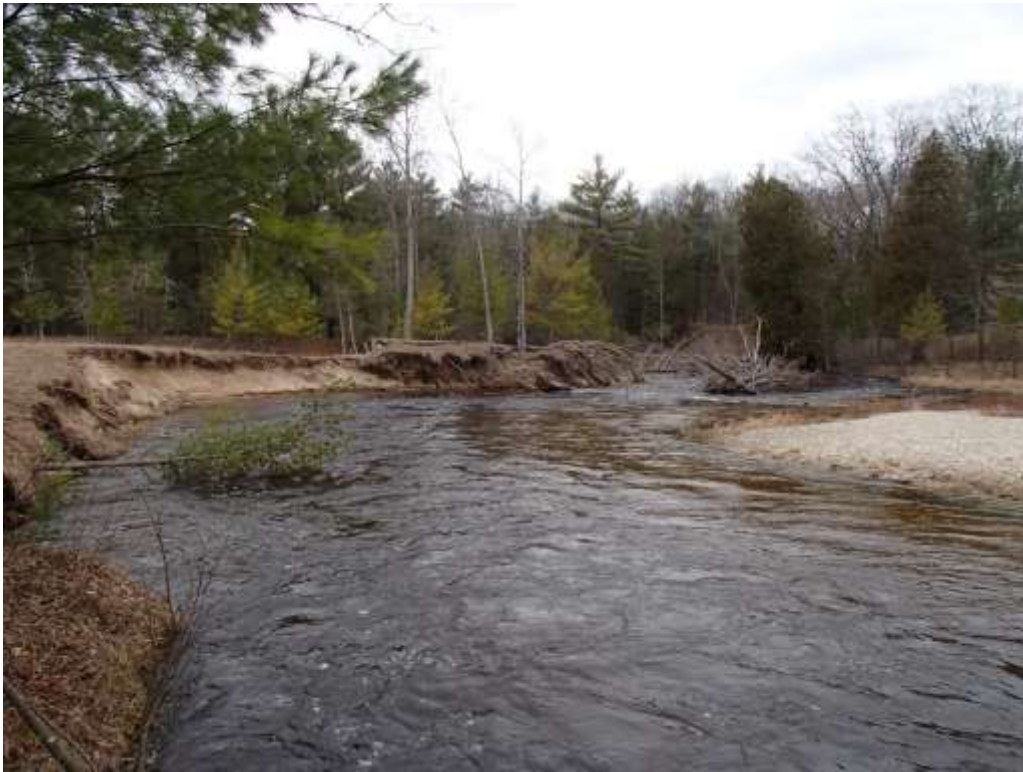
Site #60 (before)

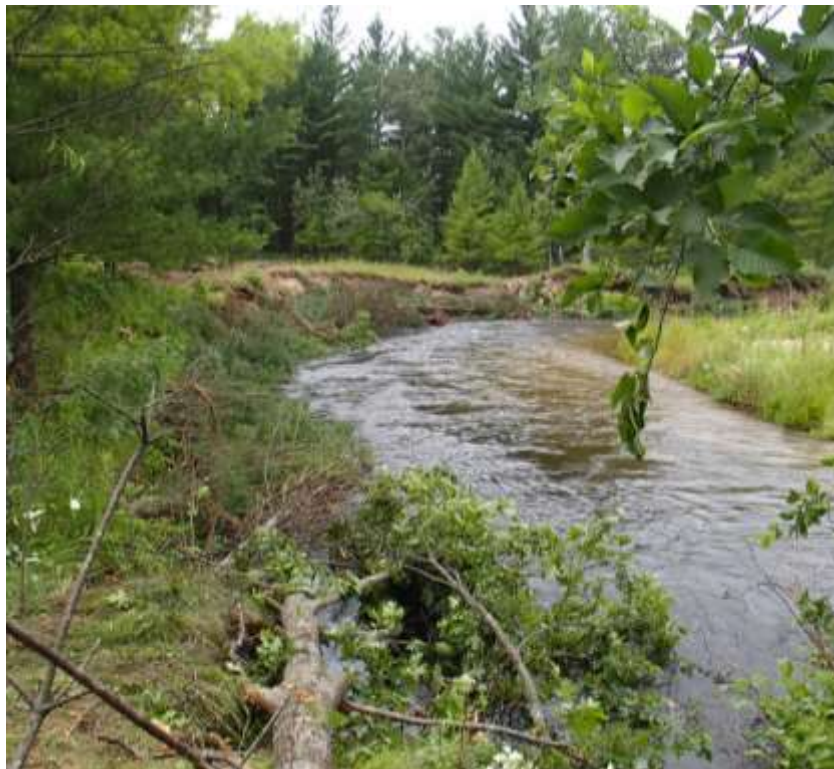
Site #60 (after)

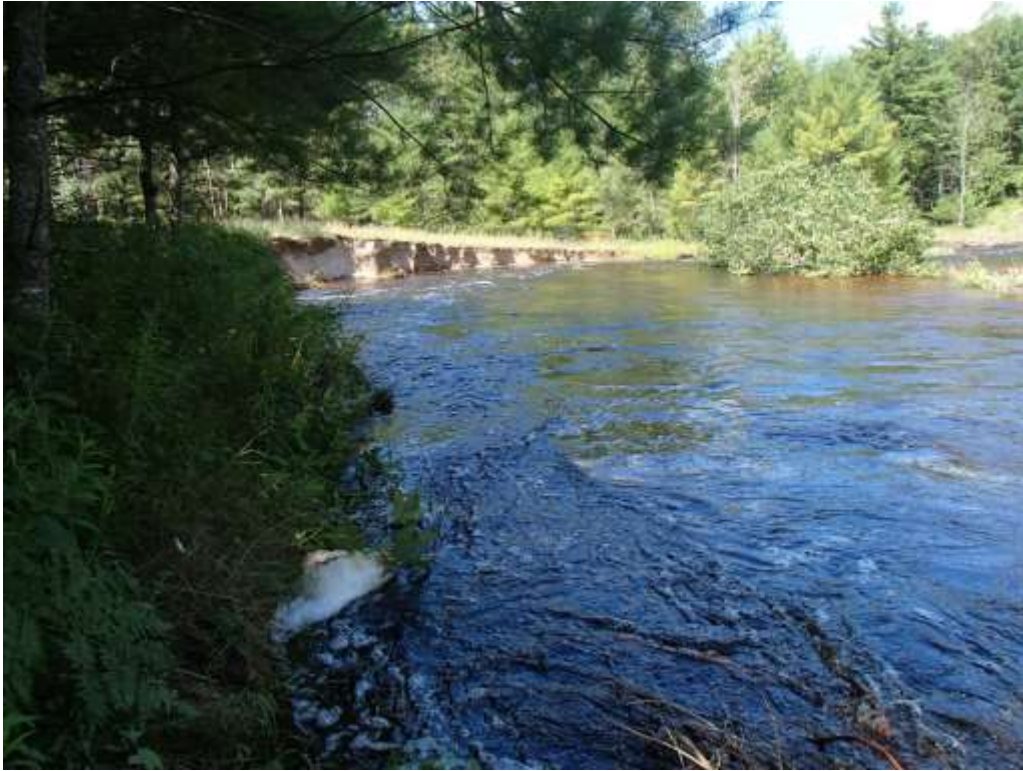
Site #60 (during 2019 high flow event)

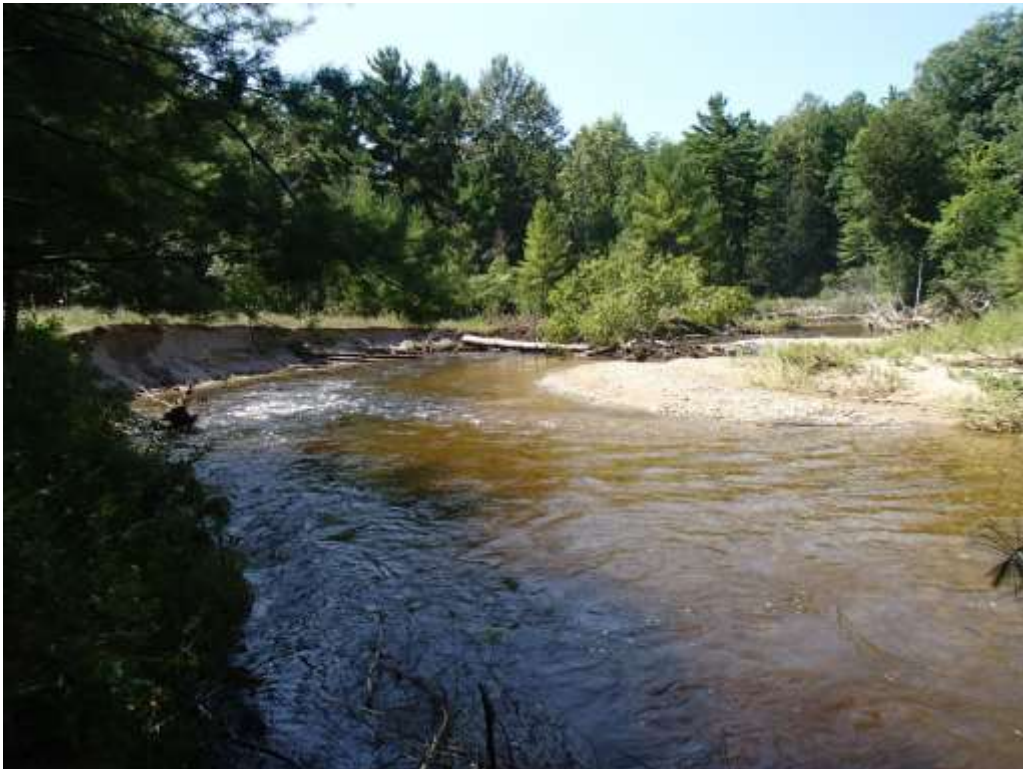
In general, the work held up very well and performed the services intended. The exceptions are the lower-most downstream site (#60) at Grooters-Latham adjacent to an abandoned gravel pit. The white pines utilized were swept pretty neatly away by the river and may have something to do with the amount of hydraulic force that particular site is exposed to. Another factor may be the highly erodible material making up the bank, which sloughs very easily (as was observed by CRA during the flood). The other issue was the top Grooters-Latham site (#56) in which the actual top of the bluff settled due to the rain and pushed the toe of the bluff and installed wood out further into the river.

Site #60 (after 2019 high flow event)

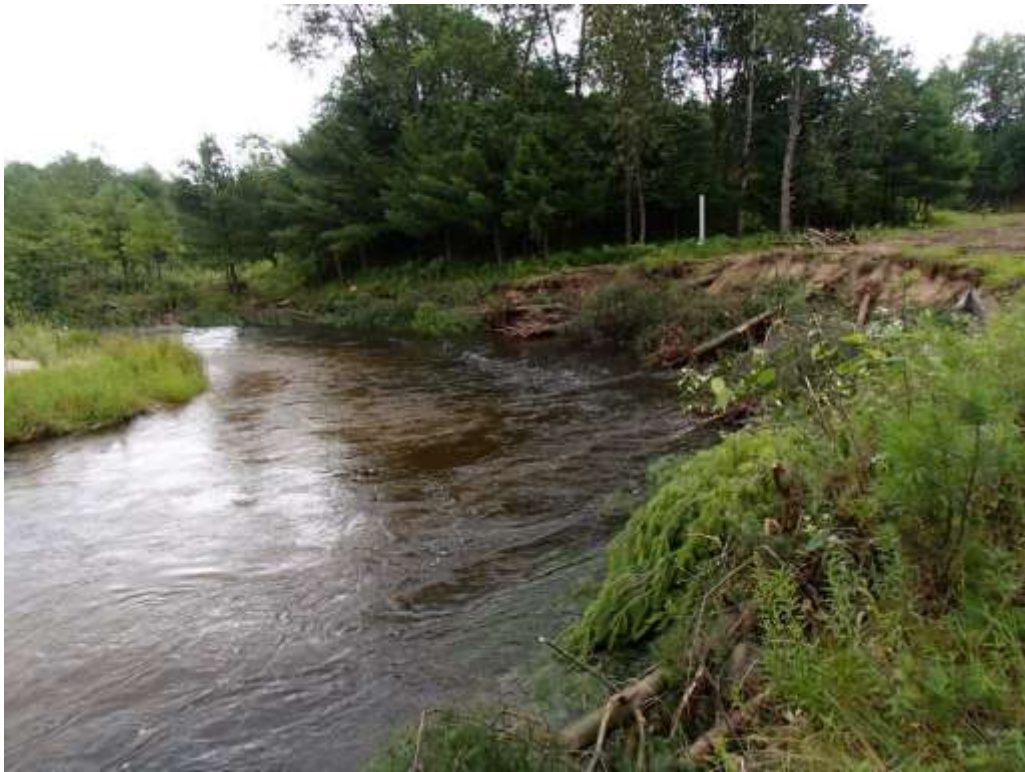
Site #60 (after) (view upstream)

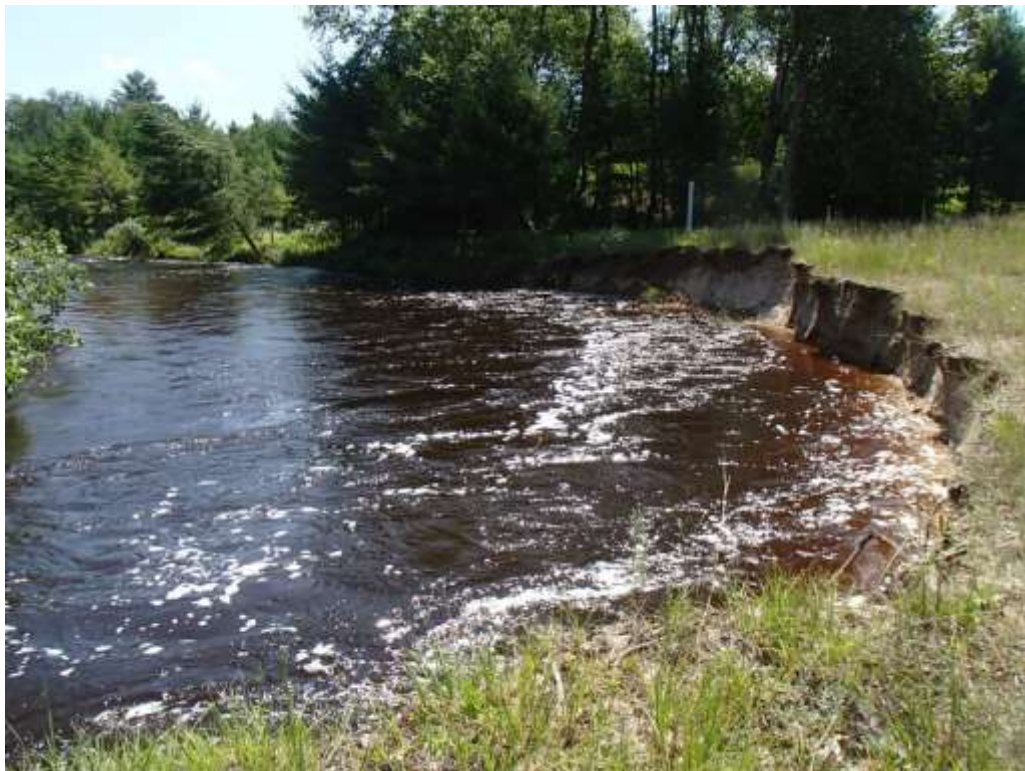
Site #60 (during 2019 high flow event) (view upstream)

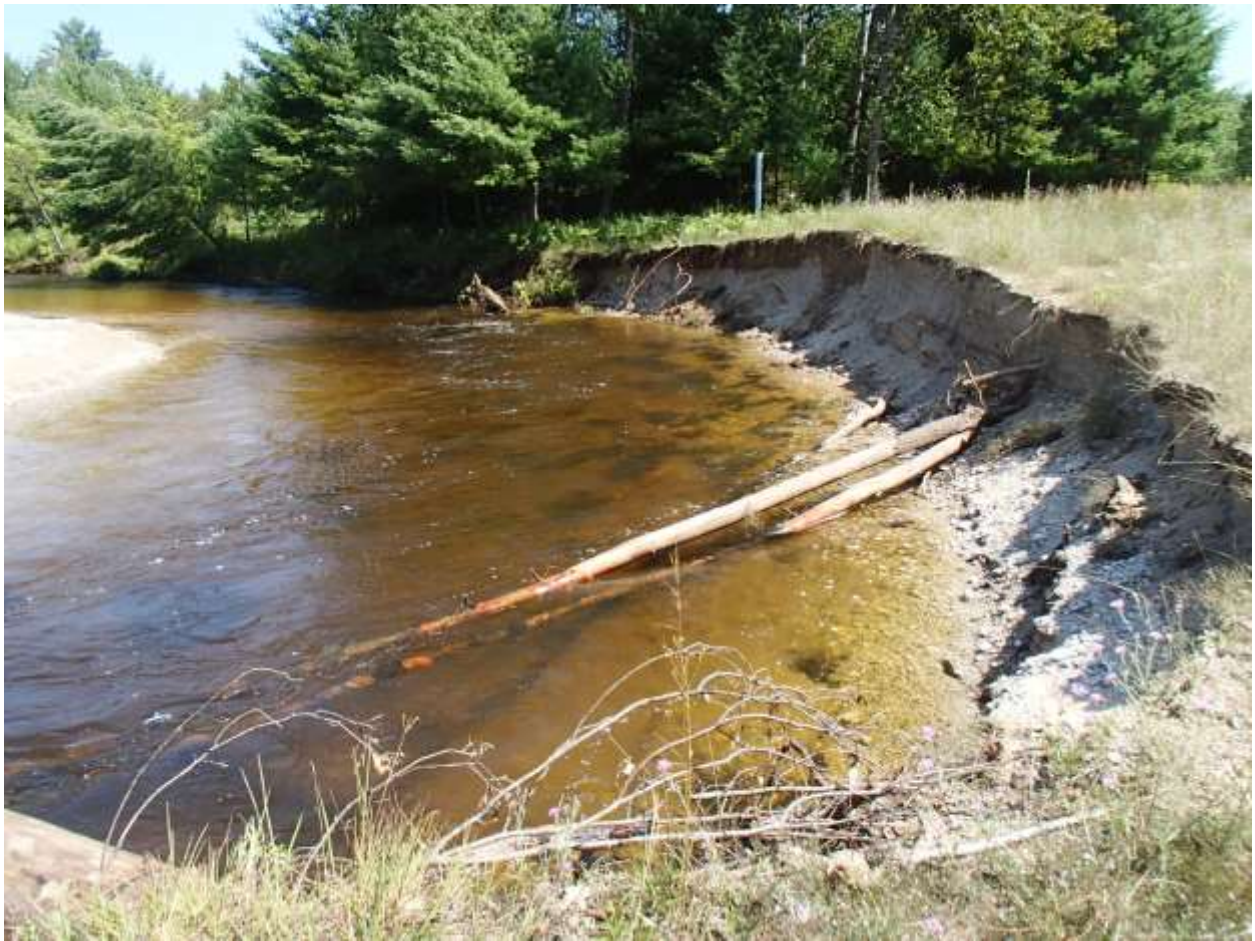
Site #60 (after 2019 high flow event) (view upstream)

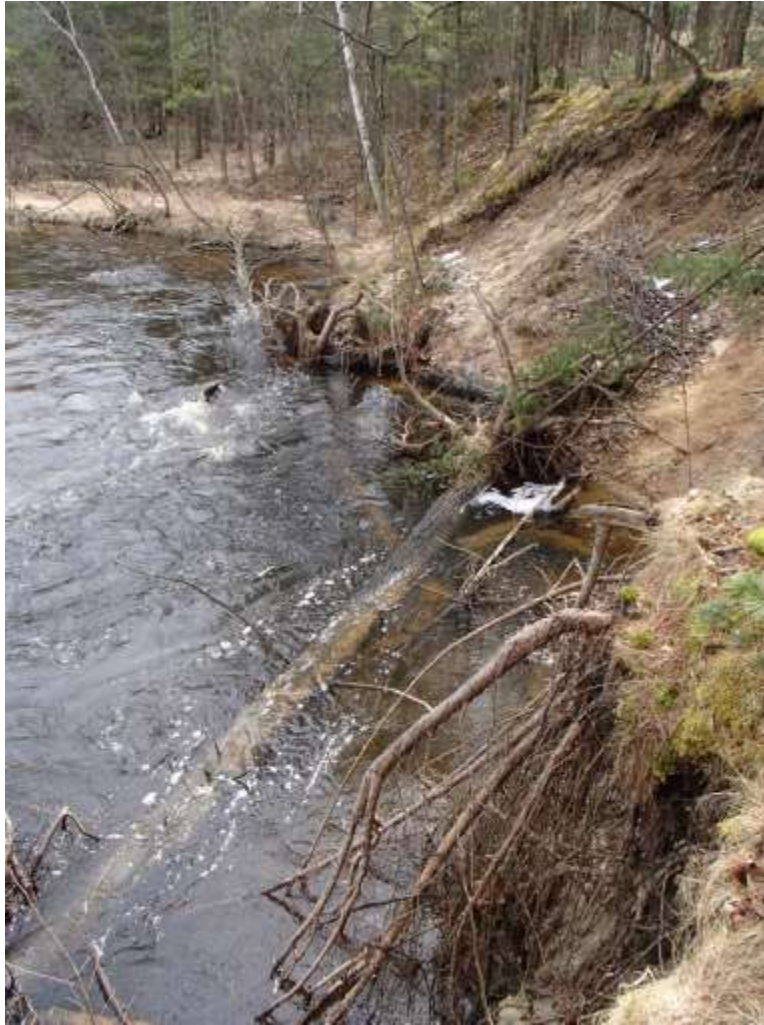
Site #63 (before)

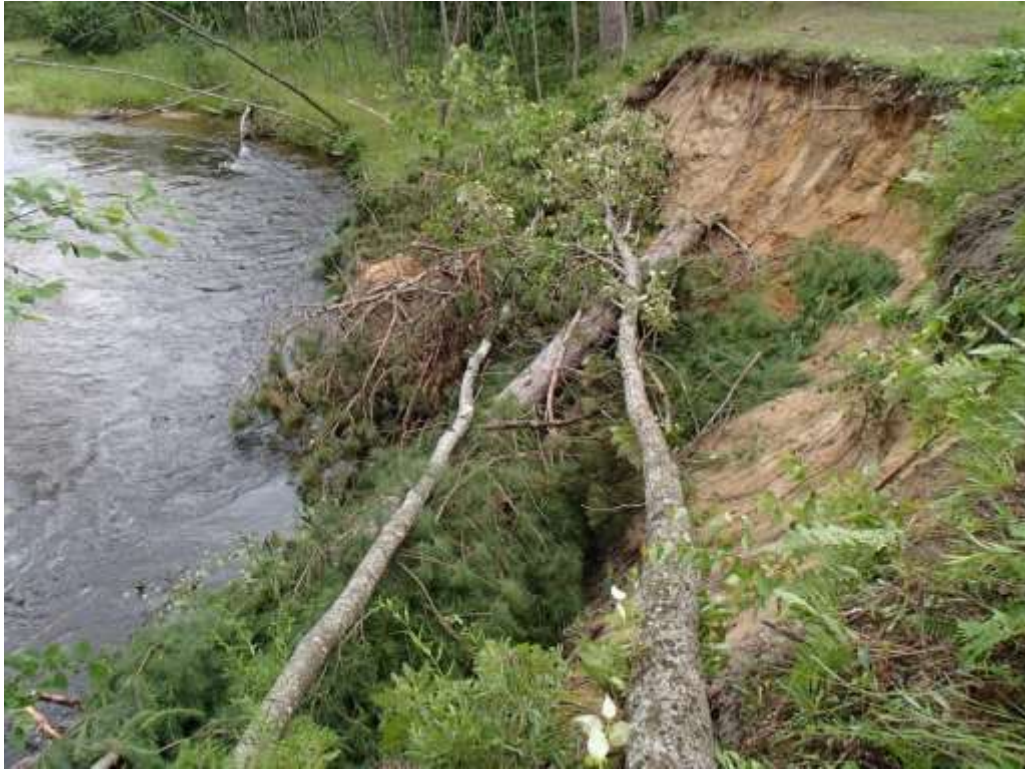
Site #63 (after)

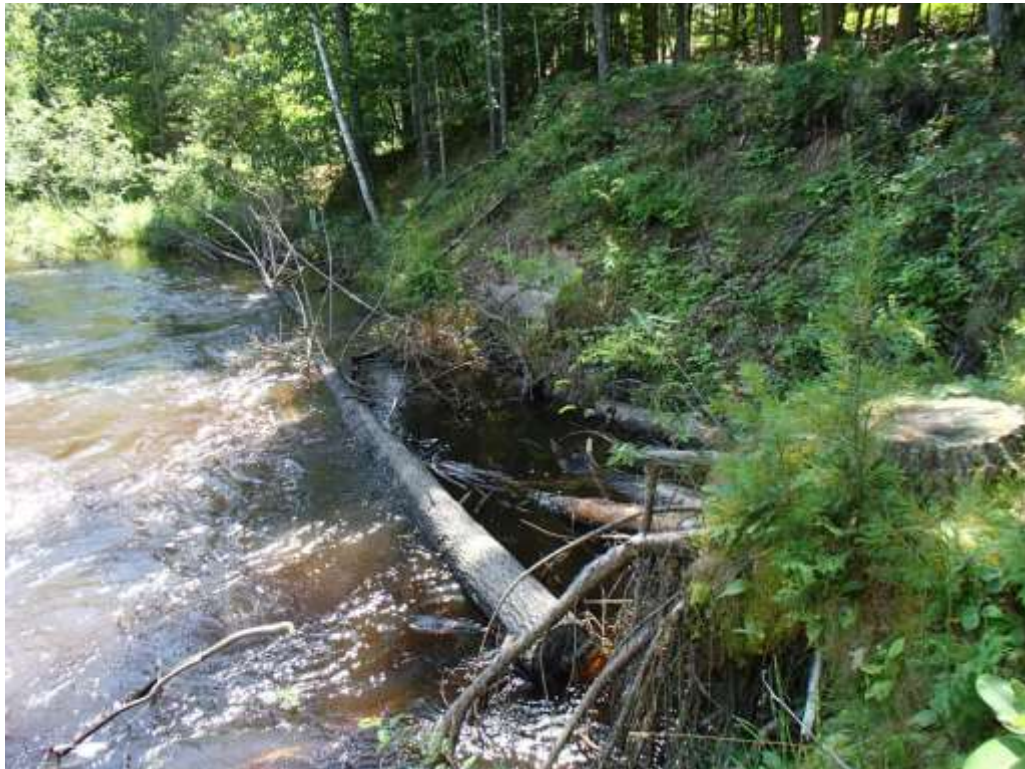
Site #63 (during 2019 high flow event) (view upstream)

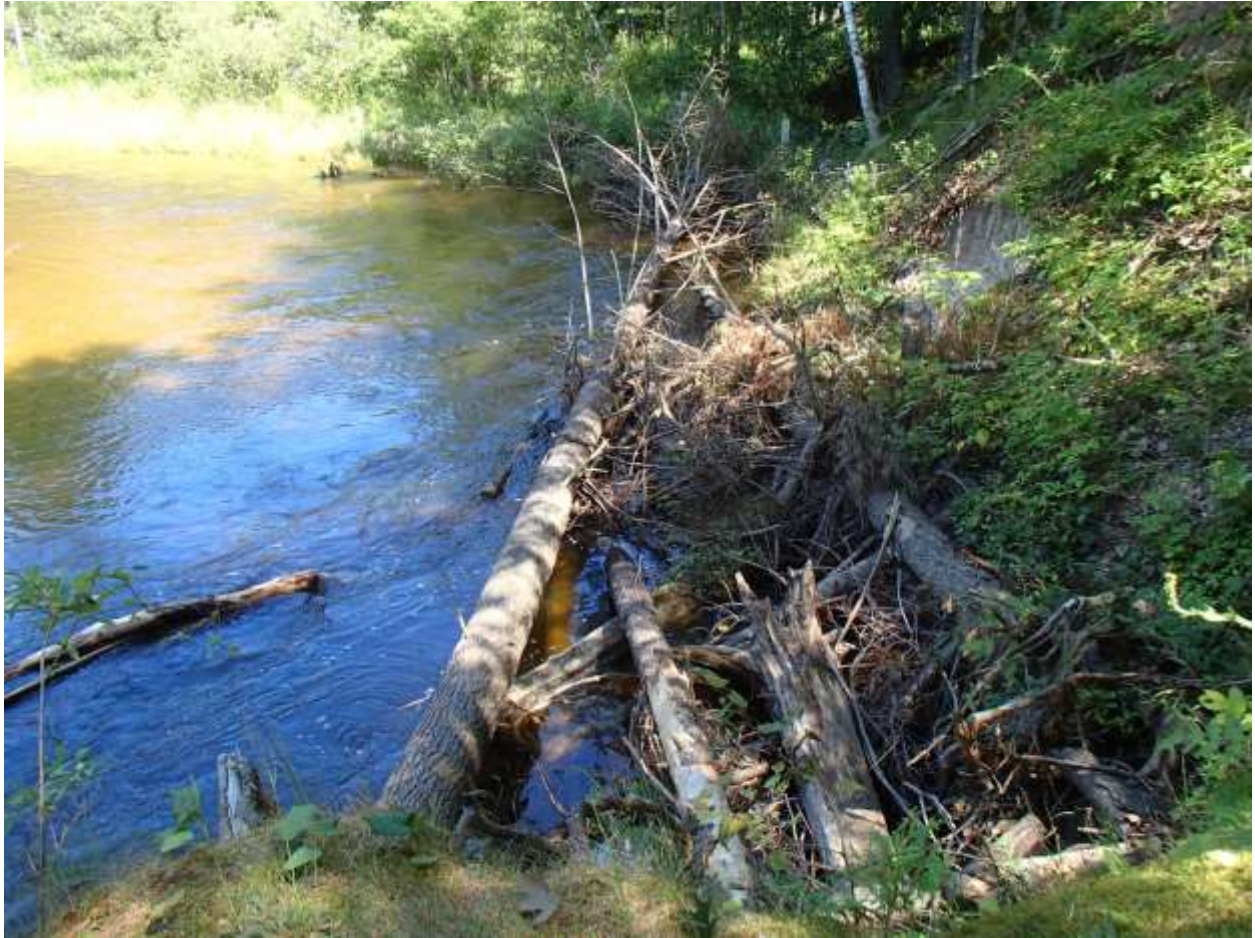
Site #63 (after 2019 high flow event) (view upstream)
