2021 Little Manistee River Eroding Stream Bank Assessment

Carrieville (Kings Highway) Bridge to Old Stronach Rd. Bridge

Nate Winkler, Biologist

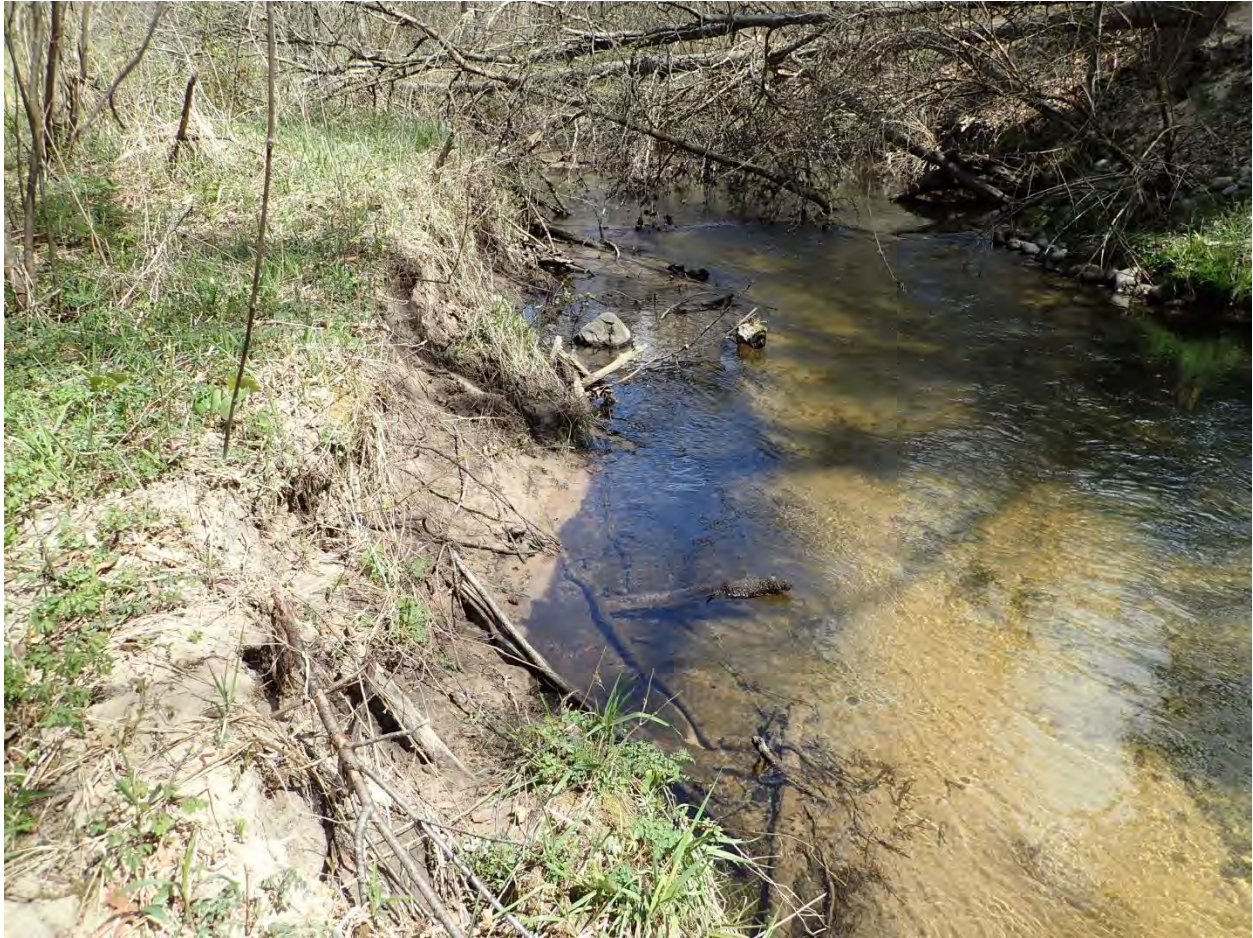
LM#2-2021

dimensions: 8' l x 8' h

river left

depth at toe: 2'

minor

substrate: sand

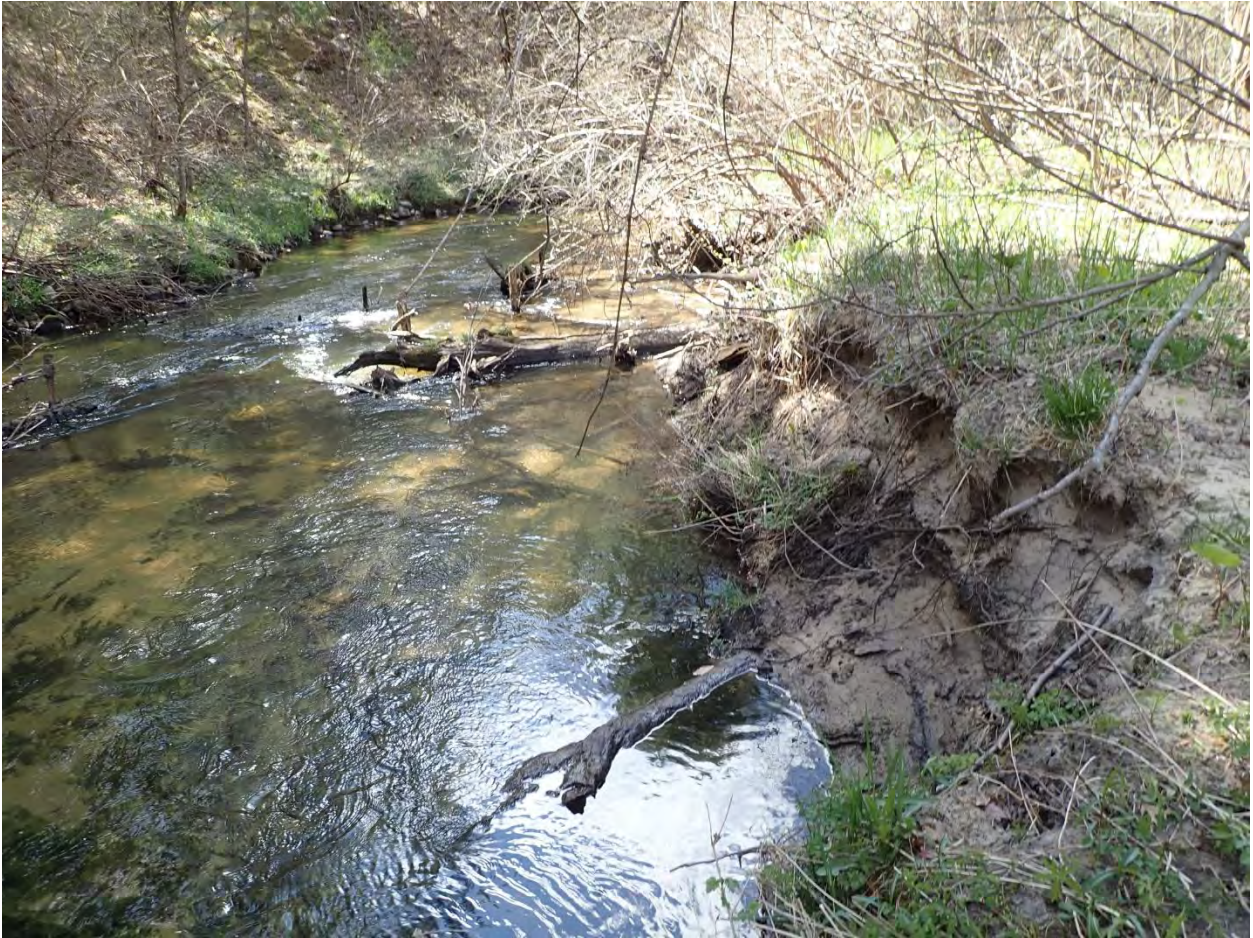
LM#3-2021

dimensions: 50' l x 4' h

river right

depth at toe: .5'

minor

substrate: sand

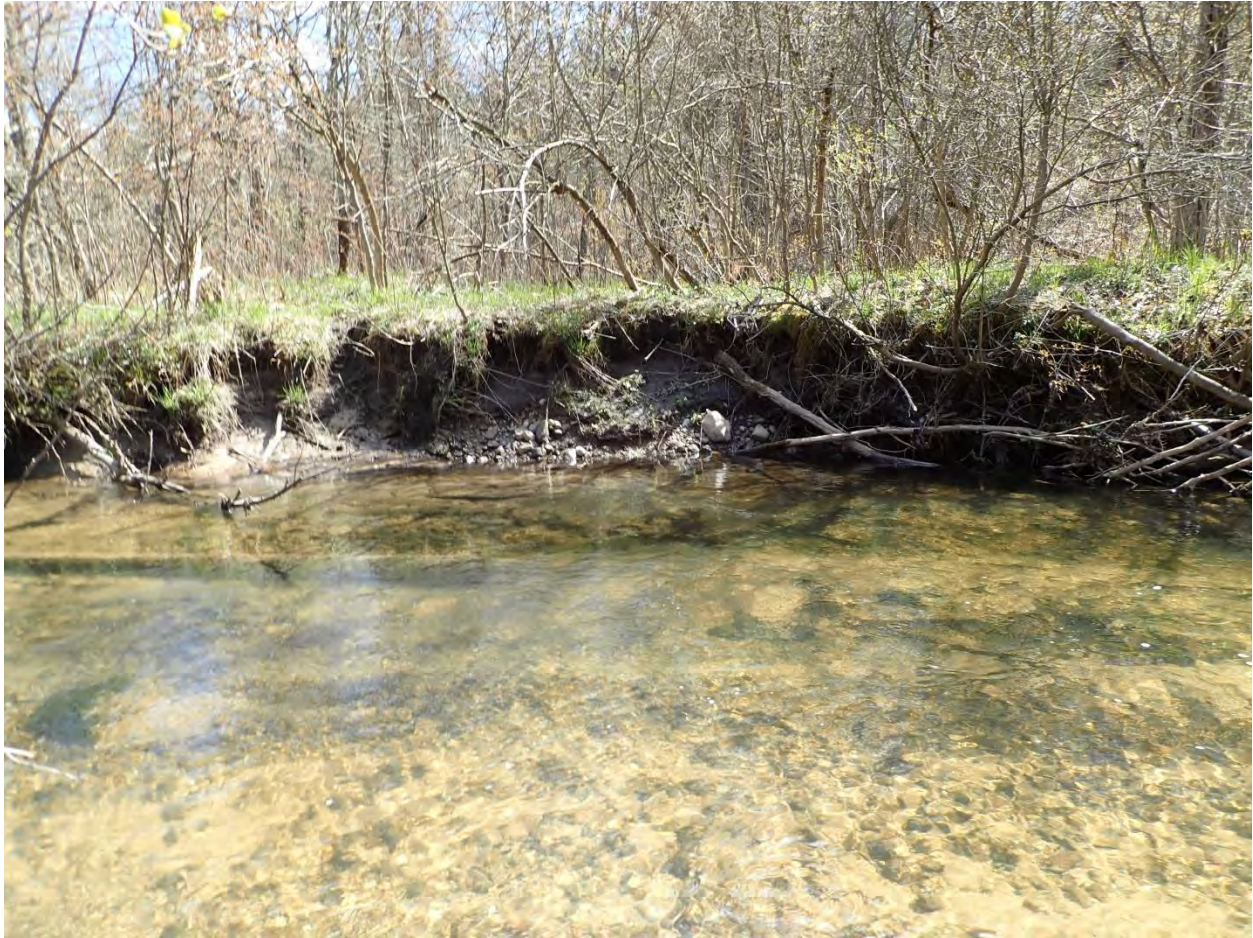
LM#4-2021 (downstream)

dimensions: 50' l x 4' h

river right

depth at toe: .5'

[moderate](#)

substrate: sand

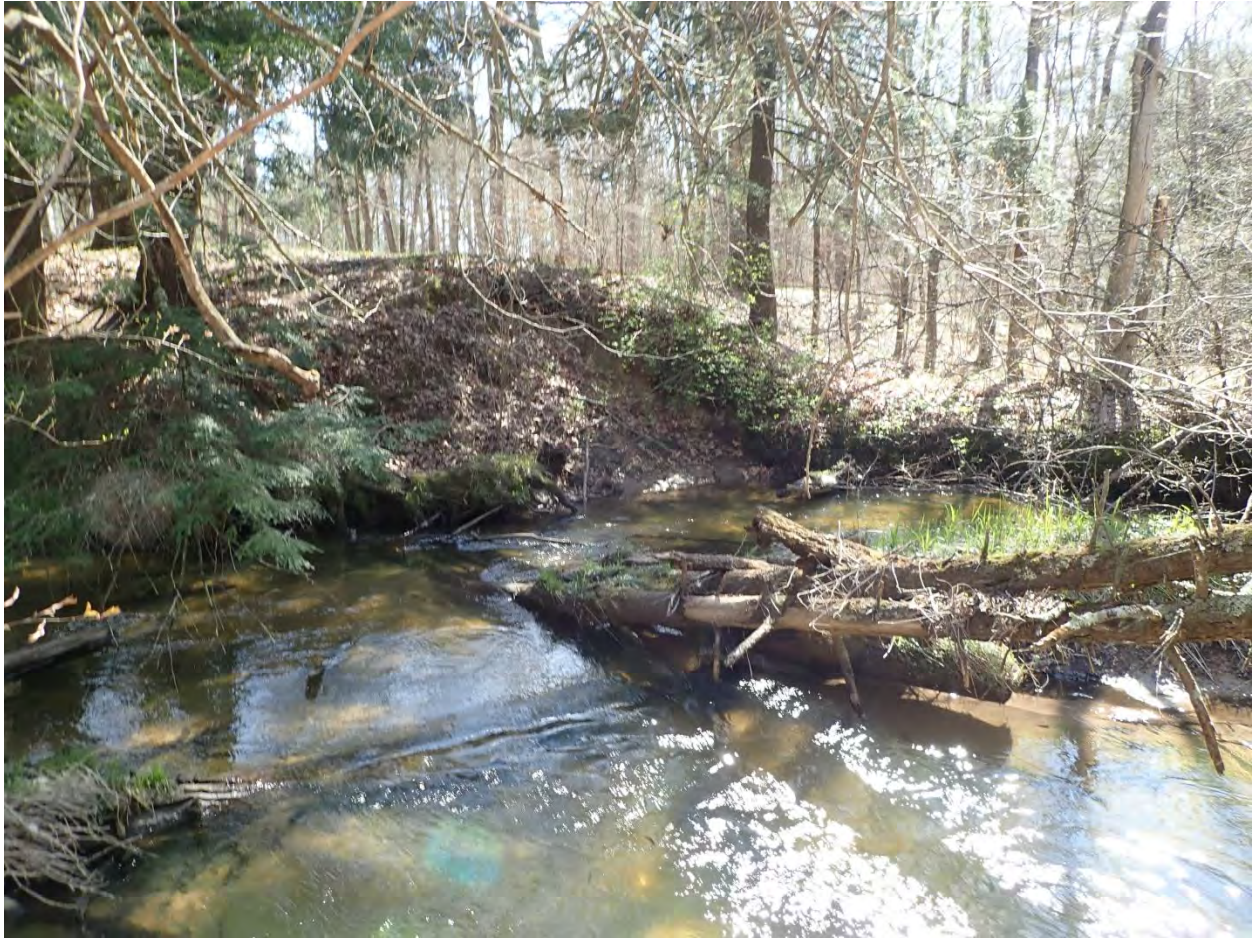
LM#7-2021

dimensions: 20' l x 5' h

river left

depth at toe: .5'

[moderate](#)

substrate: sand

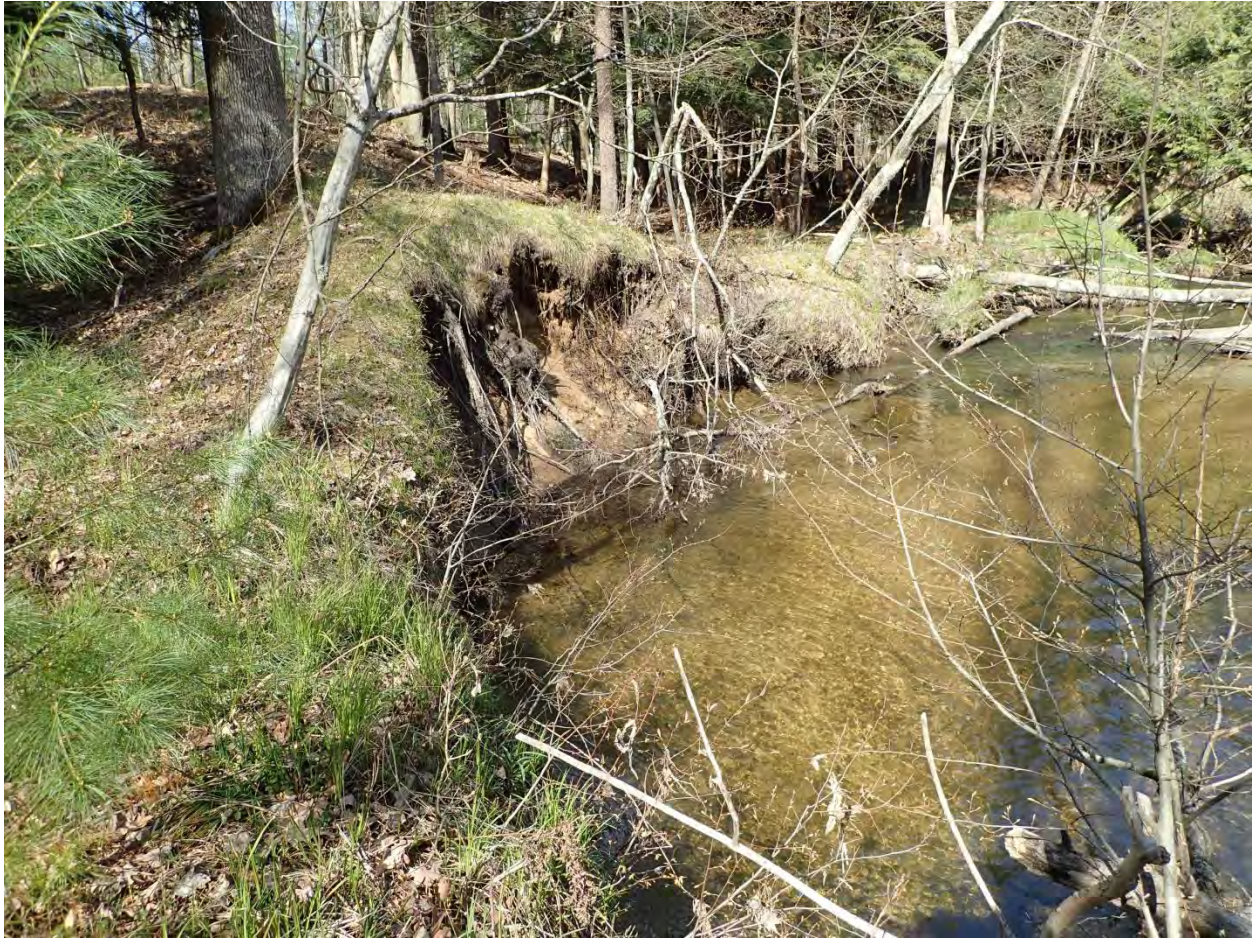
LM#8-2021

dimensions: 6' l x 7' h

river left

depth at toe: .5'

moderate

substrate: sand

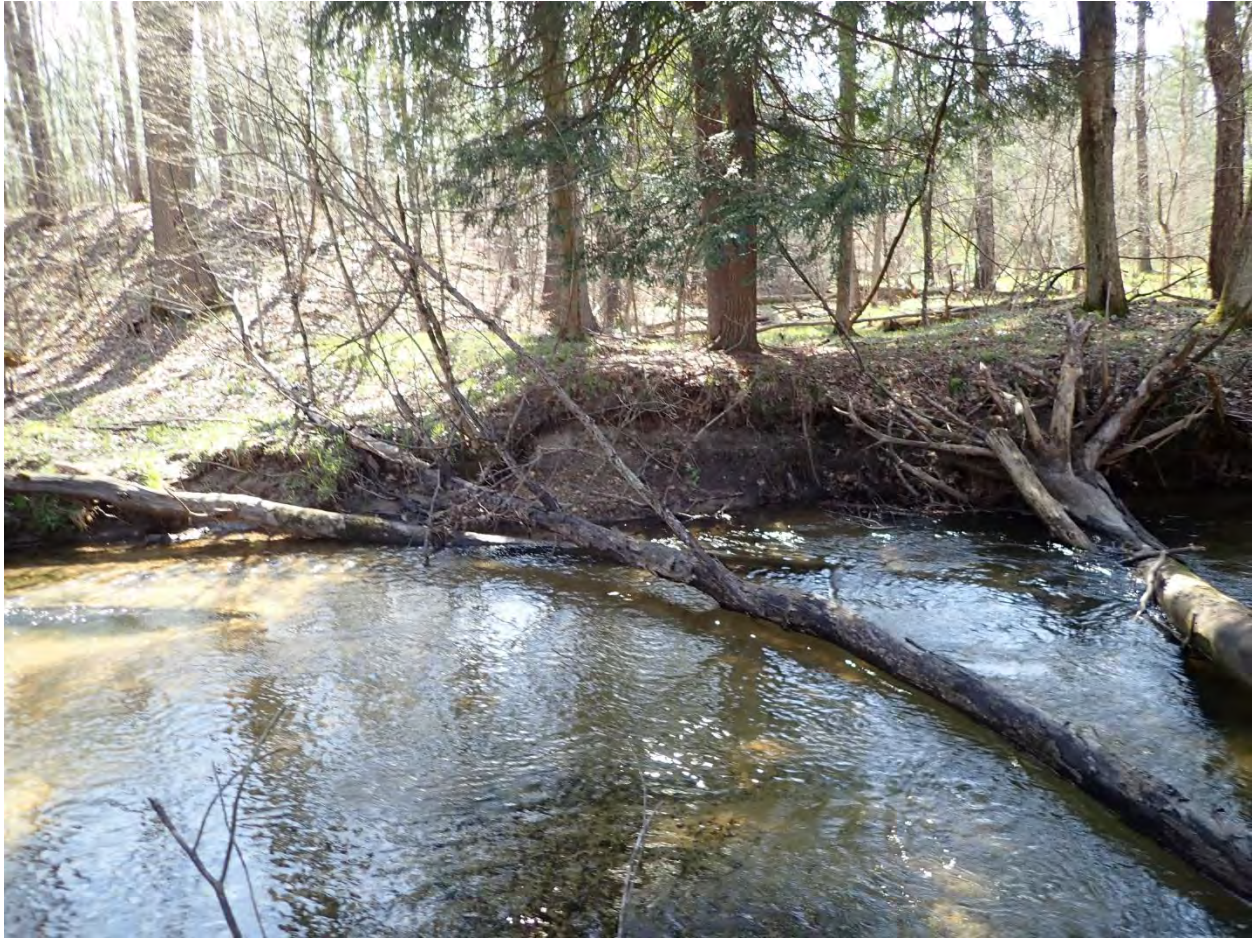
LM#9-2021

dimensions: 10' l x 10' h

river right

depth at toe: 2'

severe

substrate: sand, gravel

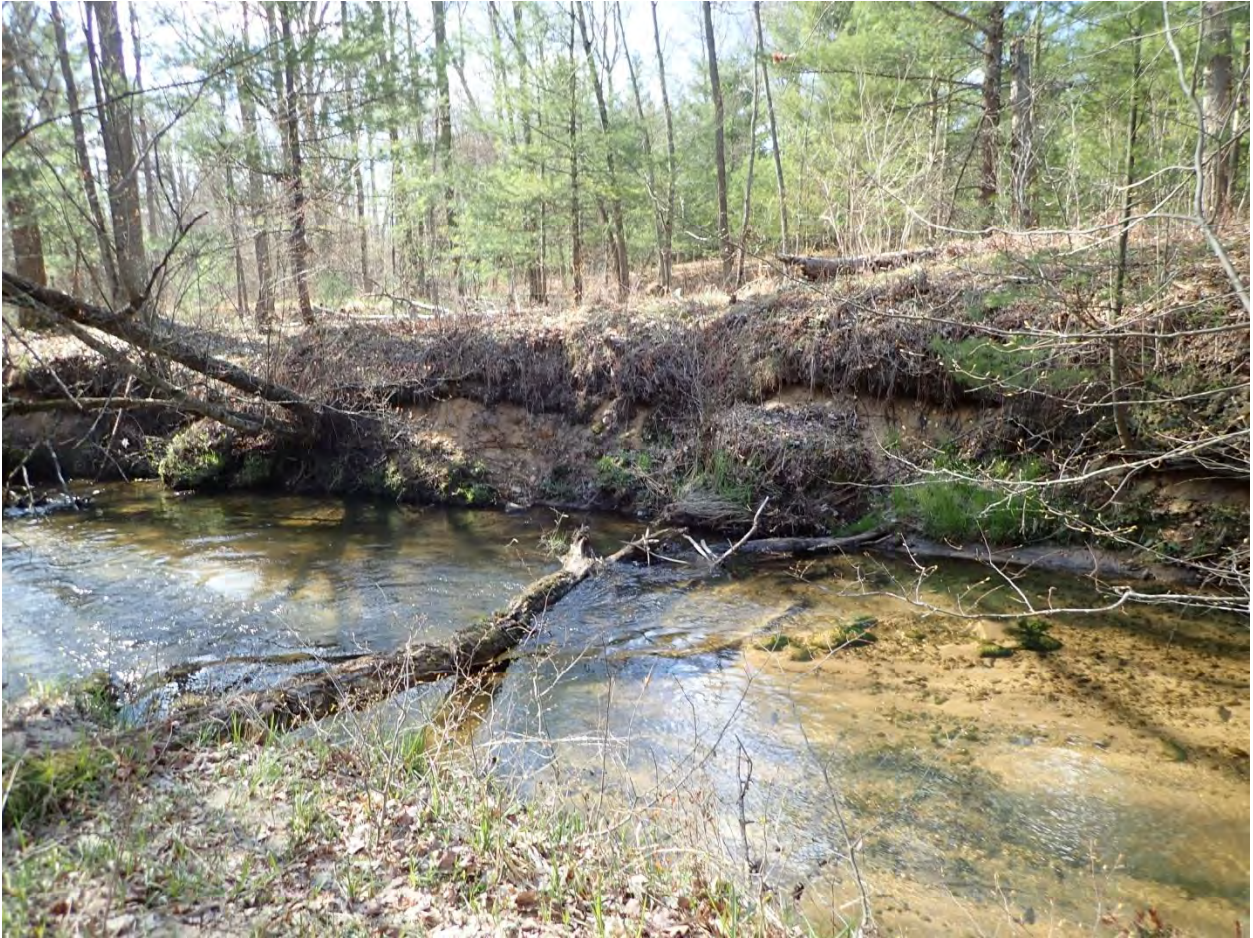
LM#10-2021
44.03519, -85.73207

dimensions: 122' l x 4'-10' h
river right
depth at toe: .5'
[moderate](#)
substrate: sand, gravel
owner: MDNR

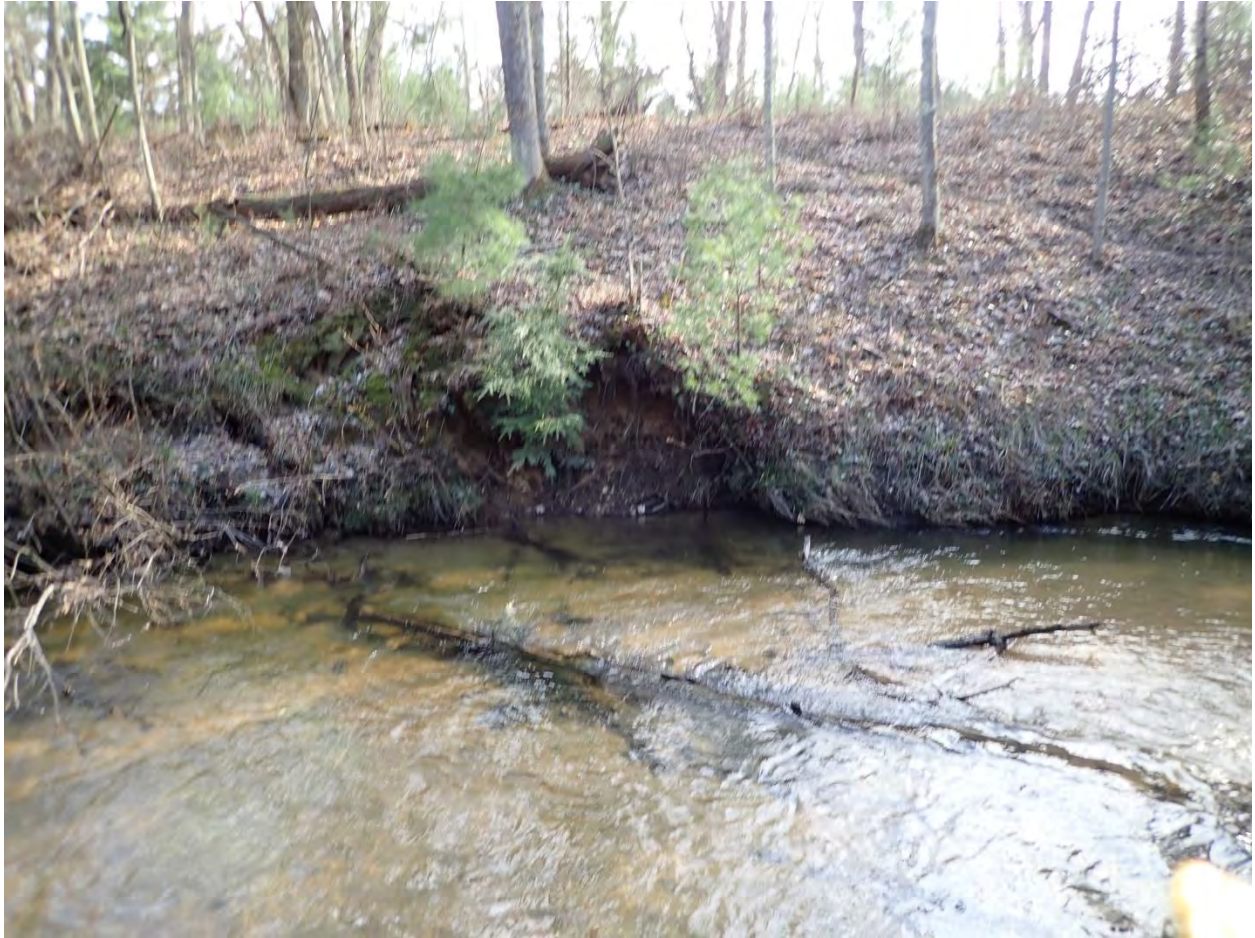
LM#11-2021

dimensions: 6' l x 5' h

river left

depth at toe: 1'

minor

substrate: sand

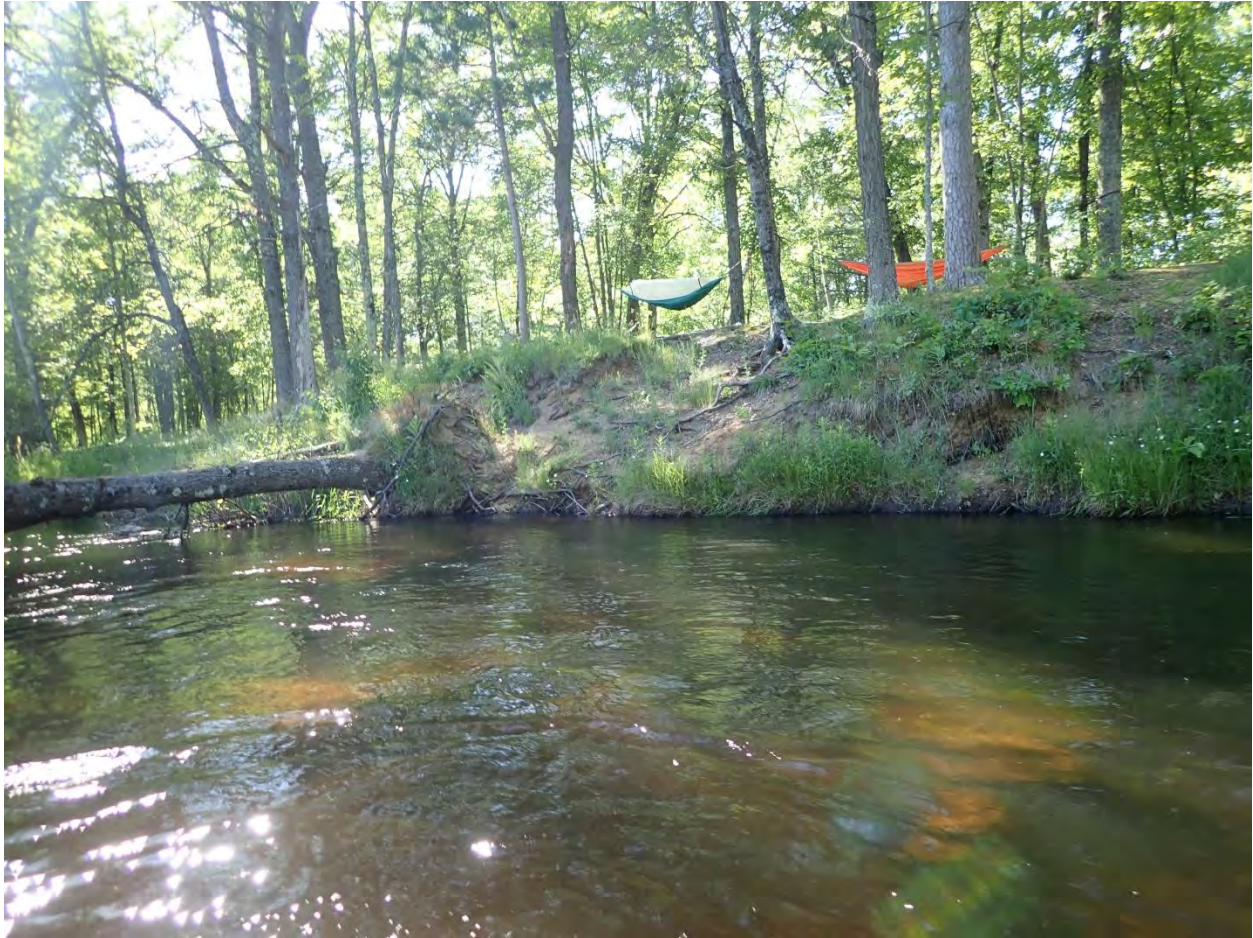
LM#14-2021

dimensions: 10' l x 6' h

river right

depth at toe: 1'

minor

substrate: sand

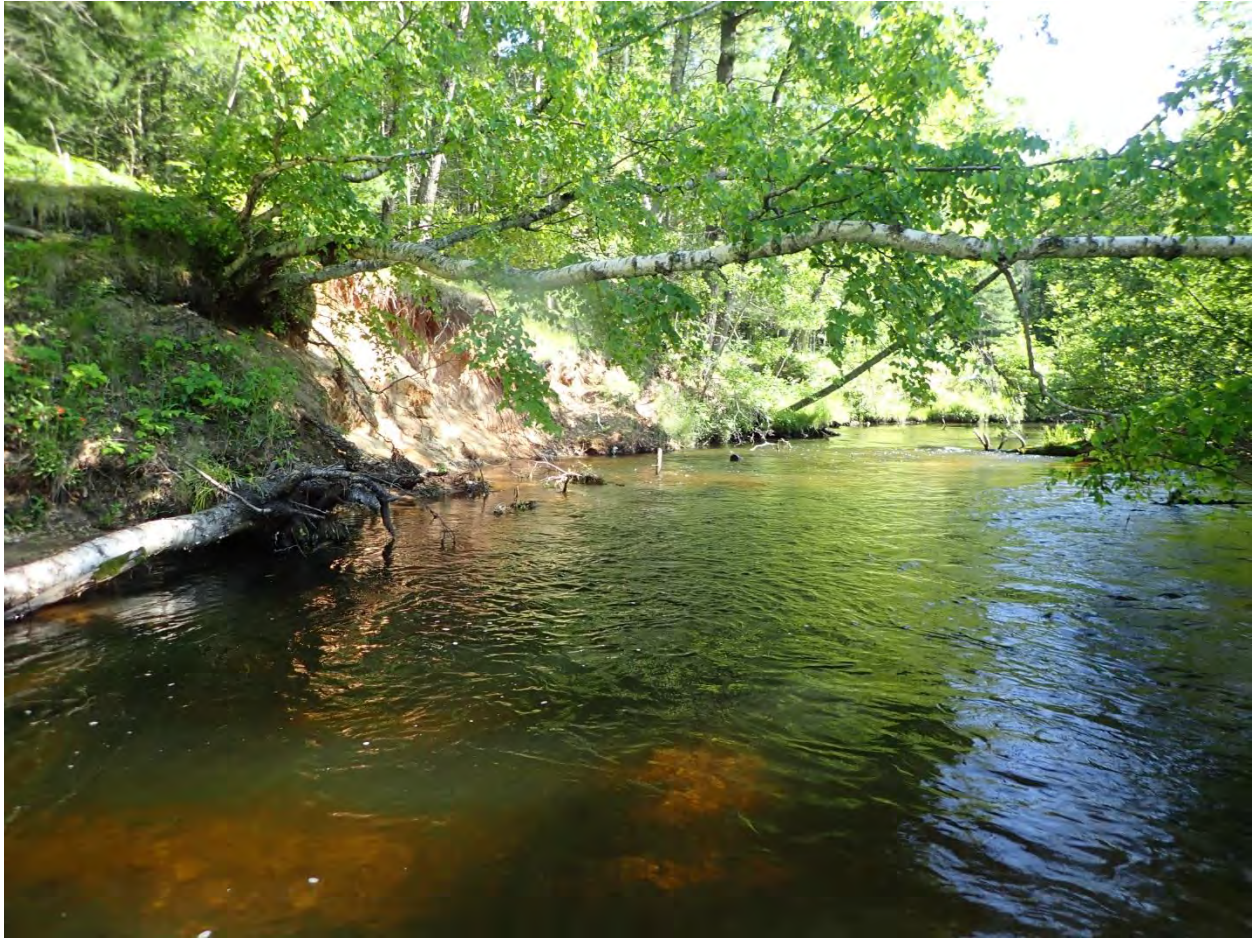
LM#15-2021

dimensions: 12' l x 8' h

river right

depth at toe: 2.5'

minor

substrate: sand

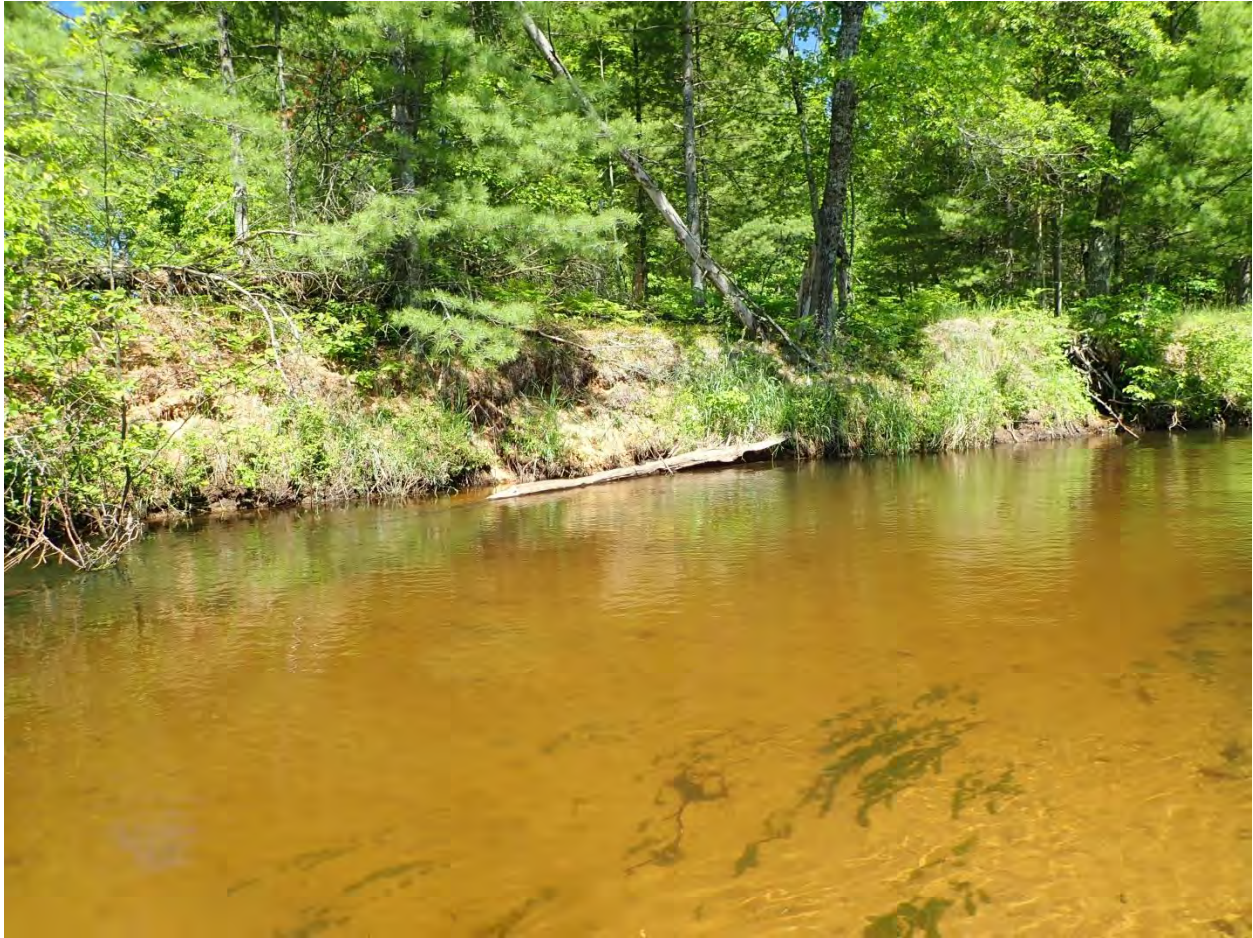
LM#17-2021

dimensions: 50' l x 12' h

river right

depth at toe: 2' - 3'

severe

substrate: medium to small gravel, sand

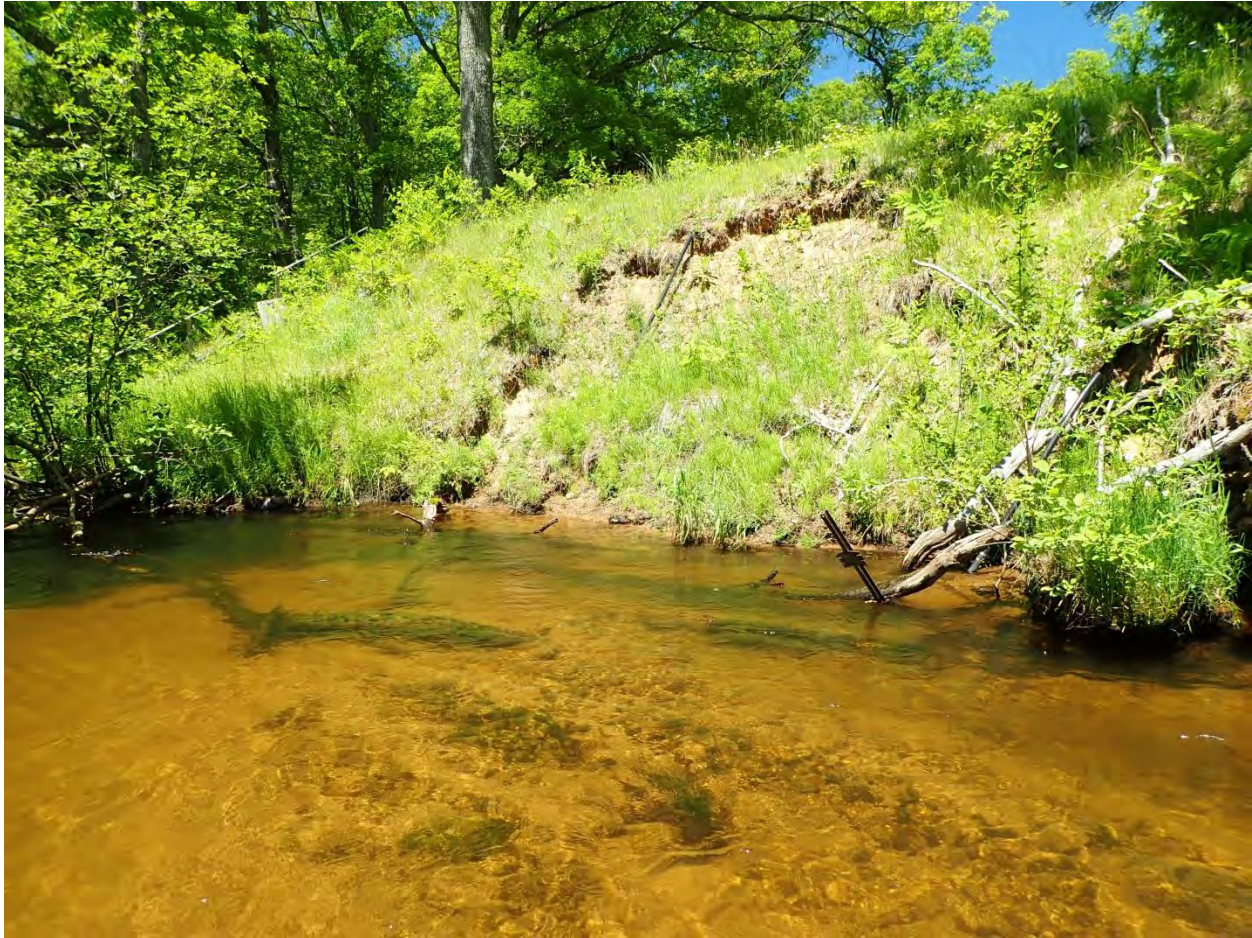
**LM#19-2021**

dimensions: 15' l x 3' h

river right

depth at toe: 4'

severe

substrate: sand

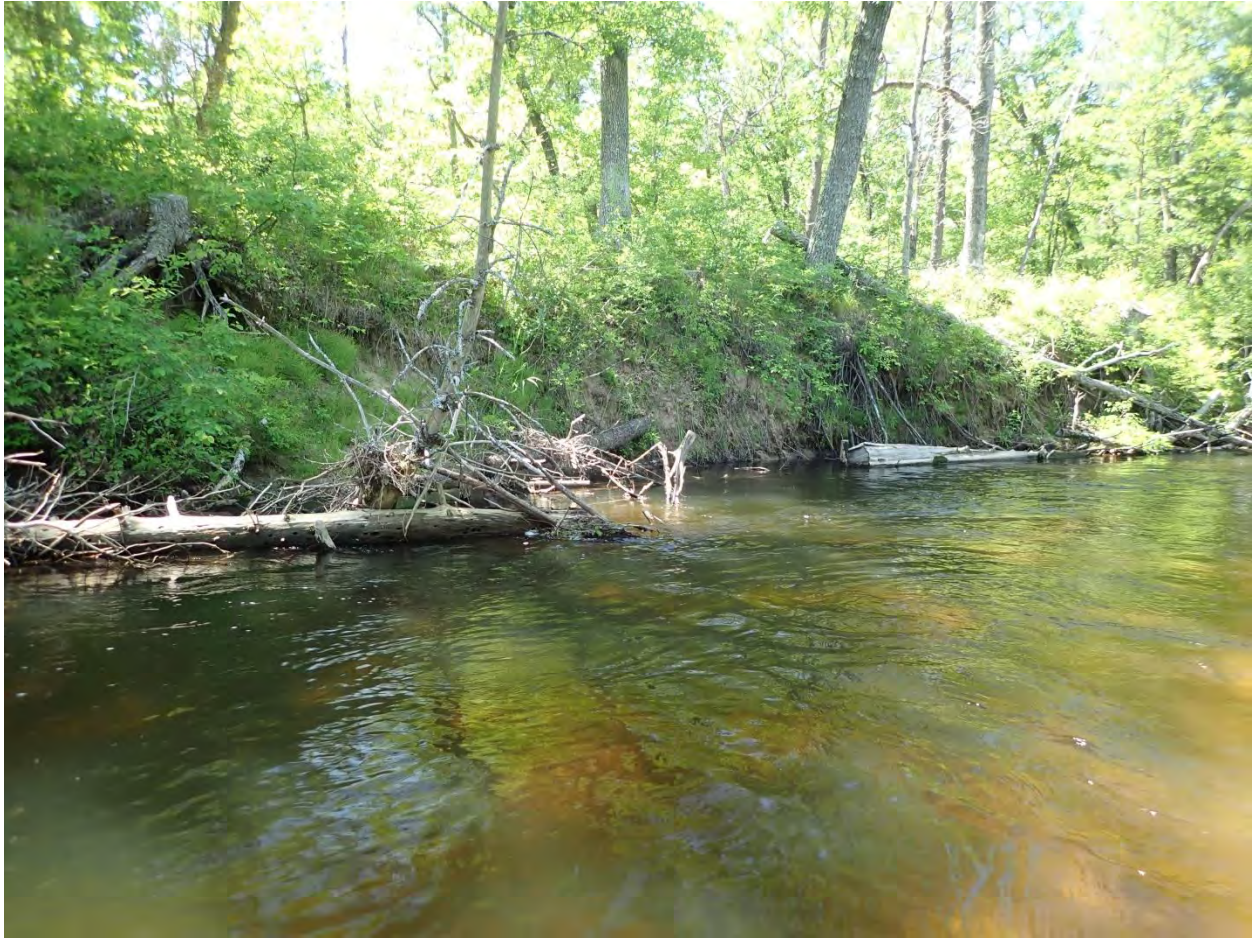
LM#20-2021

dimensions: 16' l x 20' h

river right

depth at toe: 1" to 1.5'

minor

substrate: sand, small gravel

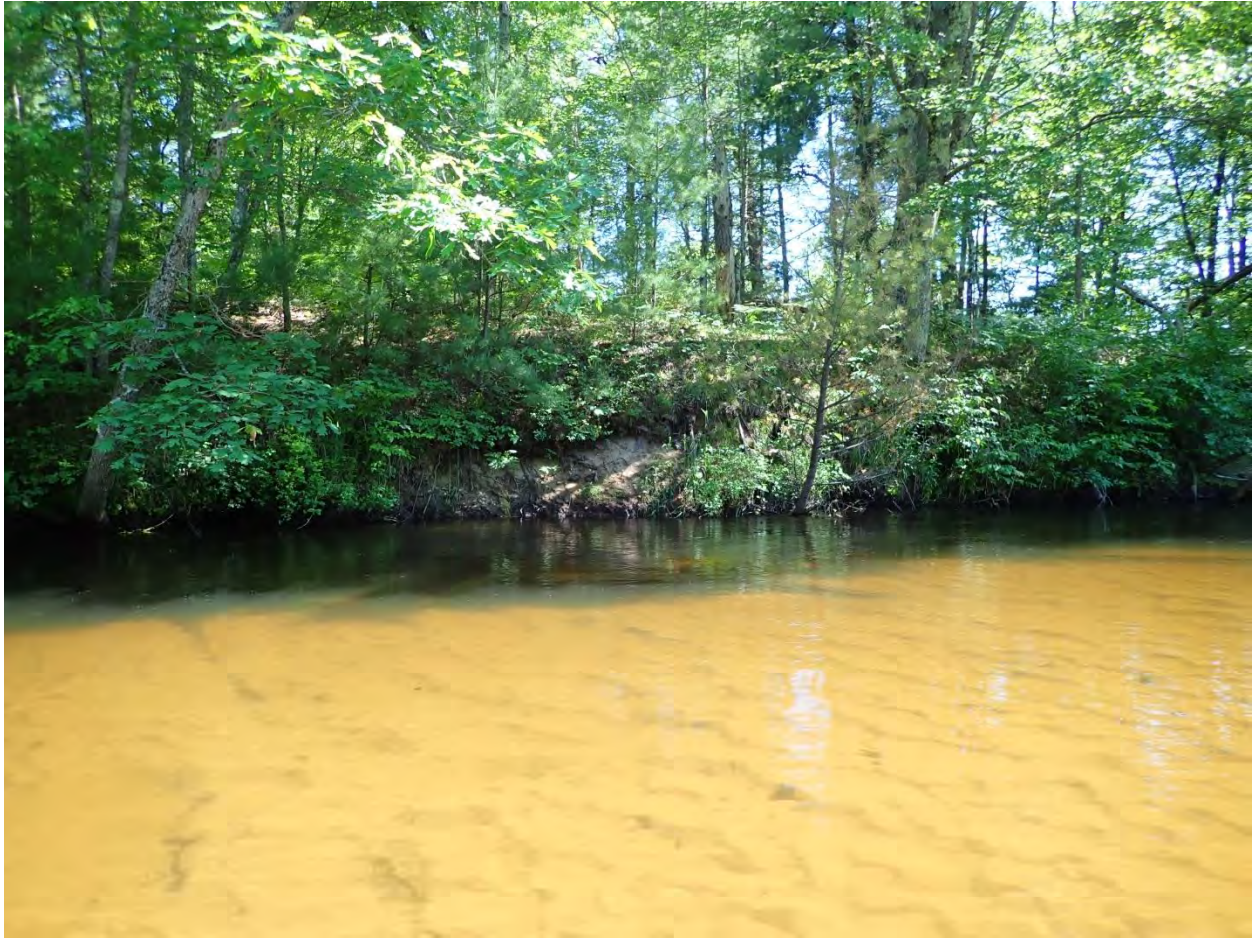
LM#21-2021

dimensions: 140' l x 12' h

river left

depth at toe: 2'- 3'

minor

substrate: small-medium gravel, sand

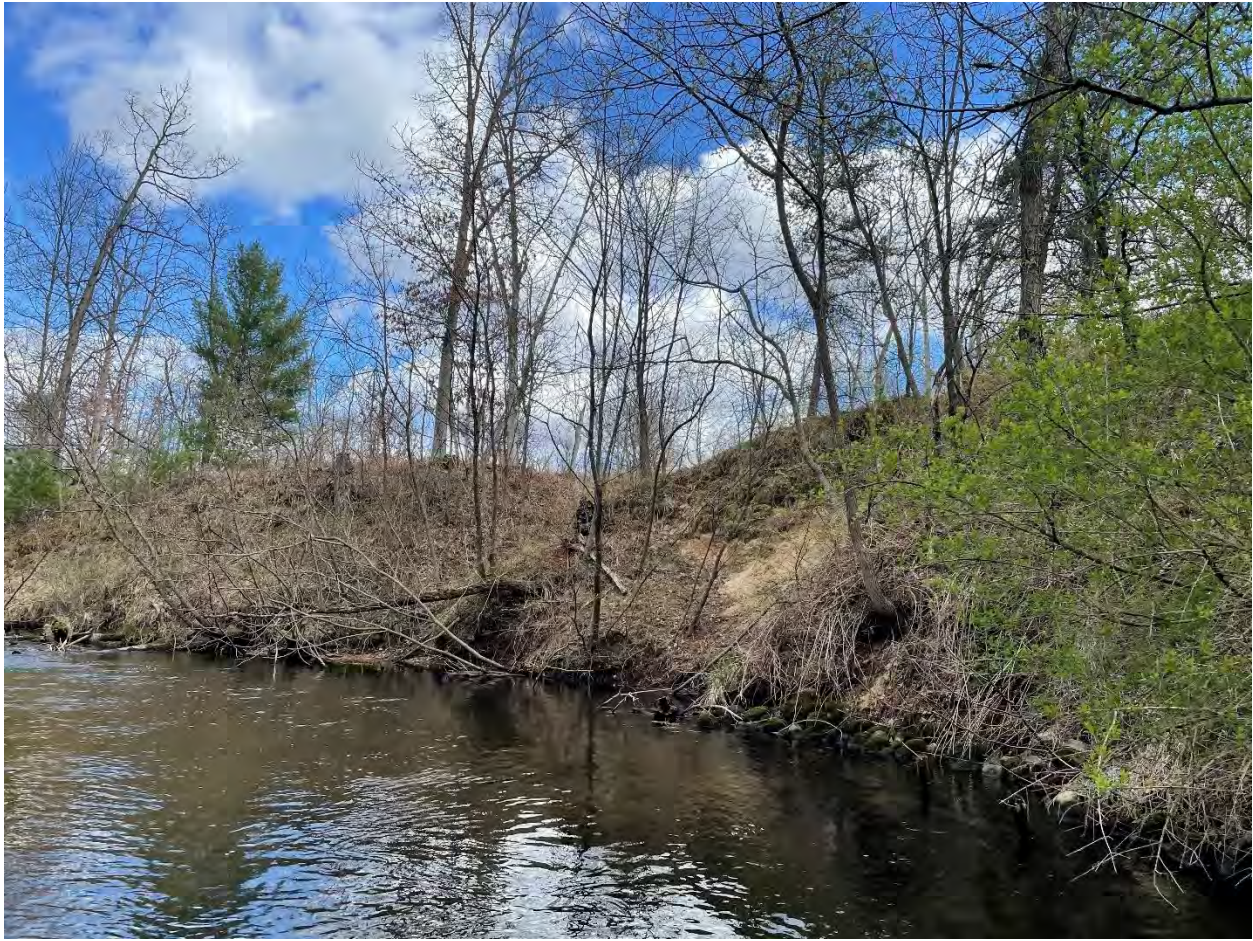
LM#23-2021

dimensions: 12' l x 8' h

river right

depth at toe: 1'-2'

minor

substrate: small-medium gravel

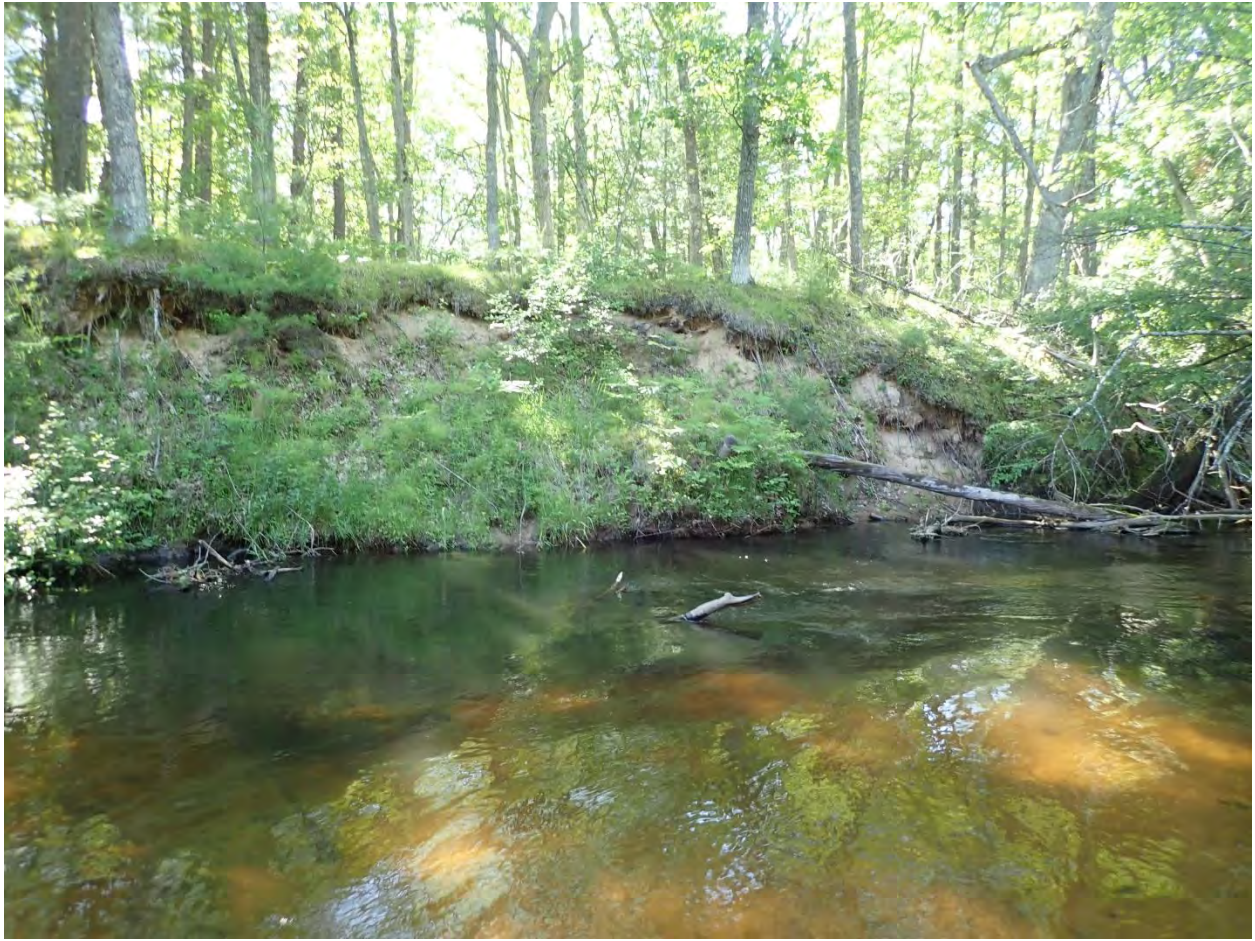
LM#24-2021

dimensions: 60' l x 18' h

river left

depth at toe: 1'-2'

[moderate](#)

substrate: sand, fieldstone

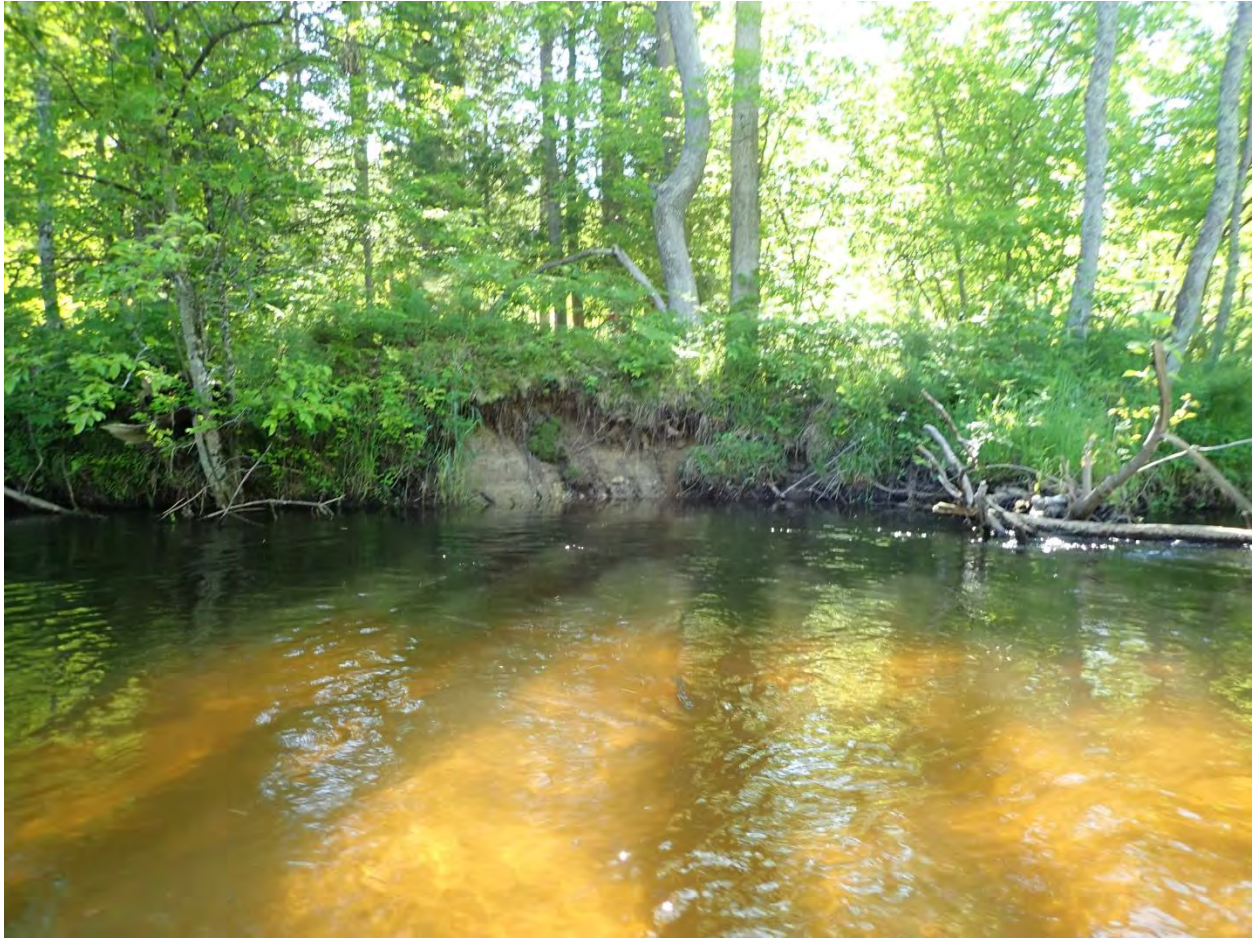
LM#26-2021

dimensions: 80' l x 19' h

river right

depth at toe: 4'

severe

substrate: sand

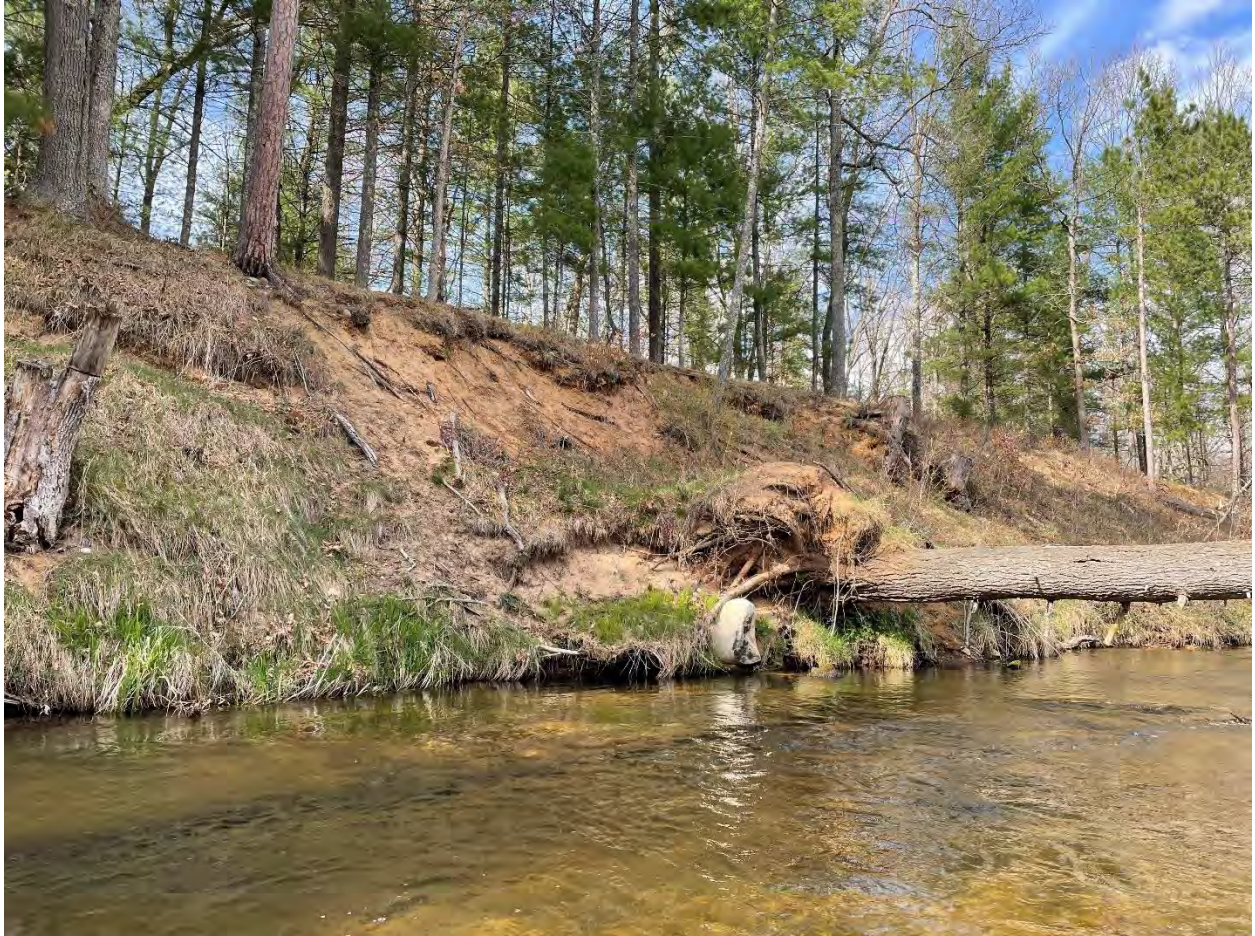
LM#28-2021

dimensions: 5' l x 8' h

river right

depth at toe: 3'

minor

substrate: sand

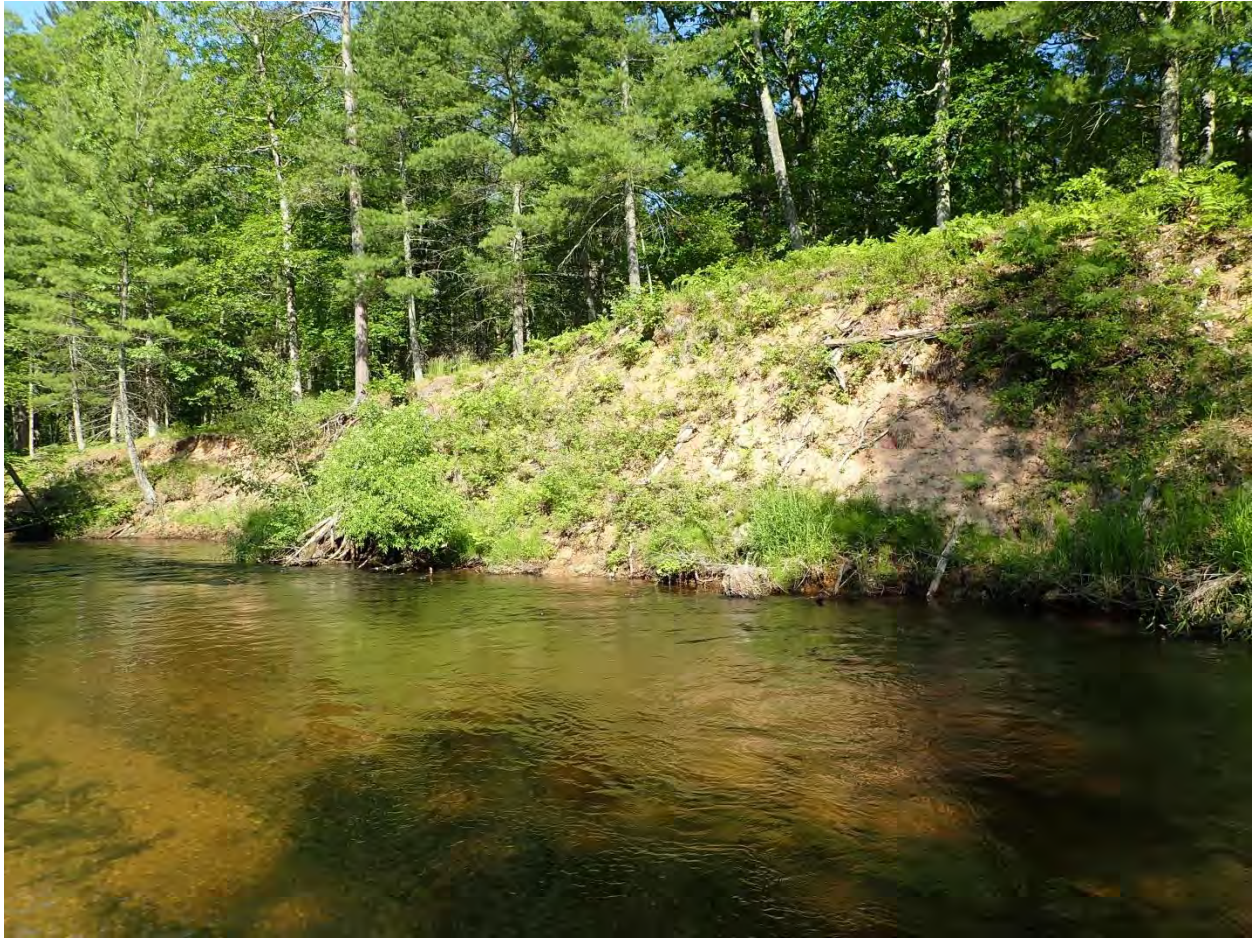
LM#29-2021

dimensions: 40' l x 20' h

river right

depth at toe: 2'

minor

substrate: cobble, gravel, sand
