2021 Little Manistee River Eroding Stream Bank Assessment

Carrieville (Kings Highway) Bridge to Old Stronach Rd. Bridge

Nate Winkler, Biologist

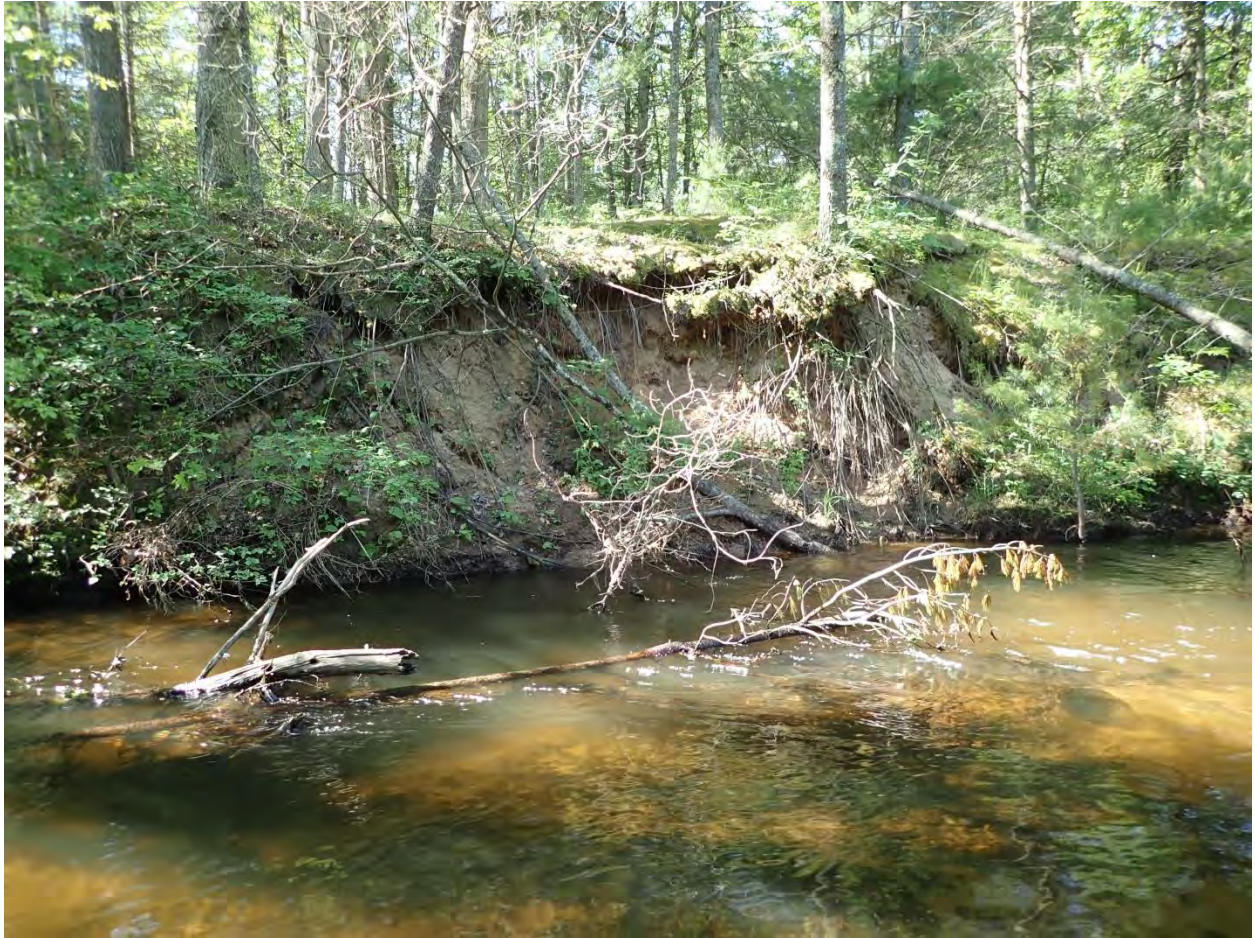
LM#30-2021

dimensions: 100' l x 10'-18' h

river right

depth at toe: 2.5'

minor

substrate: sand, vegetation

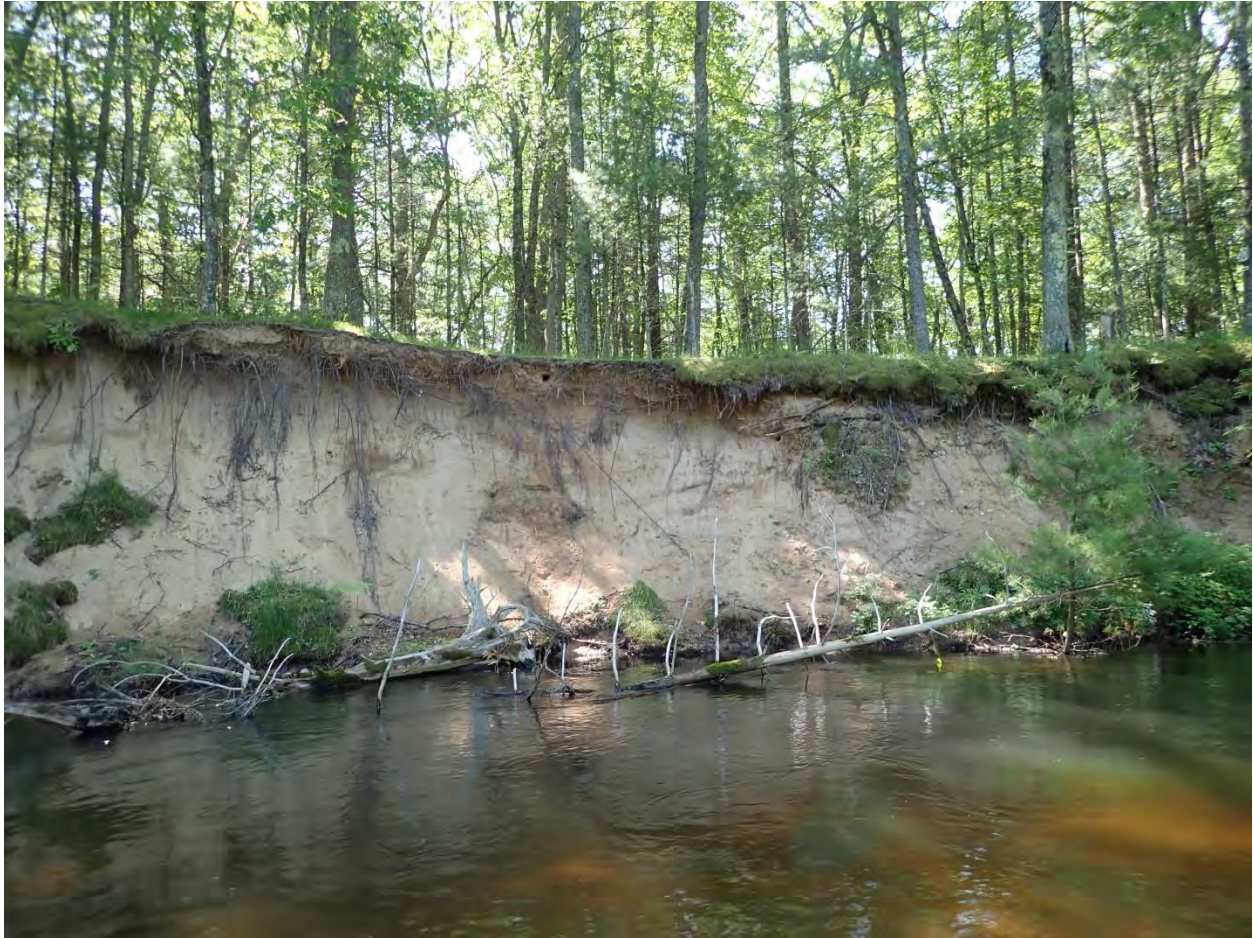
LM#32-2021

dimensions: 70' l x 10' h

river right

depth at toe: 2'

moderate

substrate: medium gravel, sand

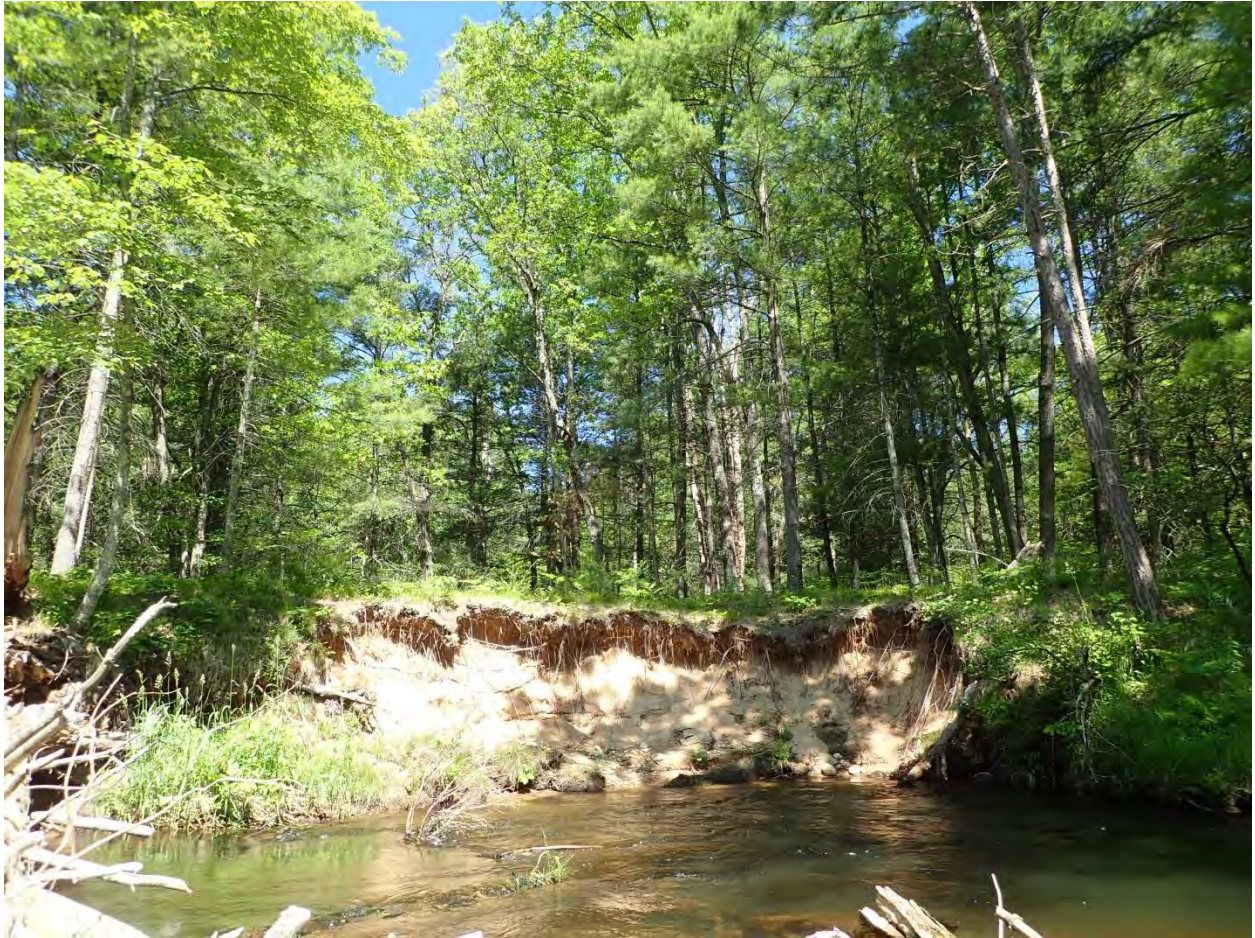
LM#34-2021

dimensions: 65' l x 8' h

river left

depth at toe: 4.5'

severe

substrate: small-medium gravel

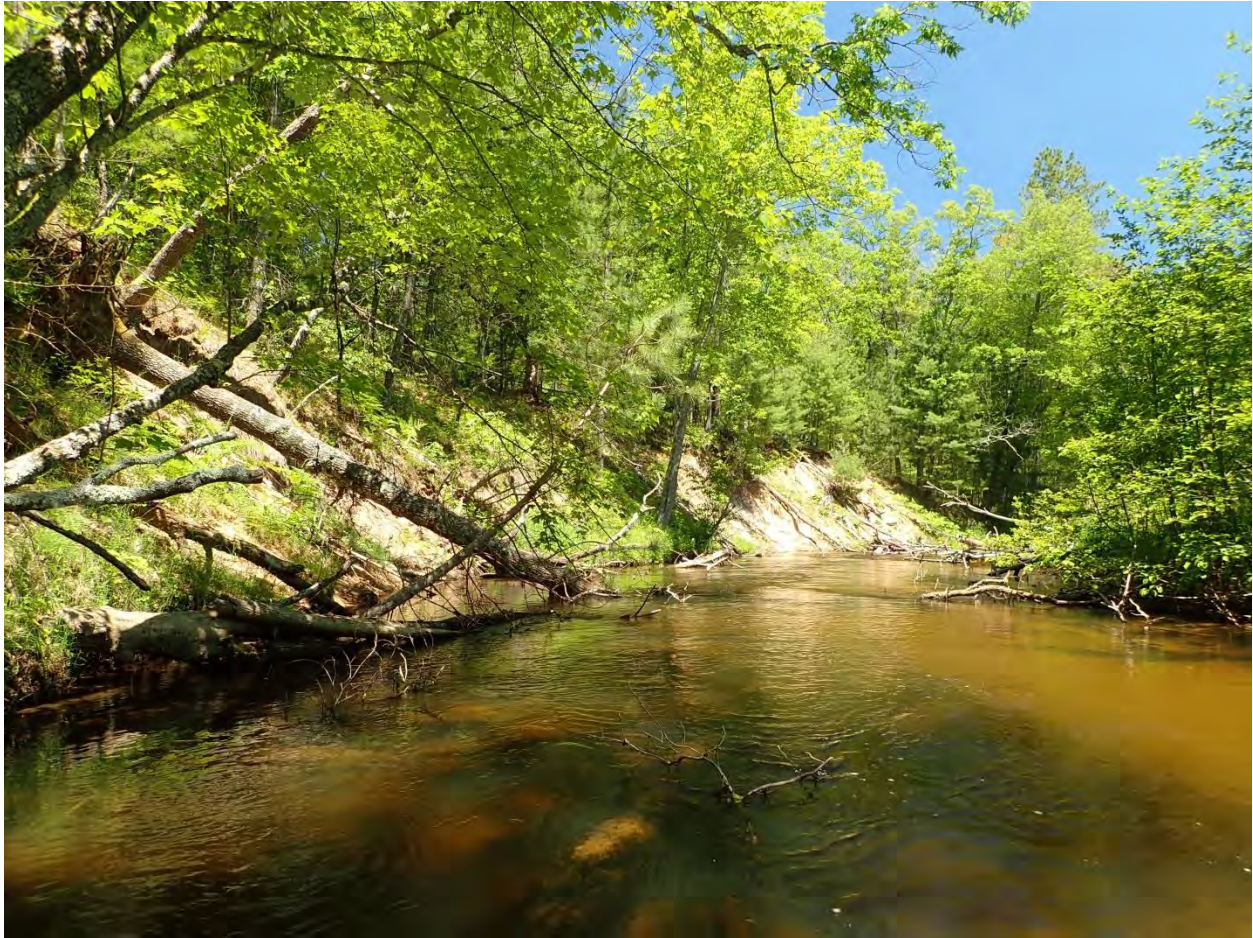
LM#37-2021

dimensions: 45' l x 20' h

river left

depth at toe: 5'

minor

substrate: gravel

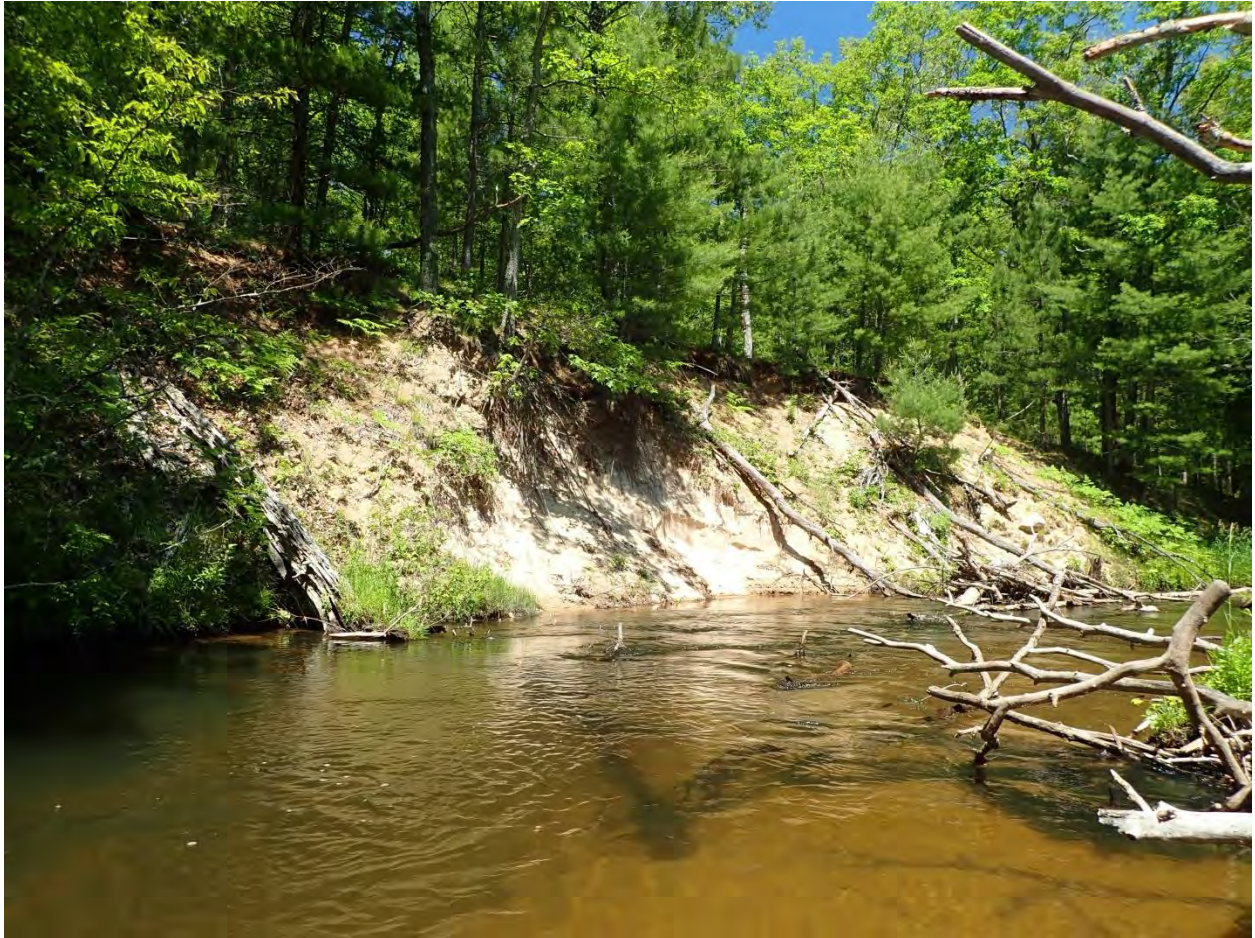
LM#38-2021

dimensions: 35' l x 20' h

river left

depth at toe: 4'

severe

substrate: sand, medium gravel

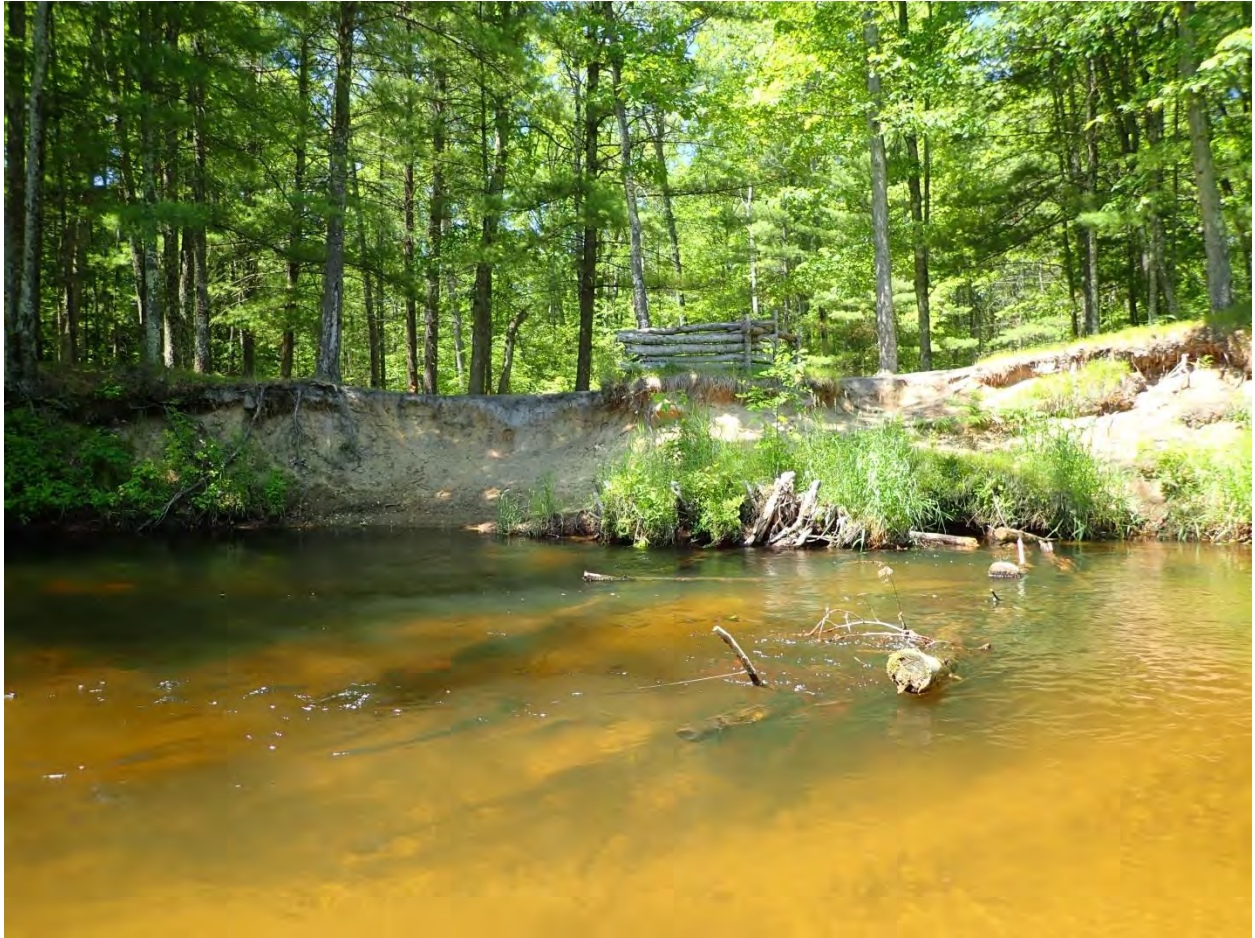
LM#41-2021

dimensions: 15' l x 8' h

river right

depth at toe: 3'

[moderate](#)

substrate: sand, gravel

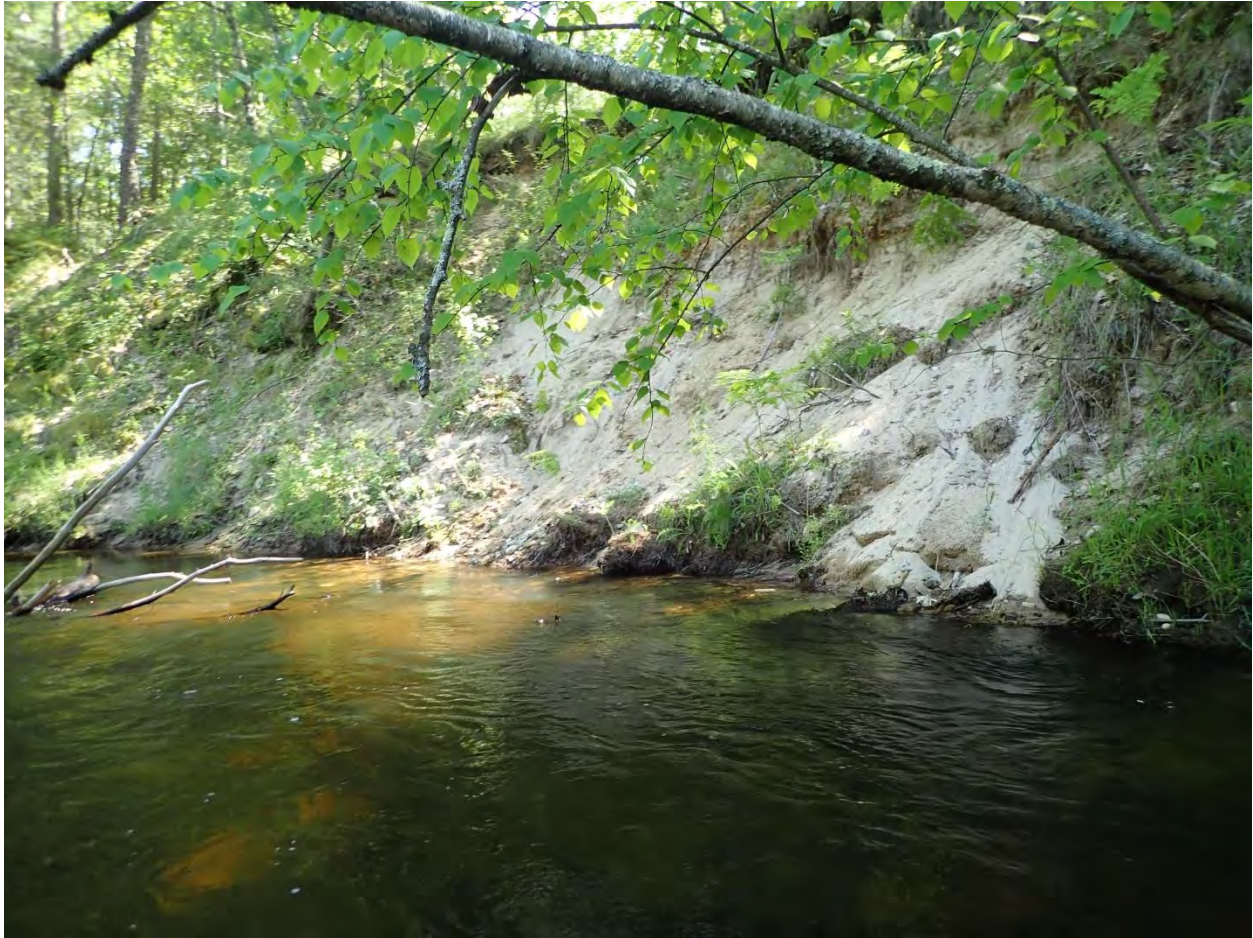
LM#44-2021

dimensions: 40' l x 12' h

river left

depth at toe: 3'

[moderate](#)

substrate: fine, medium, coarse gravel

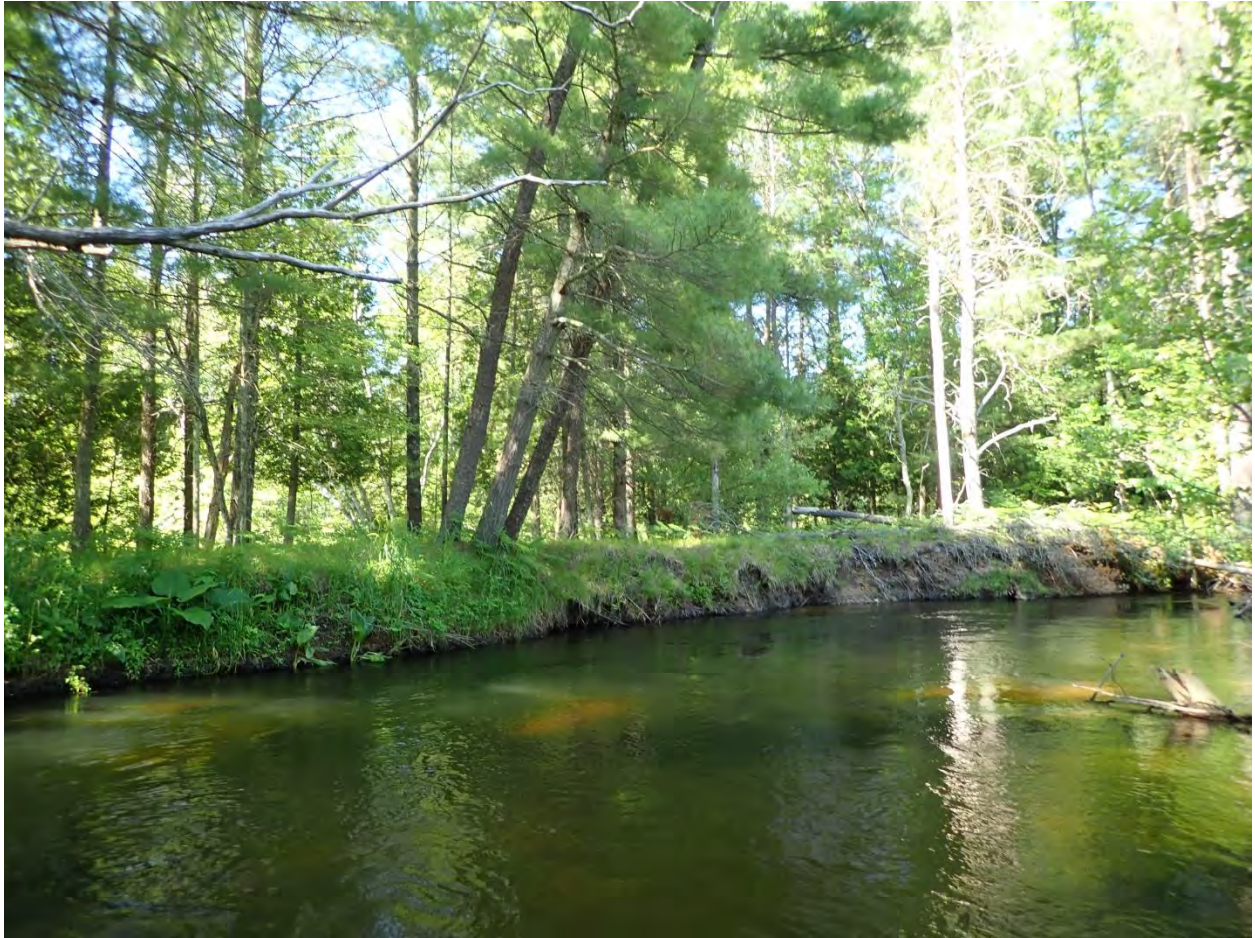
LM#45-2021

dimensions: 30' l x 12' h

river left

depth at toe: 6'

severe

substrate: sand, coarse gravel, cobble

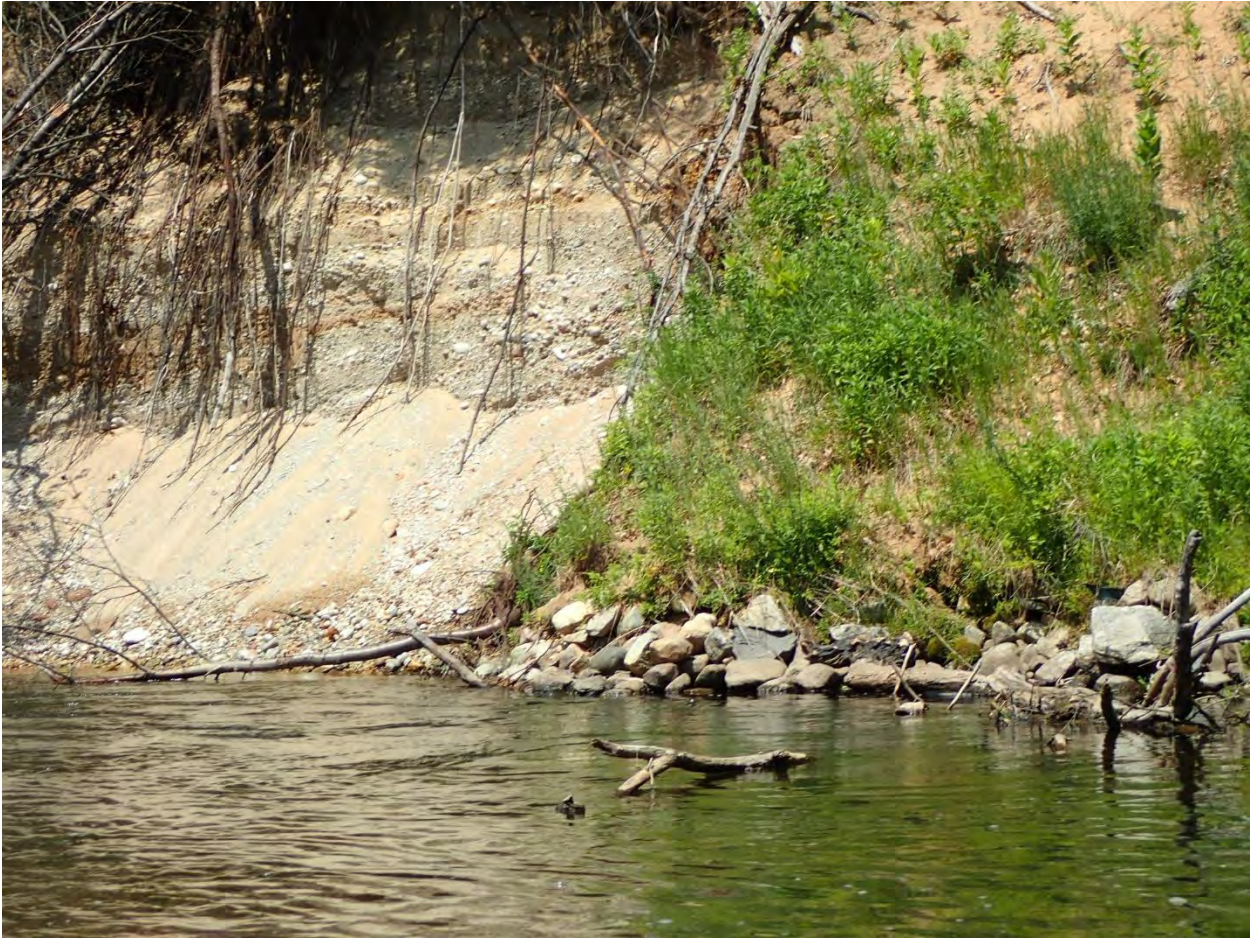
LM#73-2021 (closeup of prior fieldstone stabilization effort)
