Conservation Resource Alliance

Syers Creek Fisheries Survey 2019 Update Report

**Syers Creek Fisheries Survey
2019 Update Report**

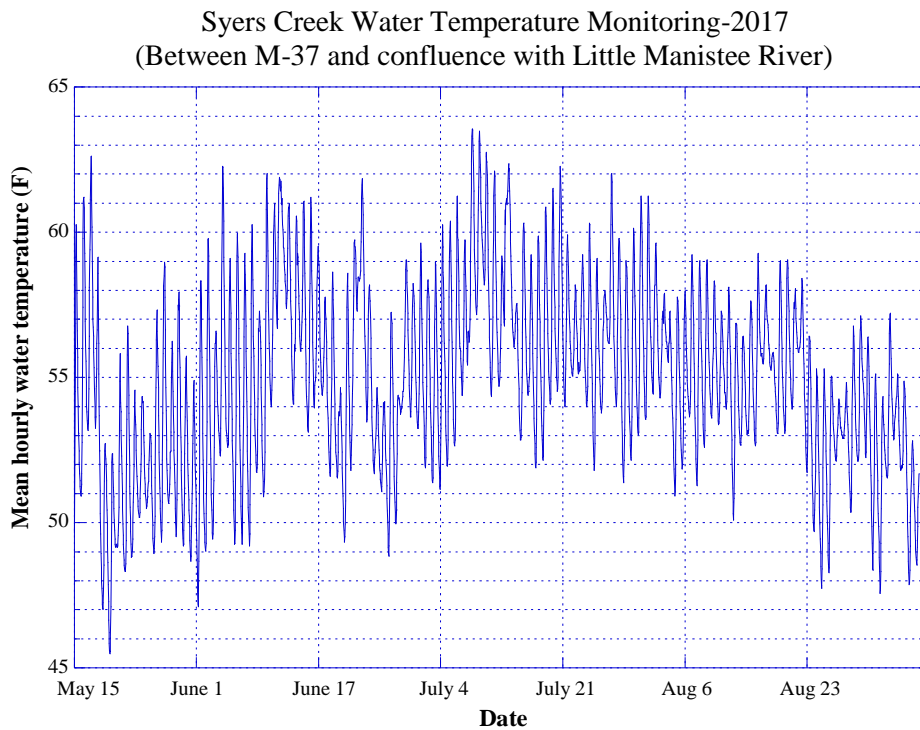
Figure 1. (data courtesy of Chris Riley, USFS-HMNF)

Figure 1. Temperature data recorded by USFS.....6

The diversity of fish species illustrated in the three tables above diverges from that normally associated with a cold water fluvial system and is explained by the presence of the eutrophic lakes at the upstream end of the relatively short creek. Warm water fish species entrained through the dam at Syers Lake likely followed the water as it receded downstream during periods of little or no flow. The ability of the creek to consistently provide habitat to cold water species (*Salmonidae*, *Cottidae*) occurs somewhere between the two crossings of M-63 whereupon groundwater spring influence and/or cold water tributaries mitigate the warm water surface discharge from Syers Lake. The data below obtained by the USFS and CRA provide a snapshot of conditions in Syers Creek, limited in its usefulness as a source of statistically significant information but provides some insight into the primary driver in determining fish species assemblages.
