# Little Manistee River 2021 Report

*Mason-Lake Conservation District*

*Little Manistee Watershed Conservation Council*

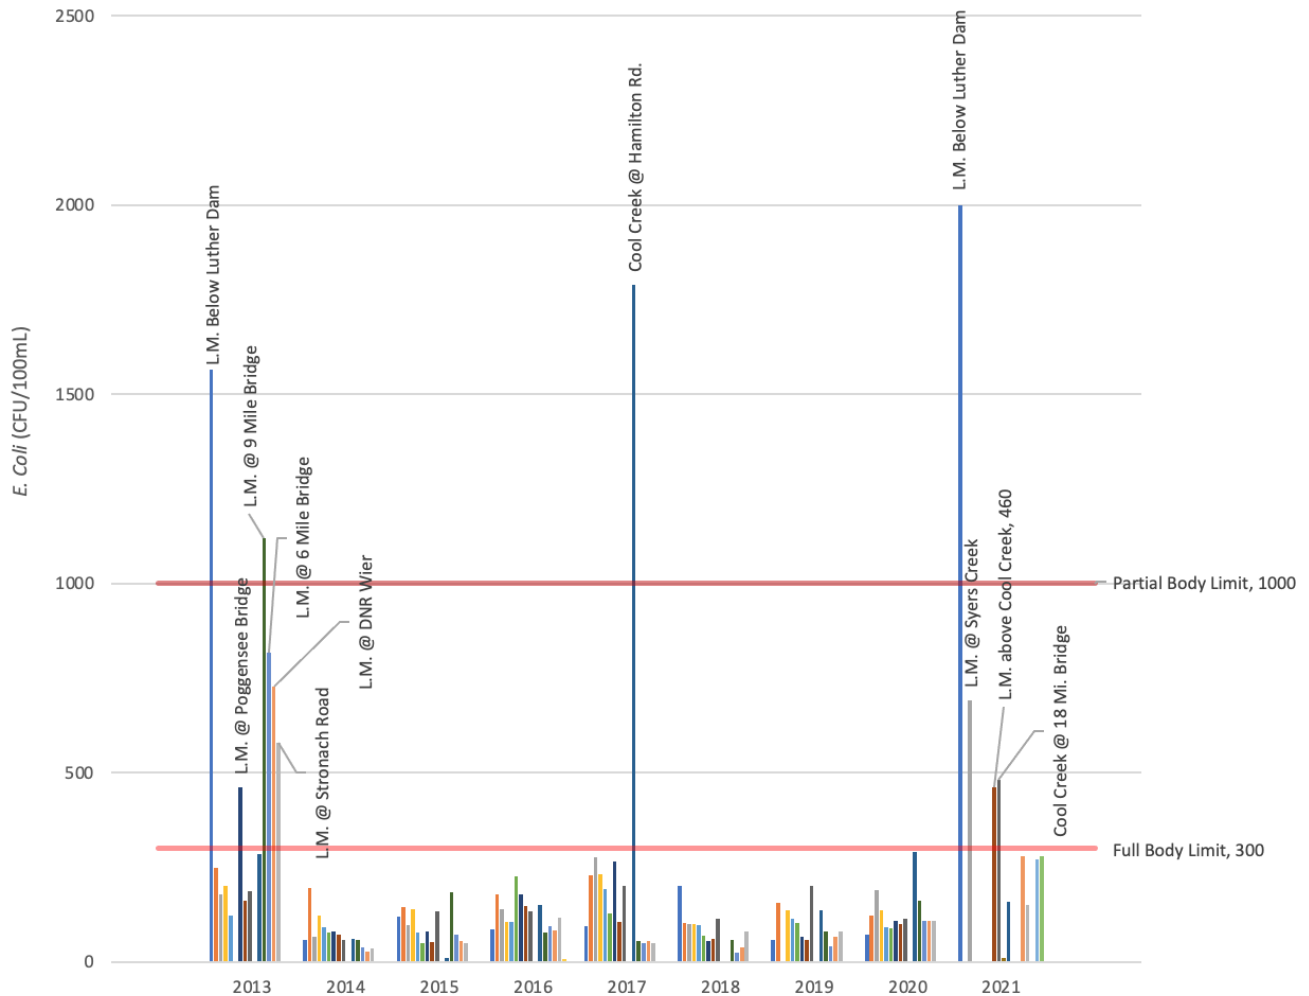
### Little Manistee *E. Coli* Results 2013-2021

The largest spike in 2021 was in the river at Luther Dam, about 20 feet from where it leaves Mill Pond. It needs to be monitored in the future, and further testing needs to be done to determine if the bacteria is coming from humans or other animals. This will help determine if further regulation needs to be done on nearby agriculture or septic systems.

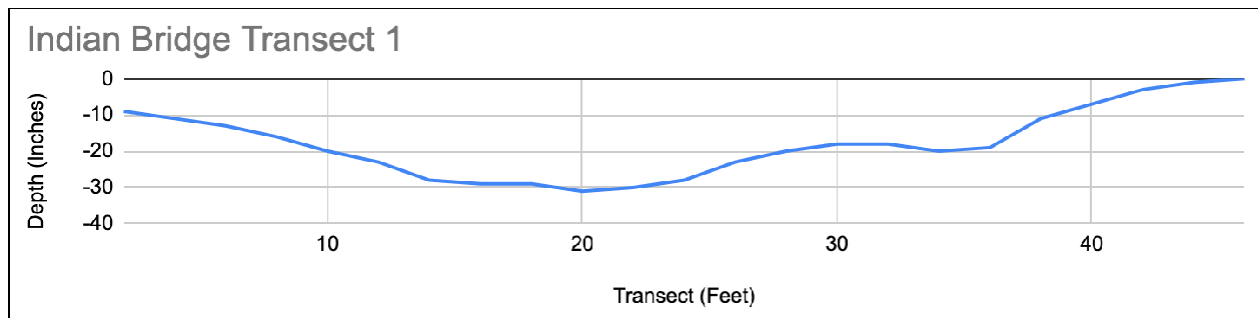
These assessments are done by measuring 300 ft of the stream. At 0, 150, and 300 feet transects are put into place. During these transects, the depth is measured, and the substrate is determined across the stream every couple of feet. While doing these transects notes are recorded about the river vegetation, riverside or riparian vegetation, and land use of the riparian areas. The riverbanks are assessed for erosion as well during the habitat assessments minimal erosion was found. Other erosion surveys have been done along the river and there are significant amounts of erosion in some areas. Below is one of the graphs that shows a transect of the Little Manistee River. This would be a cross-section of the river, with the left and right being the banks.

The sites chosen on the Little Manistee were at Indian Bridge, Queens Highway, and Old Grade Campground. All of these areas had a good vegetative buffer next to the stream. Overall, the banks were stable with some minimal spots of erosion. It is recommended to do stream habitat assessments every 1-5 years in order to keep an eye on the stream. A survey will need to be done in 2022 to be submitted to MiCorps, this can be done in the spring or fall.

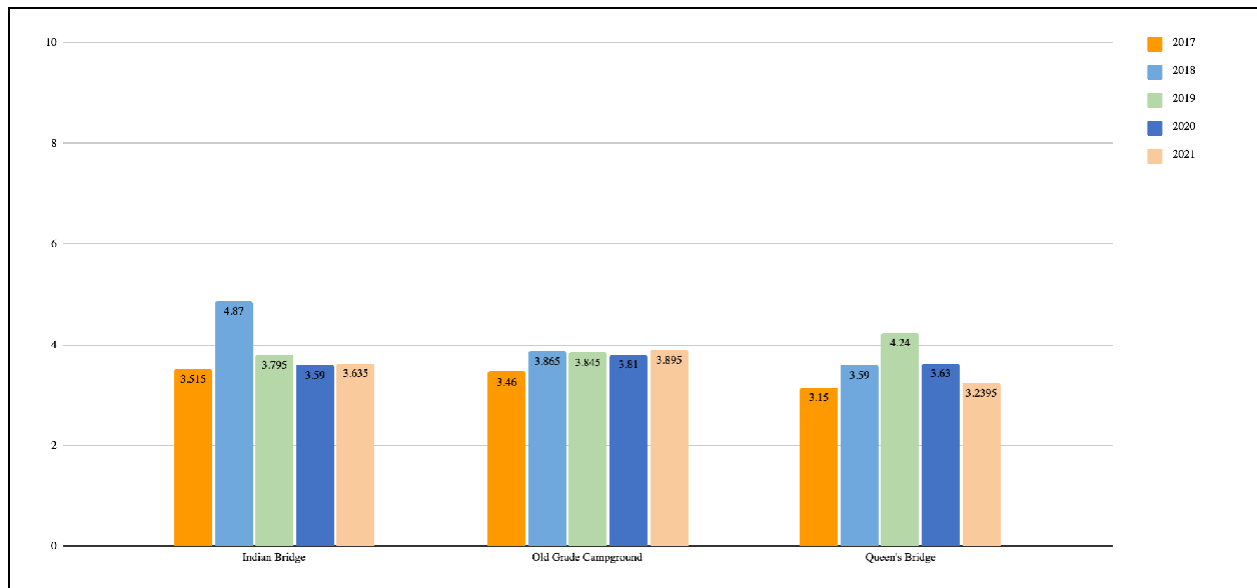
In 2020, MiCorps updated its standards for the stream ratings. In the past it was on a scale of 0-50 (under 19 being very poor, over 48 being excellent) and now is scored from 1-10 (1 being excellent, 10 being very poor). Over the summer, Abbey Hull went through the past samples at these three sites to update their ratings. Between all of the sites, they average a 3.7 out of 10 (1 being an excellent rating, 10 being a very poor rating). In October a team went out to the three sites and between all the sites they averaged a 3.8. The graph below shows the scores for all three sites between 2017 and 2021. Although there are some shifts overall, they have been steady and healthy.
