Lower Manistee River Watershed Macroinvertebrate Assessment Volunteer Stream Monitoring Program (VSMP)

Presented by the
Manistee Conservation District
In partnership with
Michigan Clean Water Corps

Spring and Fall 2024 Results

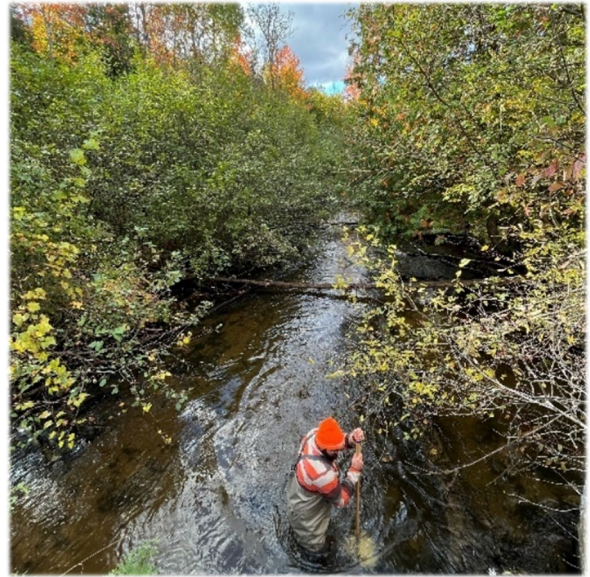
Site Results and Trends
BC01 – Bear Creek at Leffew Rd
Annual Average Score

Year	Rating
2016	Excellent
2017	Good
2018	Fair
2019	Good
2020	Excellent
2021	Excellent
2022	Very Good
2023	Very Good
2024	Very Good

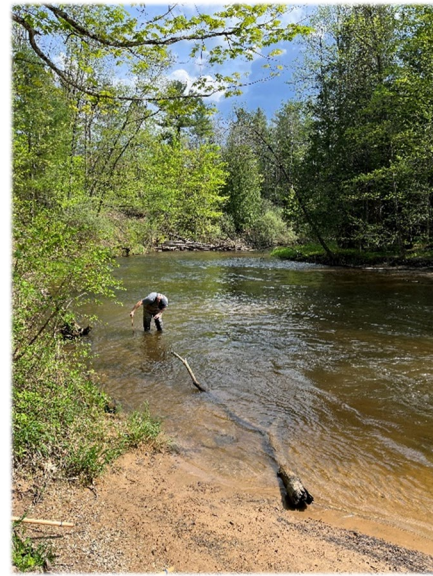
Site Results and Trends
BC02 – Bear Creek at Spirit of the Woods Annual Average Score

Year	Rating
2016	Excellent
2017	Good
2018	Good
2019	Good
2020	Good
2021	Excellent
2022	Very Good
2023	Very Good
2024	Very Good

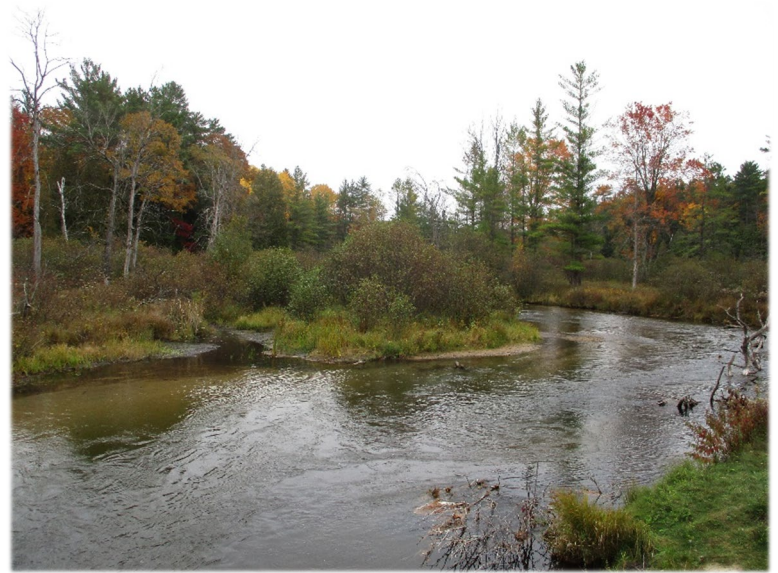
Site Results and Trends
LM01 – Little Manistee at 6 Mile
Annual Average Score

Year	Rating
2016	Excellent
2017	Fair
2018	Good
2019	Excellent
2020	Good
2021	Excellent
2022	Excellent
2023	Very Good
2024	Good

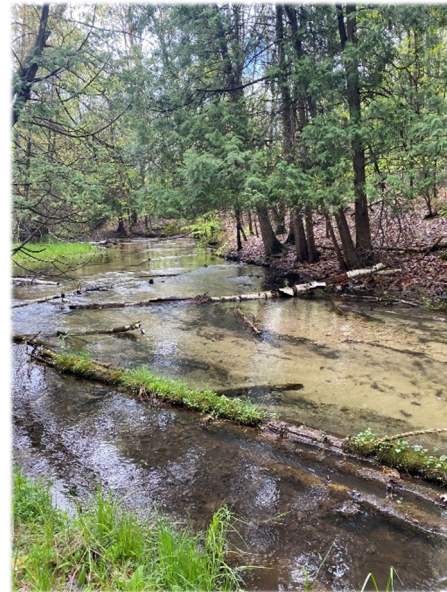
Site Results and Trends
LM02 – Cool Creek
Annual Average Score

Year	Rating
2016	Good
2017	Good
2018	Good
2019	Good
2020	Good
2021	Very Good
2022	Excellent
2023	Very Good
2024	Very Good

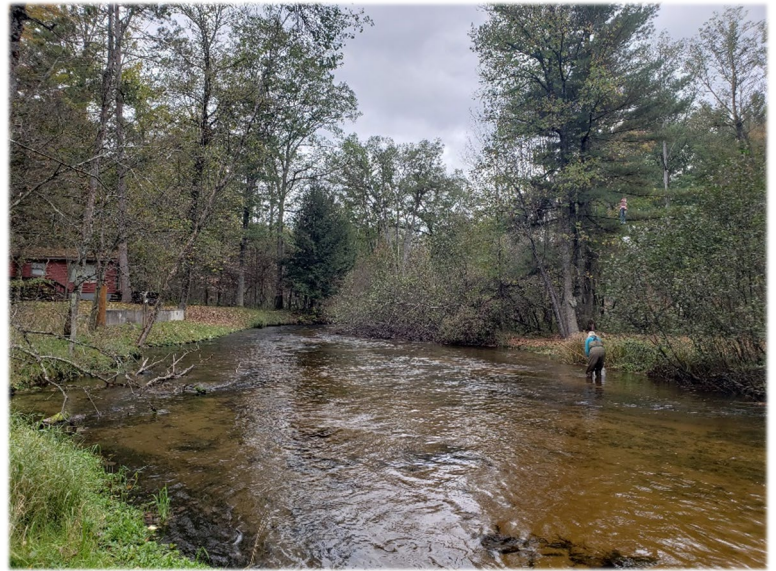
Site Results and Trends
LM03 – Little Manistee at Johnson Rd
Annual Average Score

Year	Rating
2016	Good
2017	Fair
2018	Fair
2019	Excellent
2020	Good
2021	Excellent
2022	Excellent
2023	Excellent
2024	Very Good

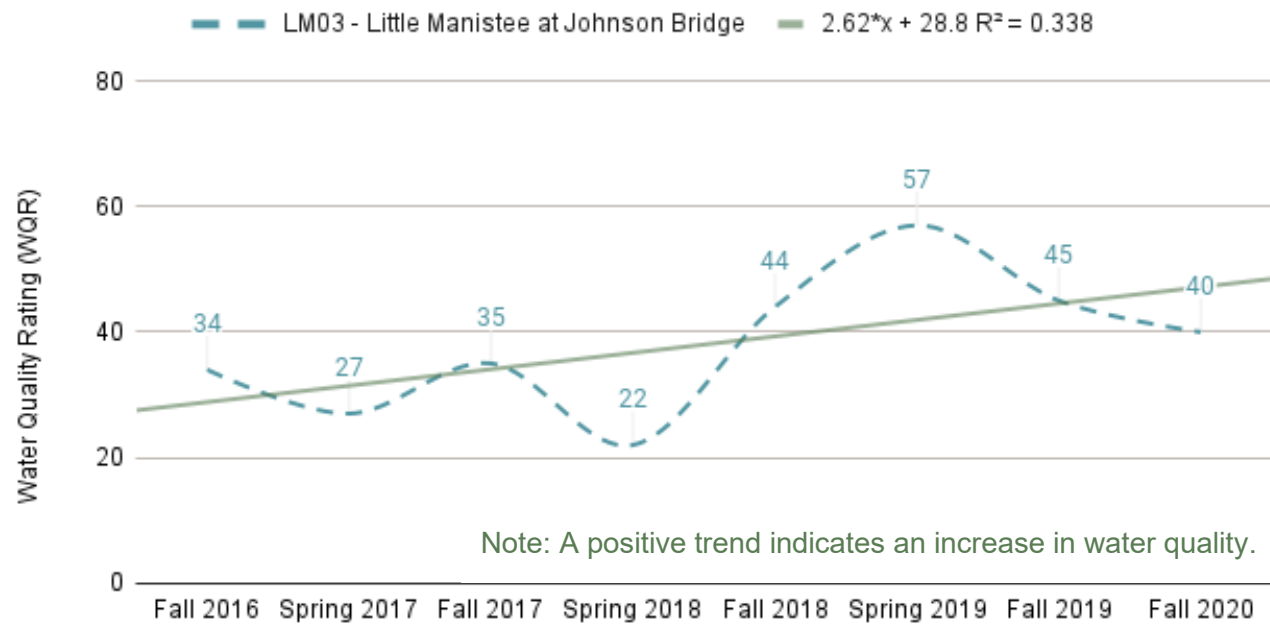
Water Quality Rating Pre-2021 Methodology

Poor (<19), Fair (19-33), Good (34-48), Excellent (>48)

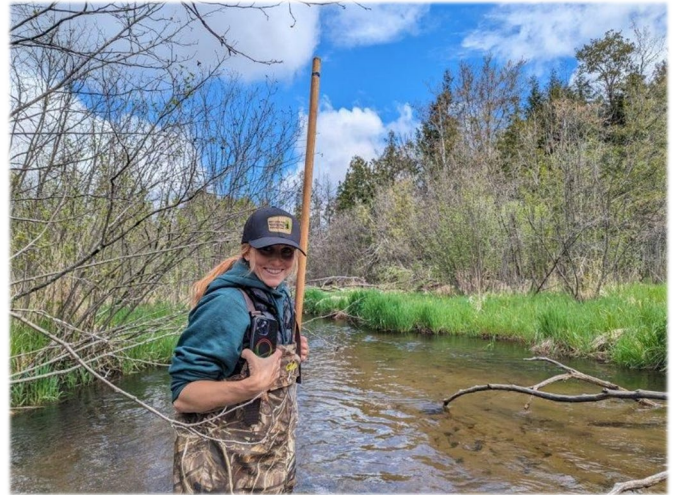
Site Results and Trends
BM01 – Adams Creek at 16 Rd
Annual Average Score

Year	Rating
2016	Good
2017	Fair
2018	Good
2019	Good
2020	Excellent
2021	Excellent
2022	Fair
2023	Very Good
2024	Very Good

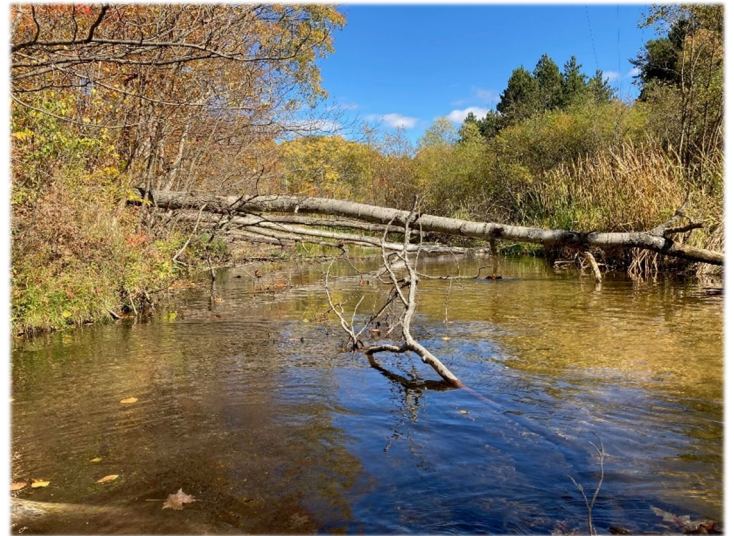
Site Results and Trends
BM02 – Fletcher Creek
Annual Average Score

Year	Rating
2016	Good
2017	Fair
2018	Fair
2019	Good
2020	Good
2021	Good
2022	Very Good
2023	Good
2024	Good

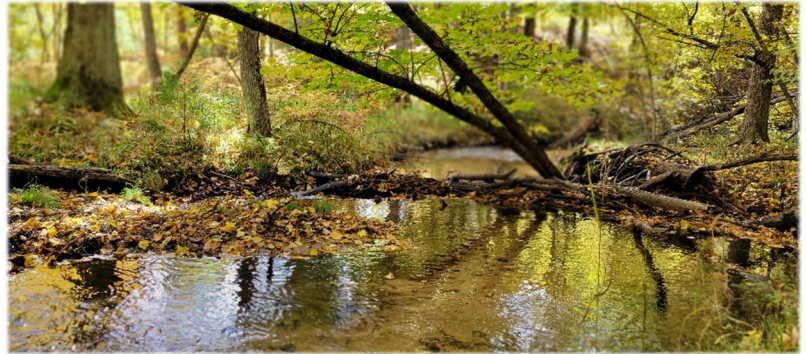
Site Results and Trends
BM03 – Hinton Creek
Annual Average Score

Year	Rating
2016	Good
2017	Good
2018	Fair
2019	Good
2020	Good
2021	Excellent
2022	Very Good
2023	Very Good
2024	Excellent

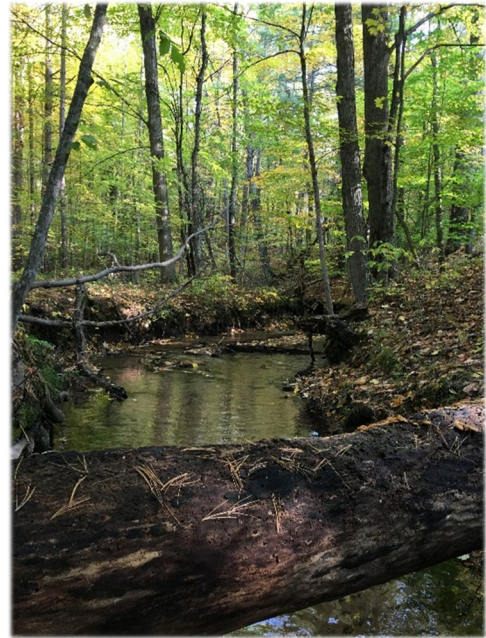
Site Results and Trends
BM04 – Sickie Creek
Annual Average Score

Year	Rating
2016	Good
2017	Fair
2018	Fair
2019	Good
2020	Fair
2021	Very Good
2022	Very Good
2023	Very Good
2024	Good

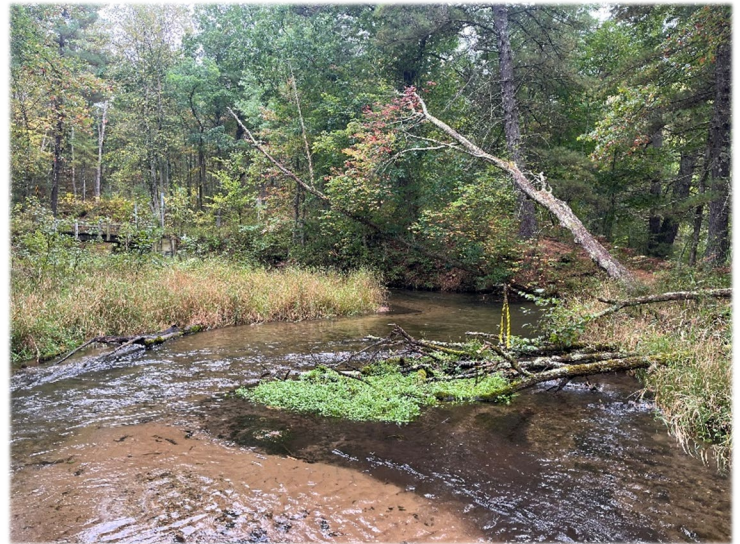
Site Results and Trends
BM05 – Slagle Creek
Annual Average Score

Year	Rating
2024	Very Good
