CONSERVATION RESOURCE ALLIANCE

Little Manistee River Eroding Stream Bank Assessment

Carrieville (Kings Highway) Bridge to Old Stronach Rd. Bridge

12/31/2014

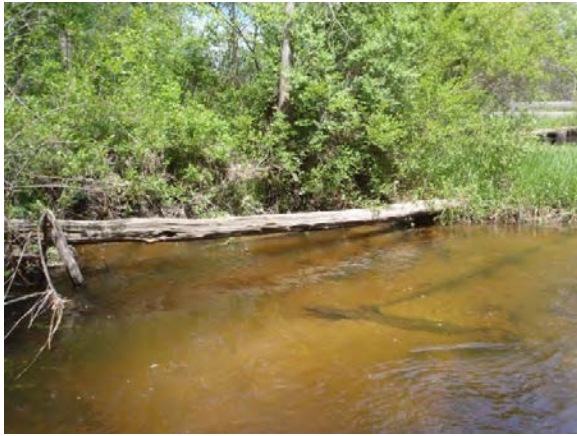
View straight on (2013)

River-right

Notes: water depth 2.5-3.0' maximum, substrate sand, some gravel and wood

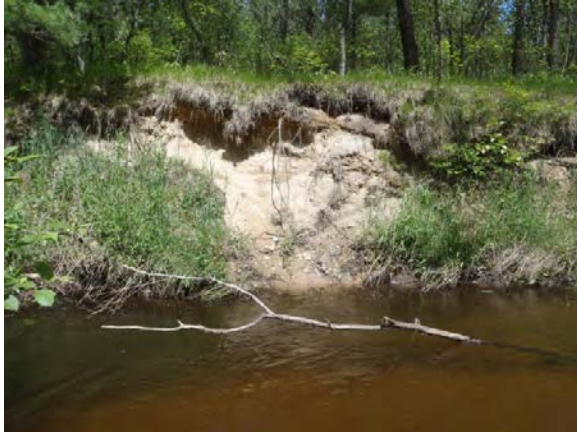
View straight on (2013)

River-right

Notes: substrate sand, channel width 16', water depth 2.0-4.0' maximum

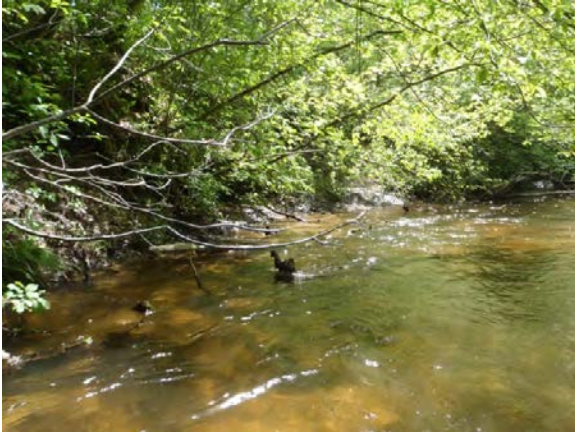
View downstream (2013)

River-left

Notes: channel width 20', substrate sand, water depth 2.5-3.0' maximum

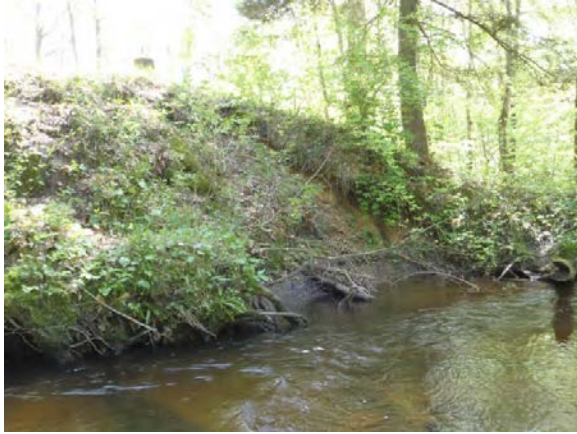
View downstream (2013)

River-left

Notes: water depth 3.0', channel width 12', substrate sand

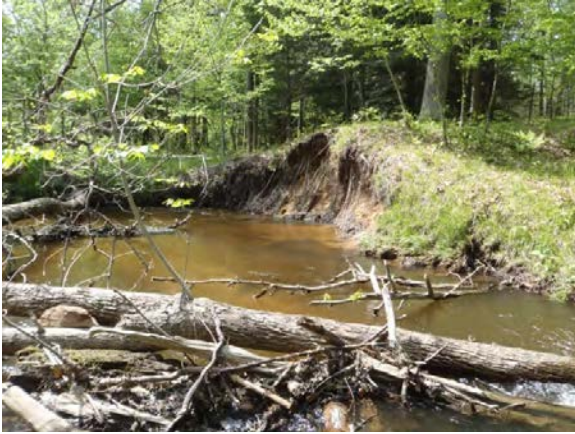
View downstream and across (2013)

River-right

Notes: water depth 1'-2.5', substrate sand/some gravel

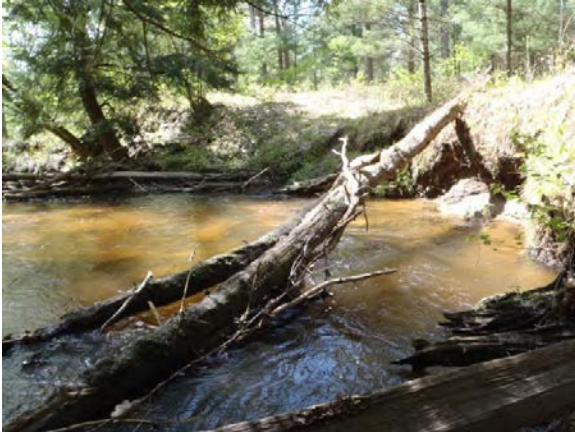
View downstream (2013)

River-right

Notes: substrate gravel/some sand, channel width, water depth .5'-1.5'

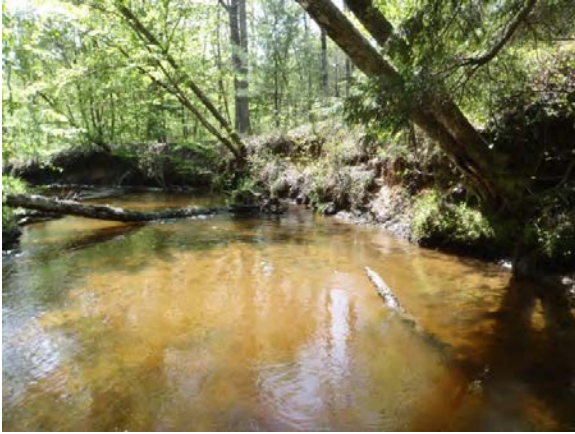
View downstream (2013)

River-right

Notes: substrate sand/some gravel, water depth 1'-2', channel width 15'

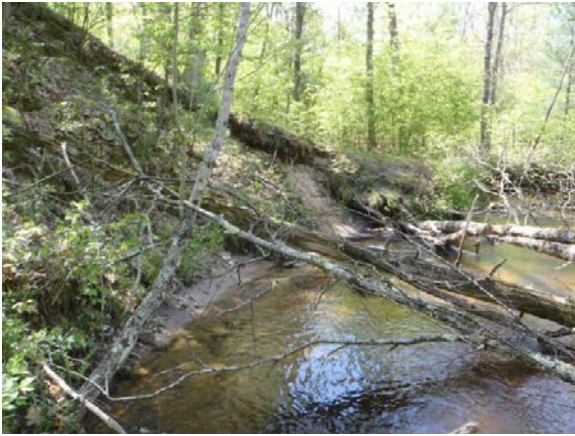
View downstream (2013)

River-left

Notes: channel width 24', water depth .5', substrate sand

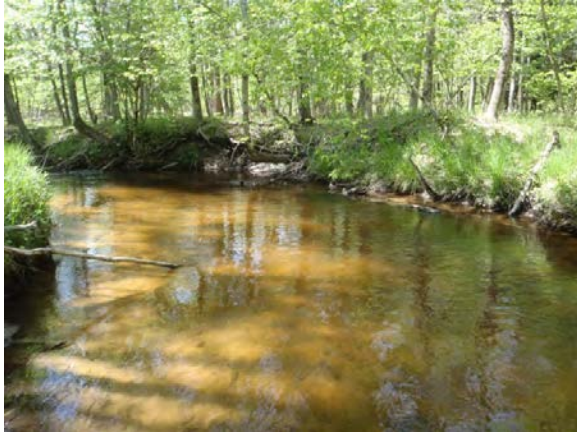
View downstream (2013)

River-right

Notes: channel width 20', water depth 1'-2.5', substrate sand/some gravel

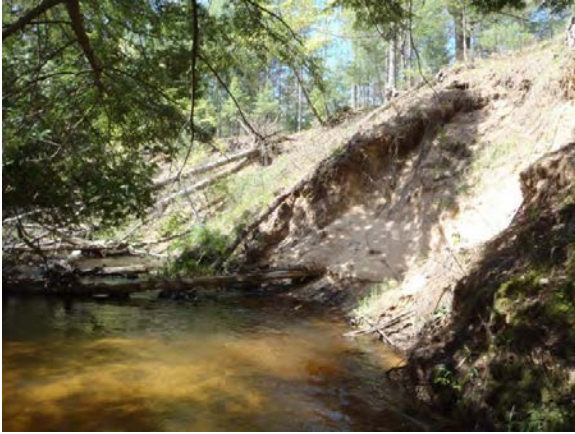
View downstream (2013)

River-right

Notes: water depth 4"-2.5', channel width 20', substrate sand

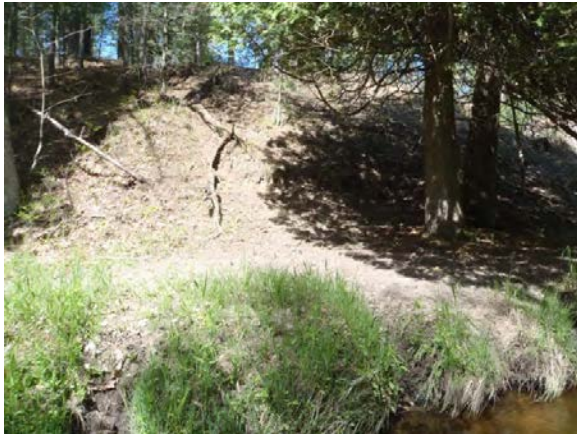
View straight on (2013)

River-left

Notes: water depth 1'-2.0', substrate sand/some gravel, channel width 24'

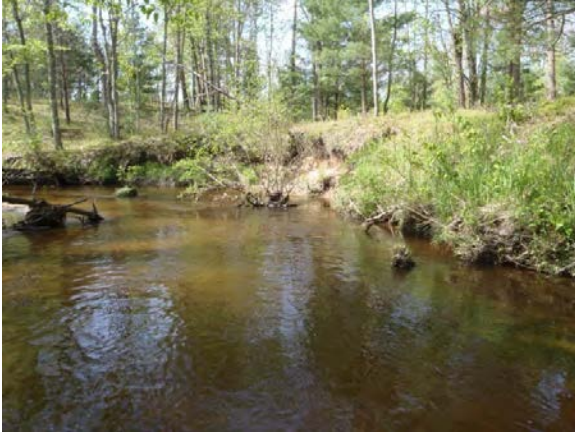
View downstream (2013)

River-right

Notes: water depth 1'-1.5', substrate sand/some gravel, channel width 24'

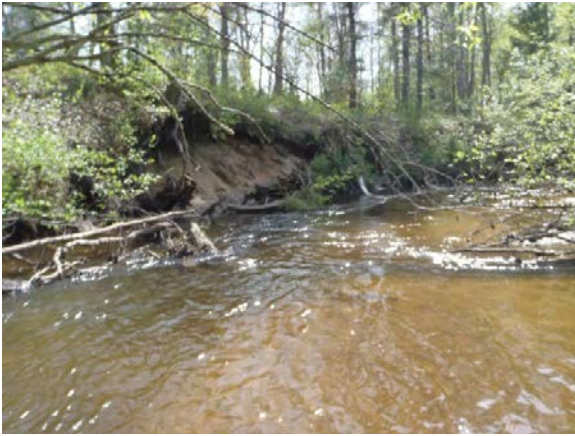
View downstream (2013)

River-left

Notes: channel width 15', substrate sand, water depth .5'-3.0'

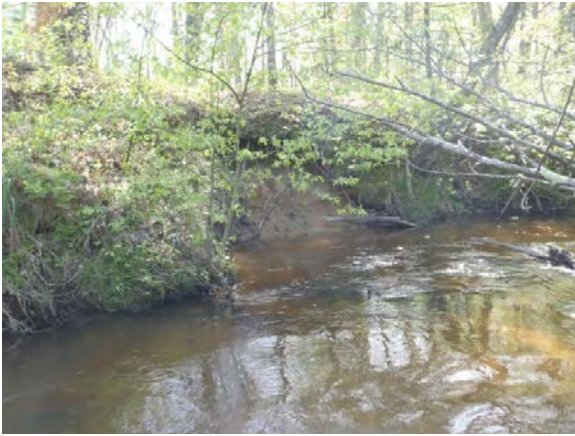
View downstream (2013)

River-left

Notes: water depth .5'-2.0', substrate sand, channel width 30'

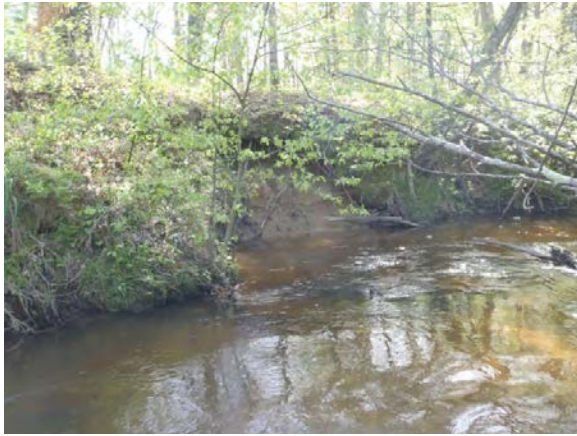
View downstream (2013)

River-left

Notes: water depth .5'-3.5', channel width 14', substrate sand

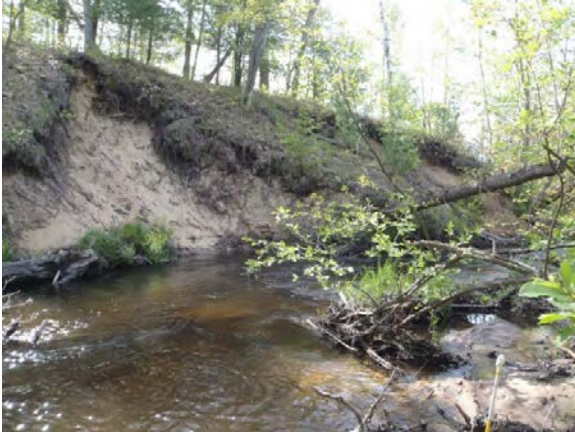
View upstream (2013)

River-right

Notes: channel width 30', water depth .5'-2.0', substrate fieldstone/sand

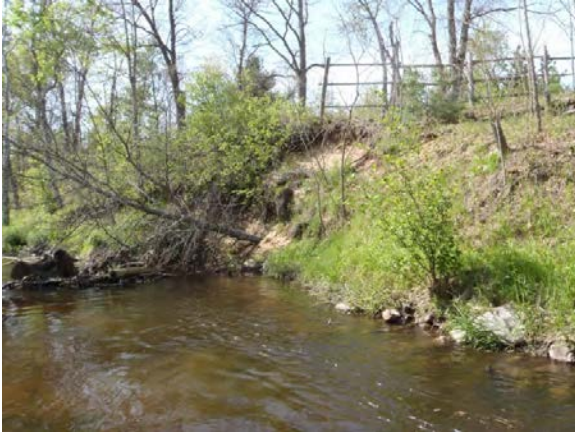
View downstream (2013)

River-right

Notes: water depth 2.0'-3.0', substrate sand, channel width 20'

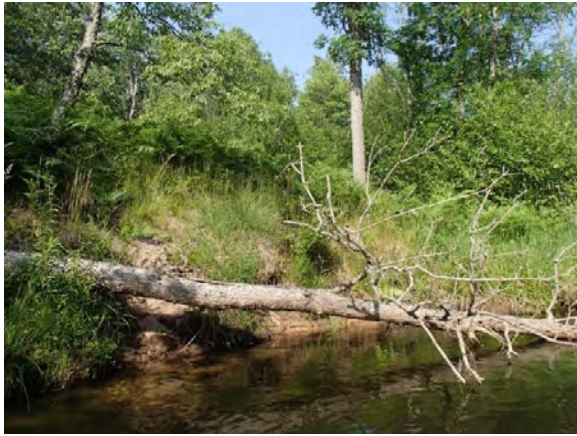
View straight on (2013)

River-right

Notes: channel width 24', water depth 3.0', substrate sand

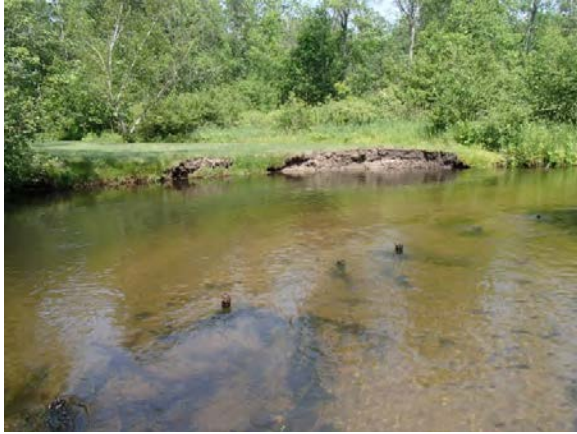
View upstream and across (2013)

River-right

Notes: water depth 4.0'-4.5', substrate sand/some gravel, channel width 43'

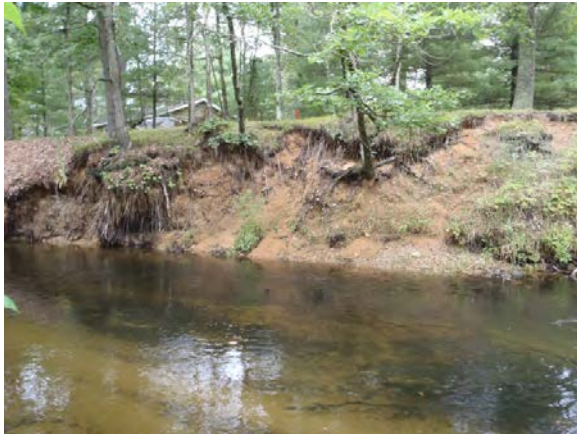
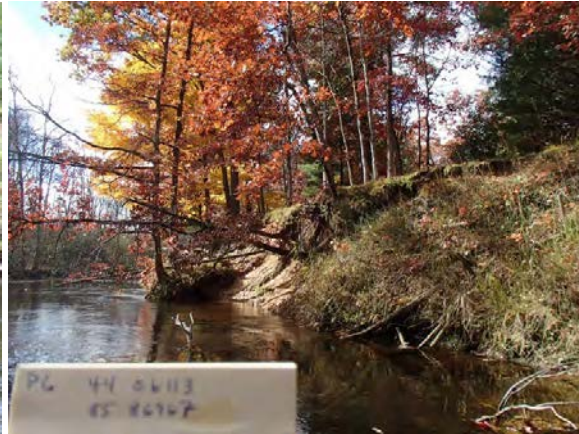
River-right

Notes: depth at toe 2.5', landowner has been in touch with CRA on stabilization-pending project

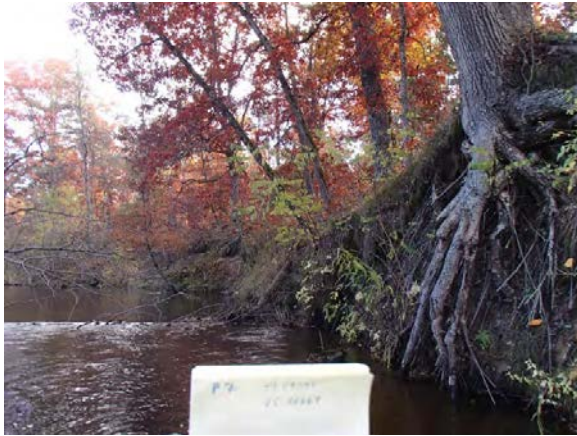
View upstream (2014)

River-left

Notes: depth at toe 3'

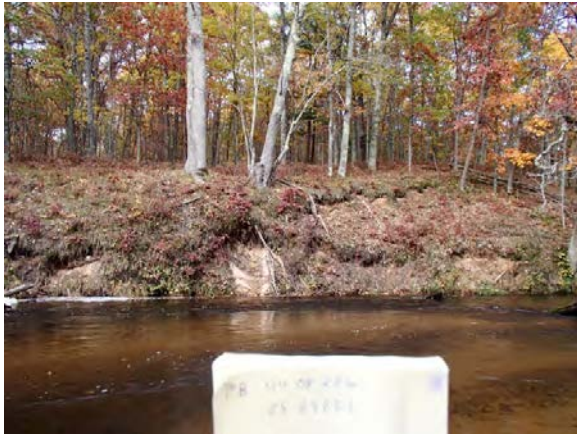
View straight across (2014)

River-right

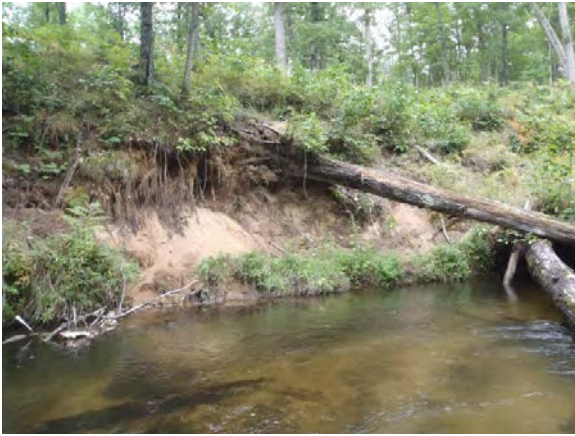
View straight on (2011)

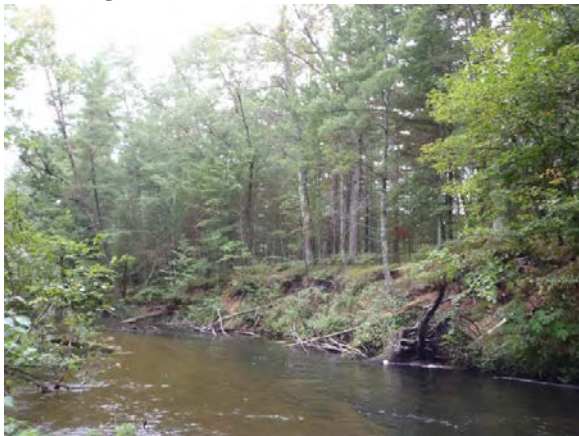
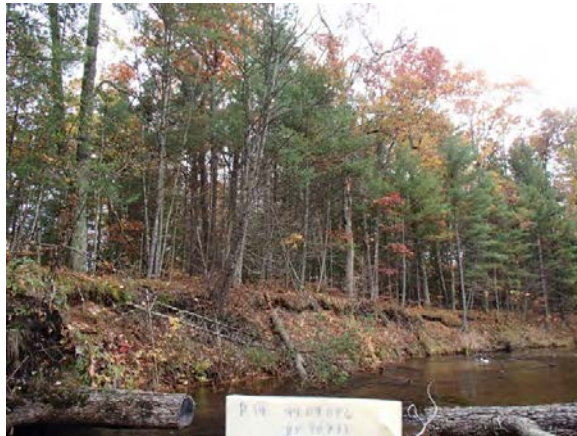
Site 25

Severity: Minor

Notes: some clay expressed at toe, water depth 3', (toe is well buffered from current, re-vegetation occurring)

View downstream (2011)

View upstream (2014)

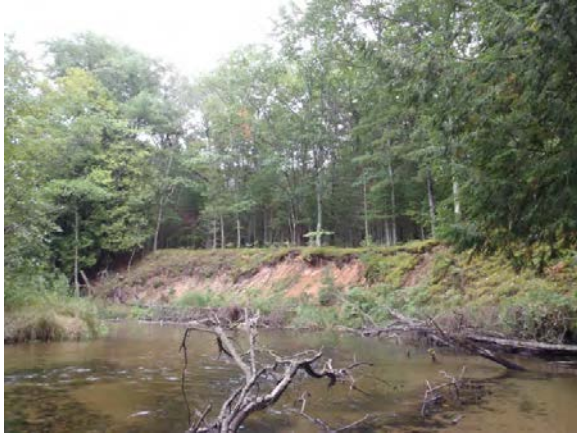
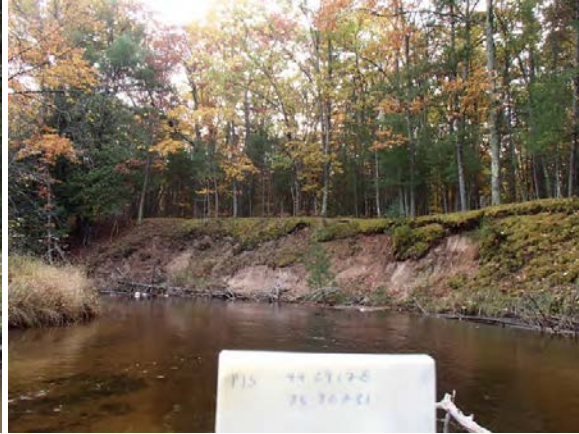
Site 26

Severity: Minor (toe is well buffered from current, re-vegetation occurring)

Notes: has had work done prior at the toe

View downstream (2011)

View downstream (2014)

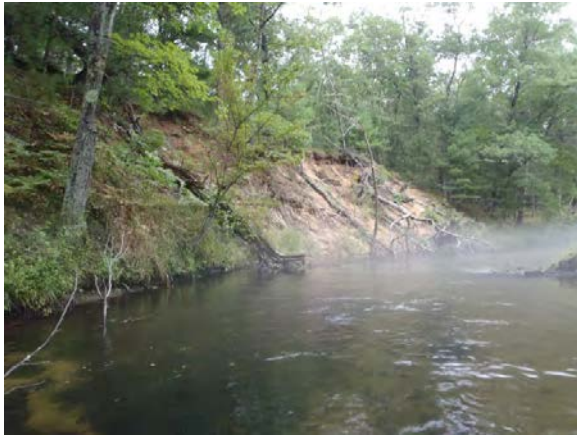
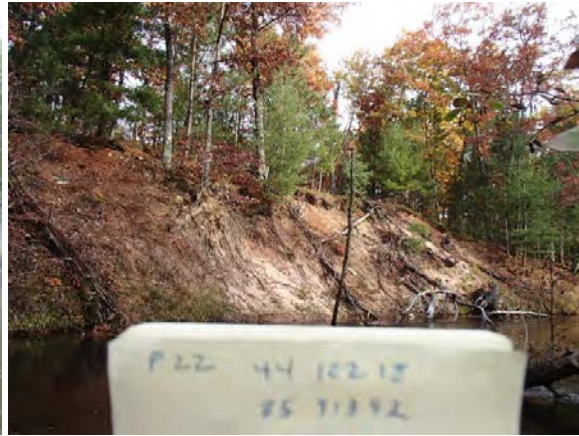
Site 27

Severity: Severe

Notes: outside of meander bend, low effort fix would be to secure large wood at toe to buffer flow

View downstream (2011)

View downstream (2014)

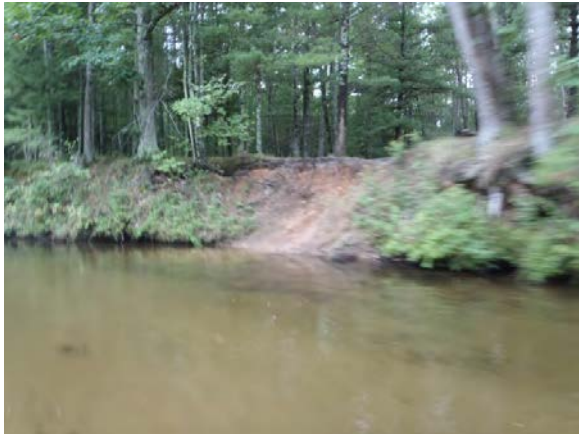
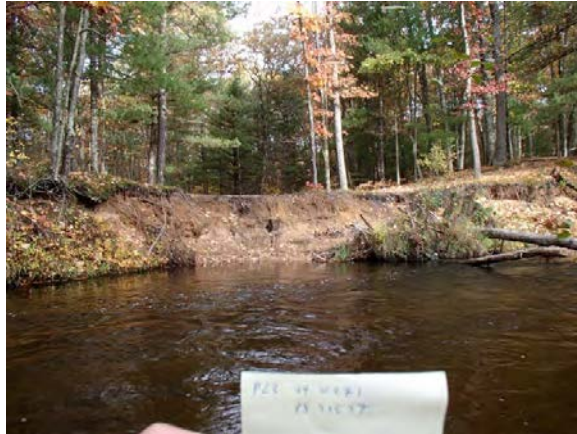
Site 28

Slope: 1:1 (from 2:1 in 2011)

Severity: Severe

Notes: the site trended from moderate to severe between 2011 and 2014 indicating recreational access may be one of the major influences to pursue on many sites

View from slightly upstream (2011)

View from slightly downstream (2014)

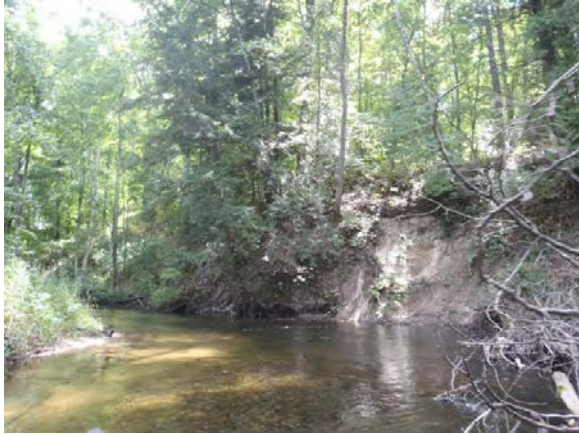
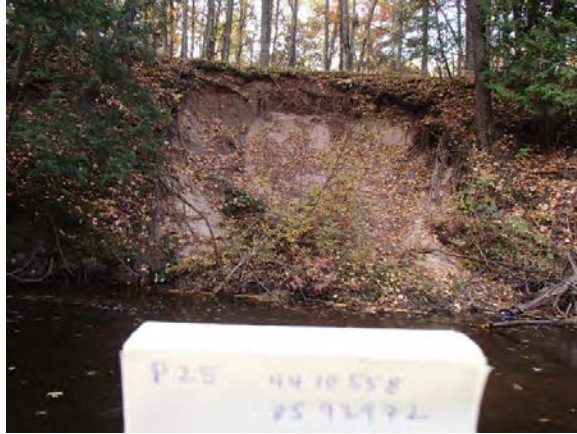
Site 29

Severity: Severe

Notes: note 2014 photo top of bluff has slumped to water level and is protecting toe, depth at toe 3.5'

View from downstream (2011)

View directly across (2014)

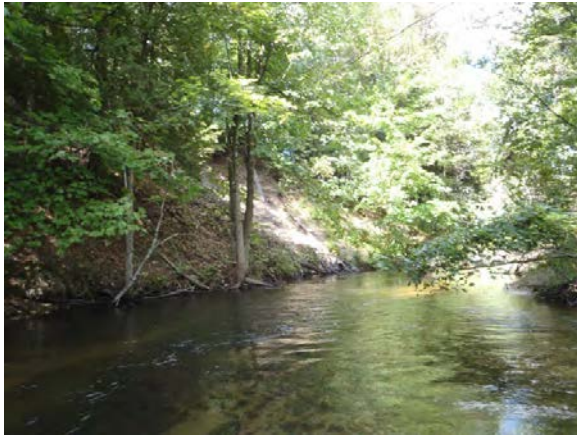
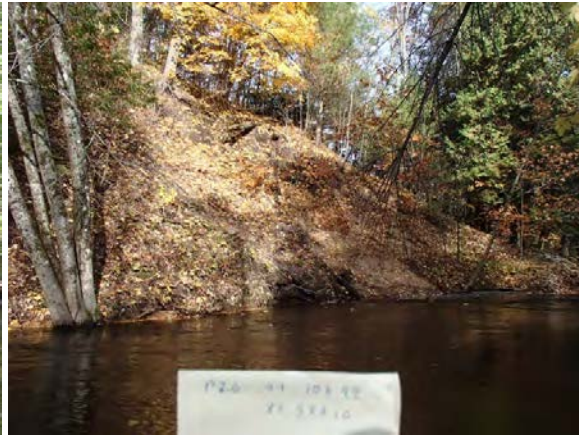
Site 30

Severity: Severe

Notes: active bleeding of sediment into stream, obscured by leaf drop in 2014 photo, depth at toe 3.5'

View from upstream (2011)

View straight across (2014)

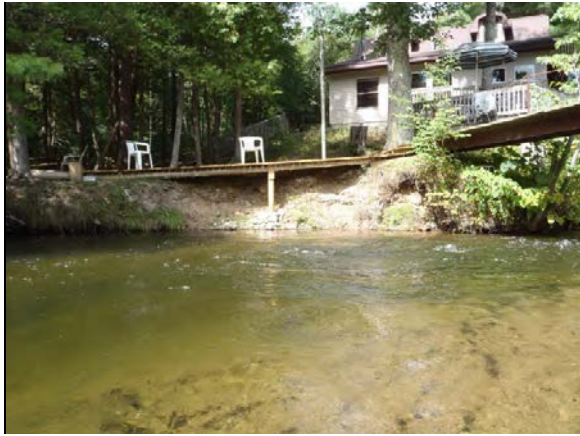
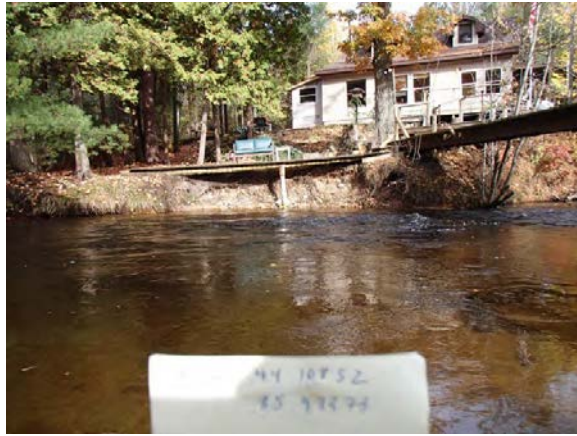
Site 31

Severity: Moderate

Notes: high clay content in bank material, low rate of sloughing, depth at toe 6'

View straight across (2011)

View straight across (2014)

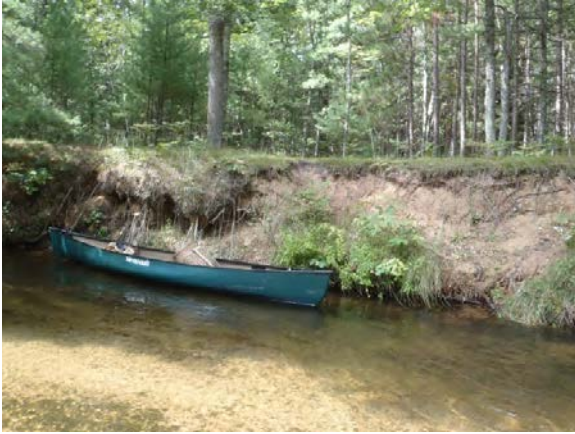
Site 32

Severity: Moderate

Notes: channel width 43', substrate gravel/sand, depth at toe 2'

View upstream and across (2011)

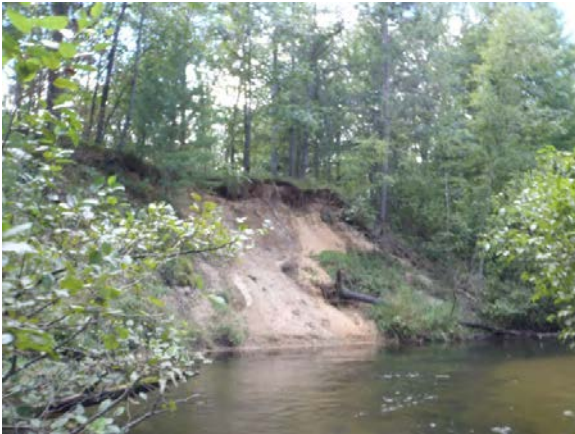
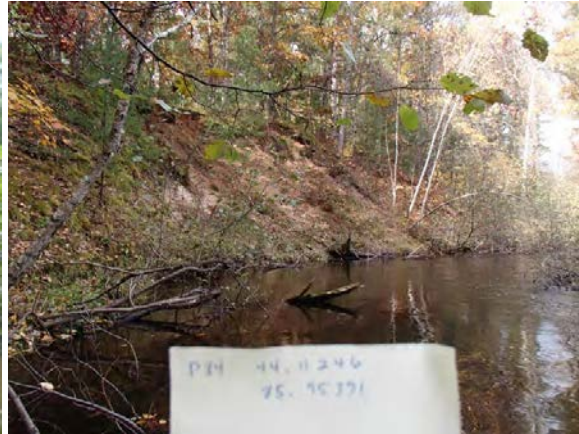
Site 33

Severity: Severe

Notes: outside of meander bend, channel width at this location 28', water depth 4', substrate fine sediment/gravel/sand

View looking downstream (2011)

View looking downstream (2014) (note toe stabilized)

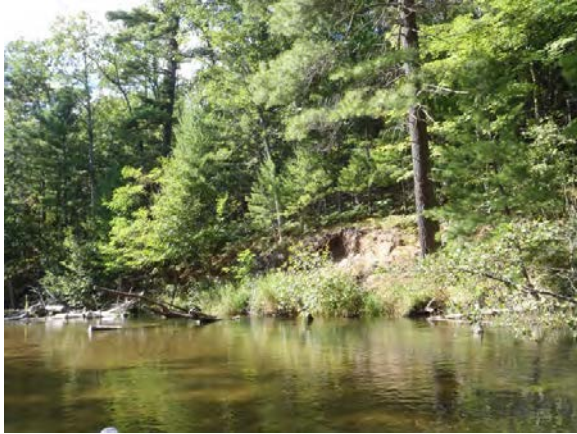
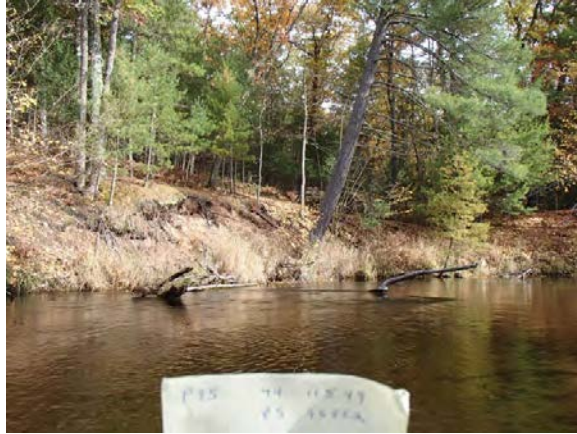
Site 34

Severity: Minor (no flow access to toe, re-vegetating on its own)

Notes: channel width 30', substrate fine sediment/sand/large wood

View downstream (2011)

View upstream (2014)

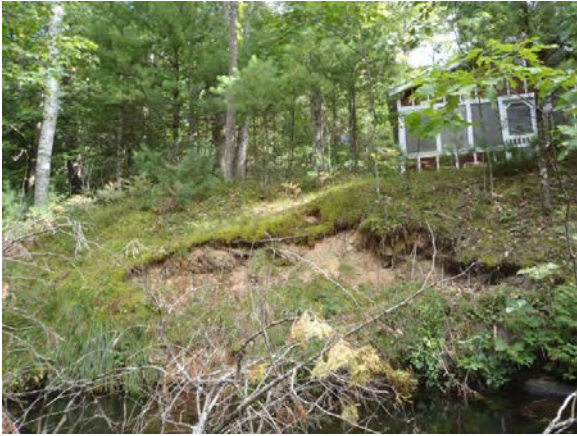
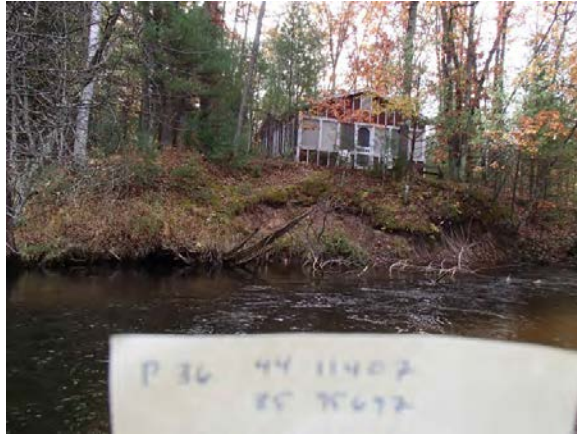
Site 35

Notes: river width 30-32', water depth at toe 4.5-5', substrate small gravel, sand, large wood, current slow

View at toe (2011)

View from across (2014)

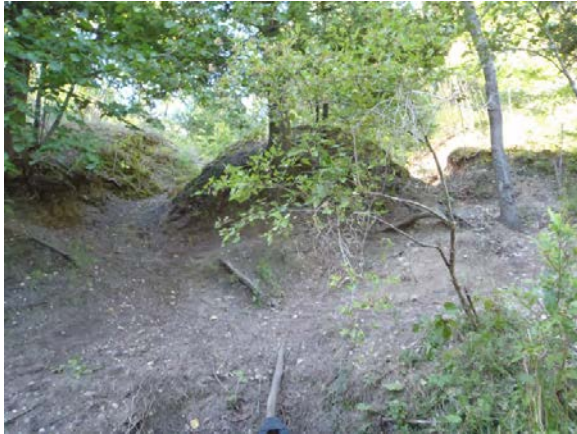
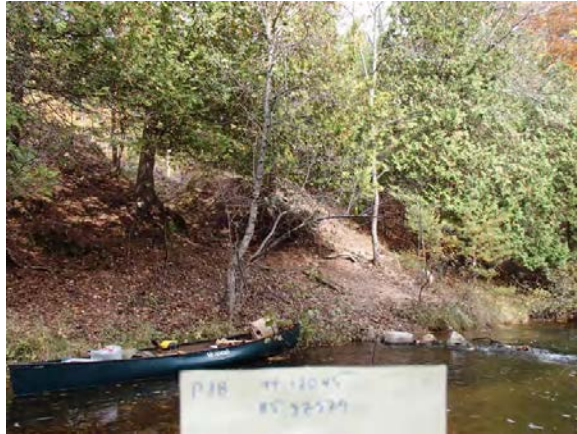
Site 36

Notes: channel width 46', water depth 1.5', two-track at top of bluff, recreational foot traffic, trail on both sides of river, substrate small gravel/sand/organic material/macrophytes (primarily *naiad*)

View looking straight on (2011)

View looking upstream and across (2014)

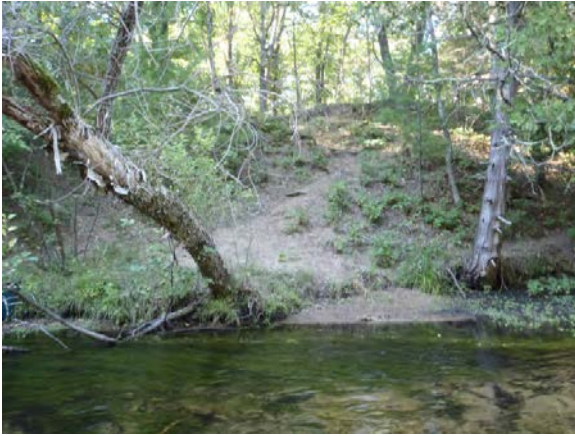
Site 37

Notes: two-track at top of bluff, recreation foot traffic, trail on both sides of river, channel width 46', substrate small gravel/sand/organic material/macrophytes, depth at toe 1.5'

View straight on (2011)

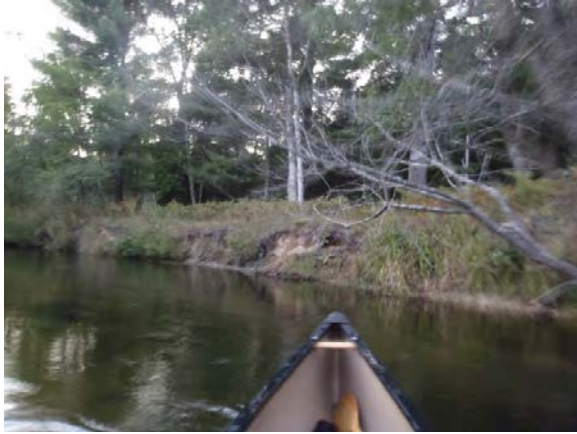
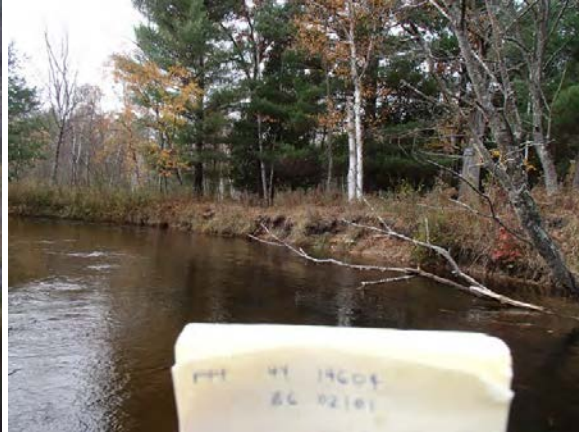
Notes: substrate gravel and macrophytes, channel width 20', depth at toe 1.5'

View downstream (2011)

View downstream (2014)

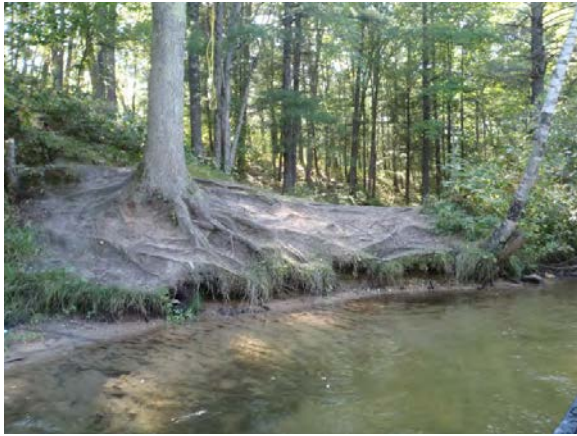
Site 41

Severity: Moderate

Notes: access to river at Bear Track Campground

View downstream and across (2011)

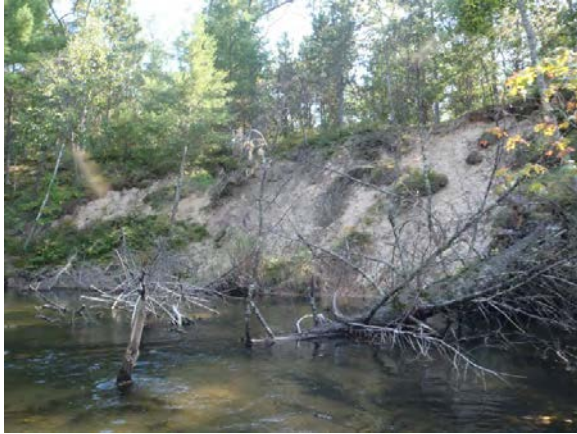
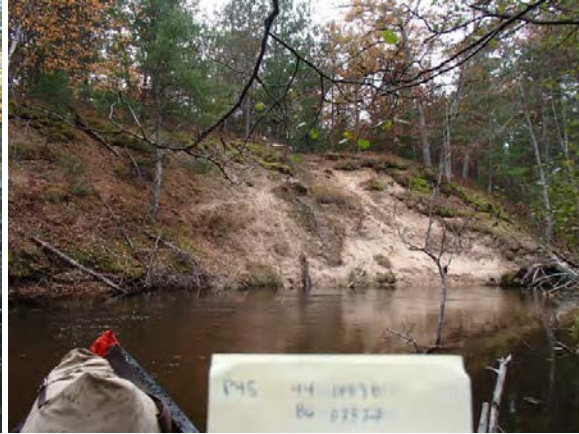
Site 42

Severity: Severe

Notes: water depth 3.5' at toe, substrate sand and large wood

View upstream (2011)

View downstream (2014)

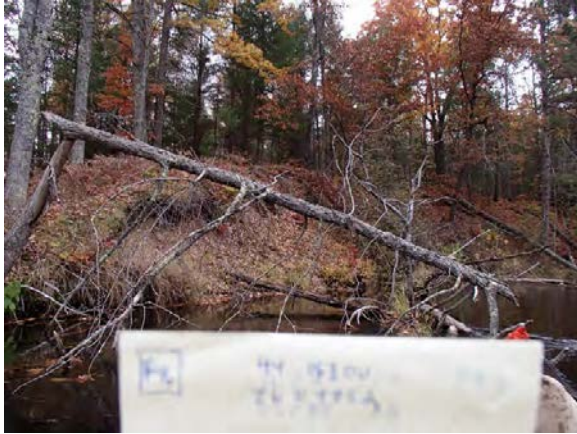
Site 43

Severity: Minor

Notes: some clay in bank-stable, substrate silt/sand/macrophytes/some gravel

View downstream and across (2014)

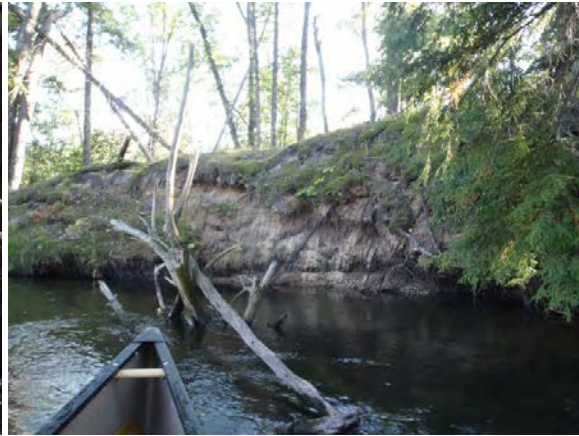
Site 44

Severity: Moderate

Notes: substrate sand/large wood/small gravel, depth at toe 3', minimal movement of wood in frame

View upstream and across (2011)

View upstream and across (2014)

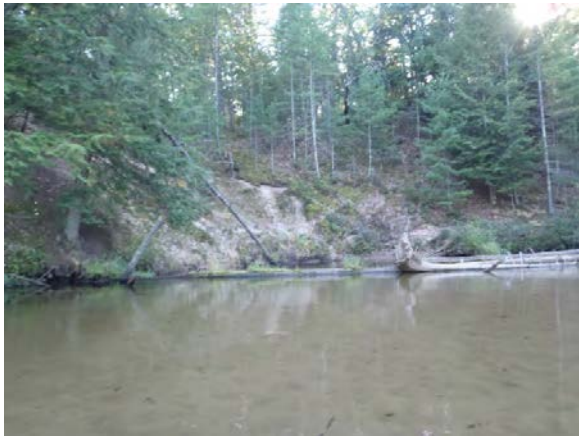
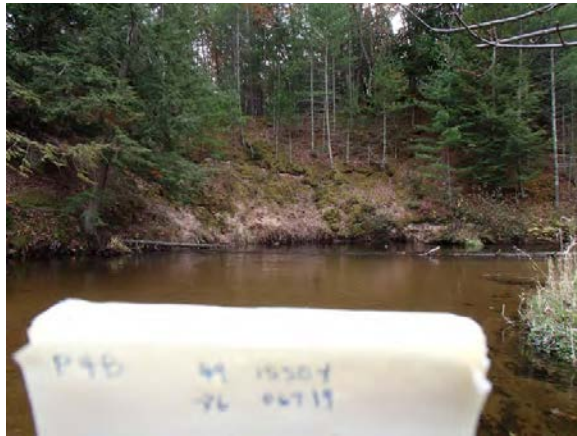
Site 45

Severity: Severe

Notes: starting to see number of dead standing cedar in this area, channel extremely wide, depth at toe 4', substrate silt and sand

View looking downstream (2011)

View looking downstream (2014)

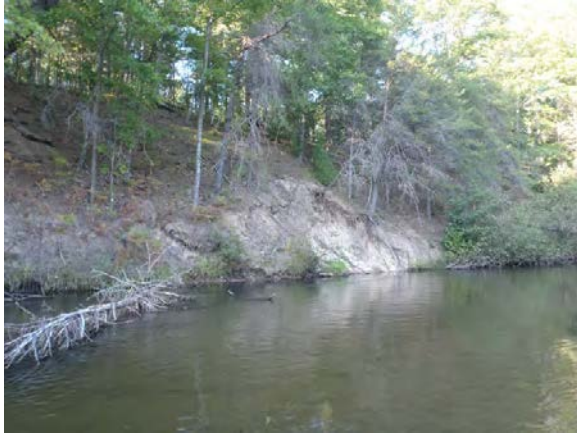
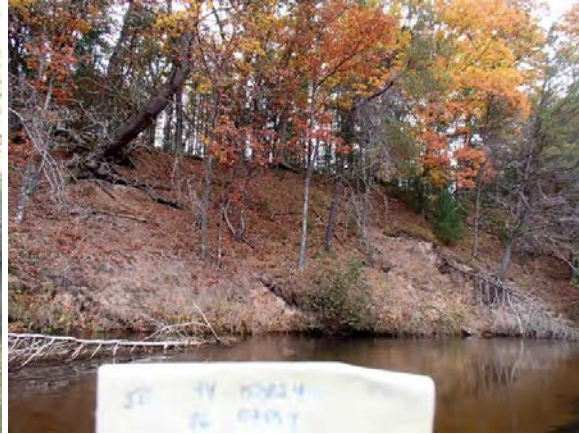
Site 47

Severity: Moderate

Notes: water depth at toe 5', slow back eddy, substrate sand and silt

View downstream (2011)

View downstream (2014)

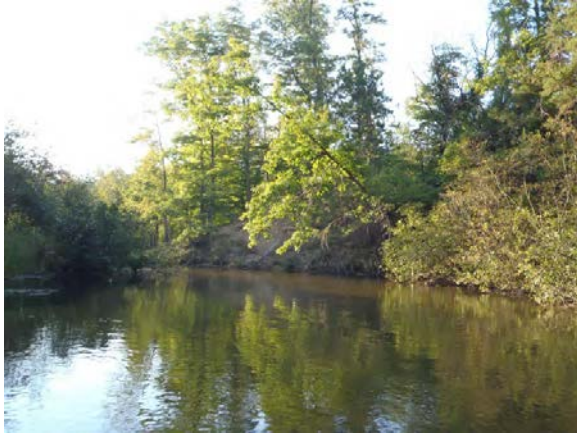
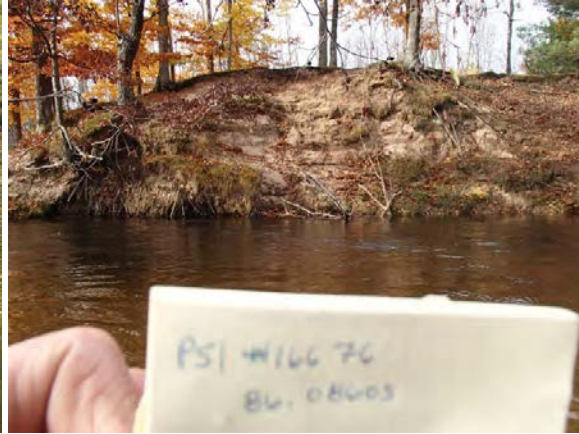
Site 48

Severity: Moderate

Notes: campsite and associated recreational traffic, substrate silt and sand, depth at toe 3'

View downstream, approach to site (2011)

View across (2014)

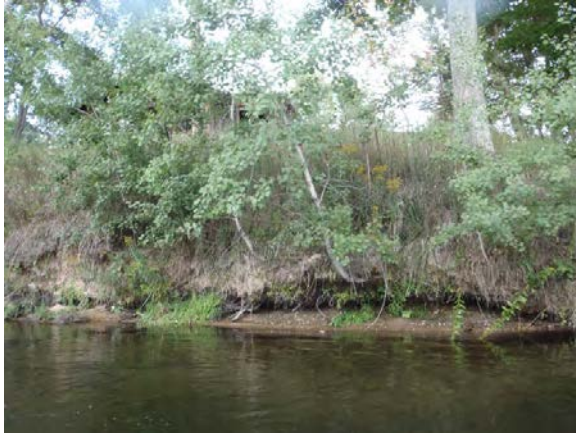
Site 49

Severity: Minor

Notes: substrate small and medium gravel, depth at toe 2', Pomeroy Springs/Indian Trail area

View across (2011)

View across (2014)

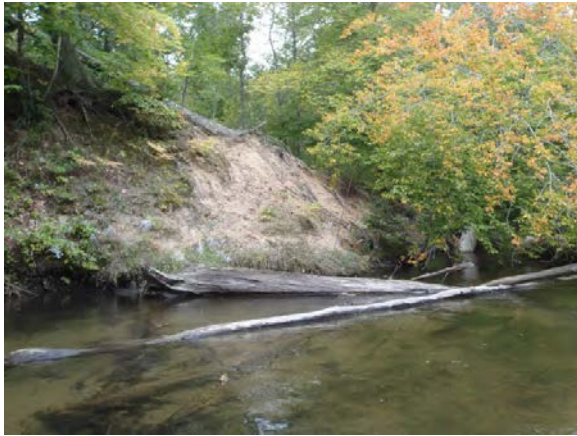
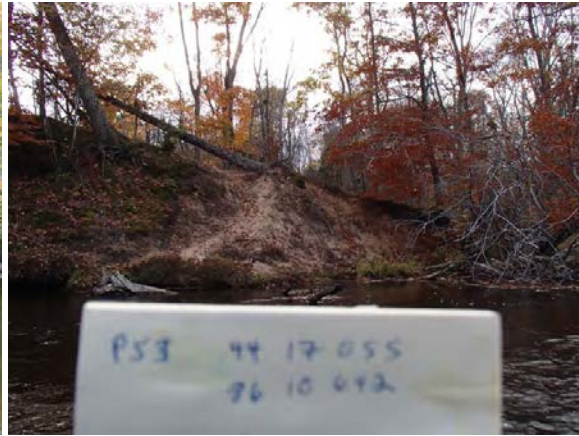
Site 50

Severity: Severe

Notes: substrate sand/wood/organic material, depth at toe 5'

View across (2011)

View across (2014)

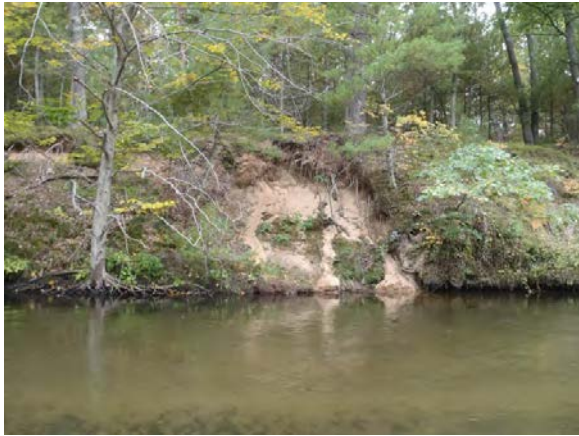
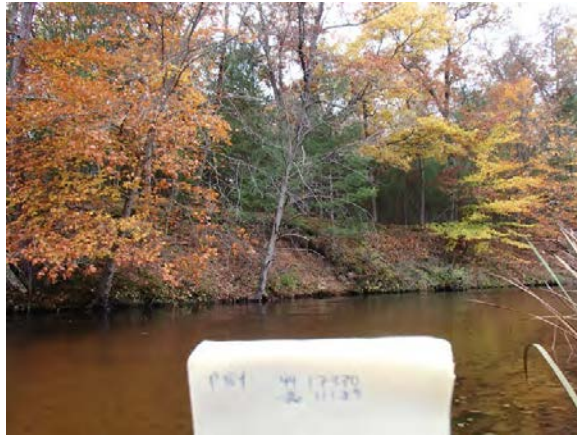
Site 51

Notes: substrate sand/medium gravel, depth at toe 4'

View across (2011)

View across and upstream (2014)

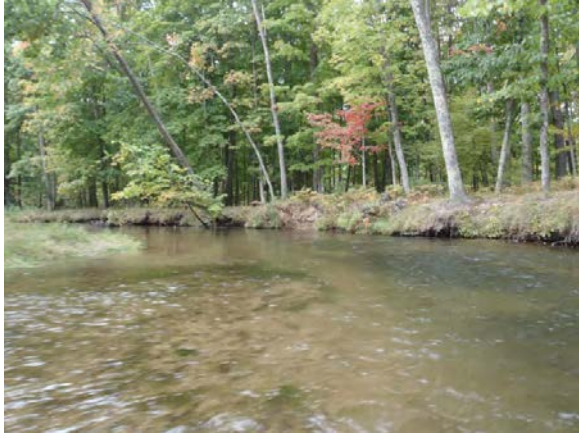
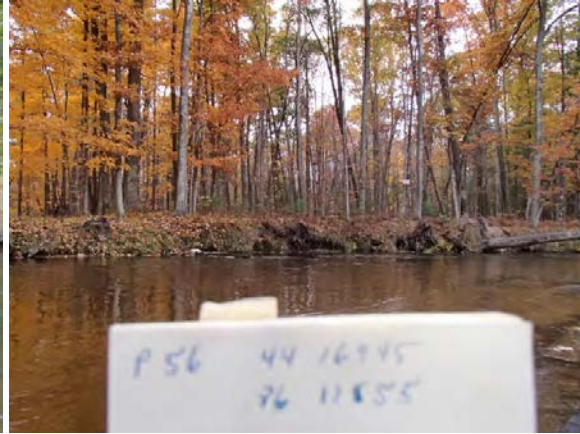
Site 52

Notes: substrate coarse gravel, depth at toe 1.5', outside of meander, undercut

View downstream and across (2011)

View upstream and across-note maple snag (2014)

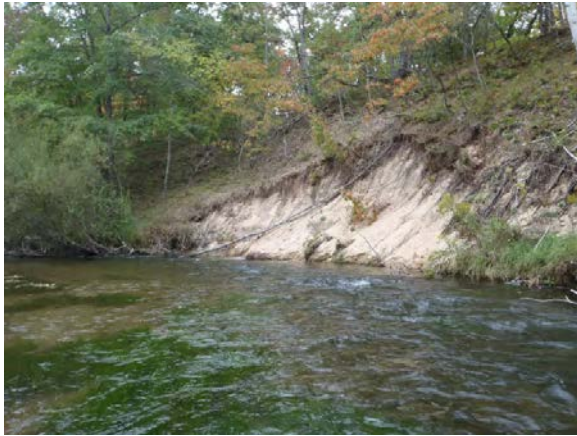
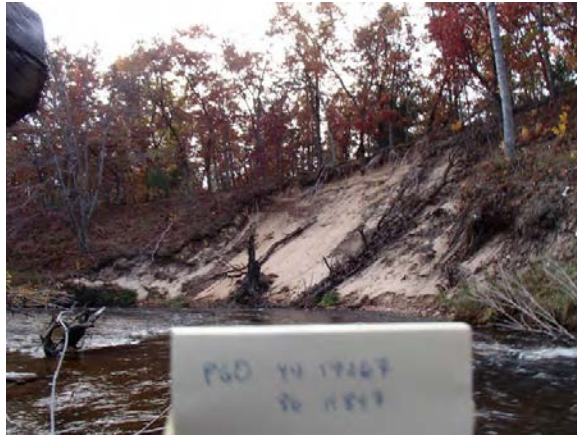
Notes: notable change in dimensions between 2011 and 2014, substrate gravel/sand, depth at toe 3'

View downstream (2011)

View downstream (2014)

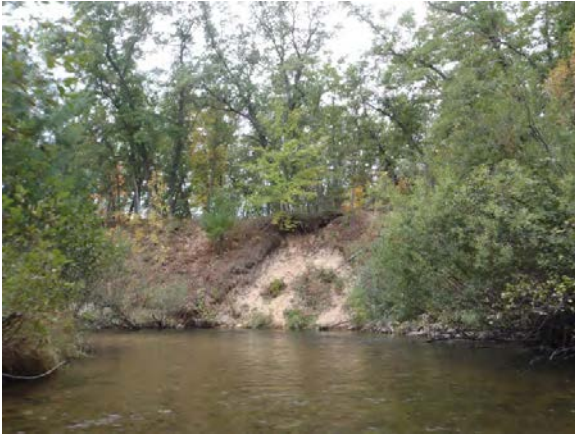
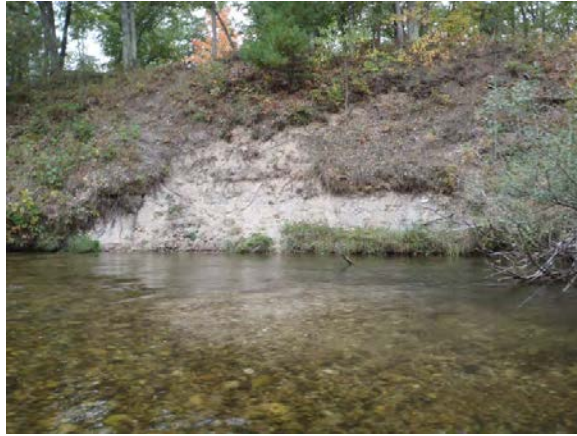
Site 54

Notes: toe-stone had been installed as well as terracing farther up the bluff, recreational traffic at issue, substrate gravel/sand/wood debris

View of midsection of site (2011)

View of downstream end of site (2011)

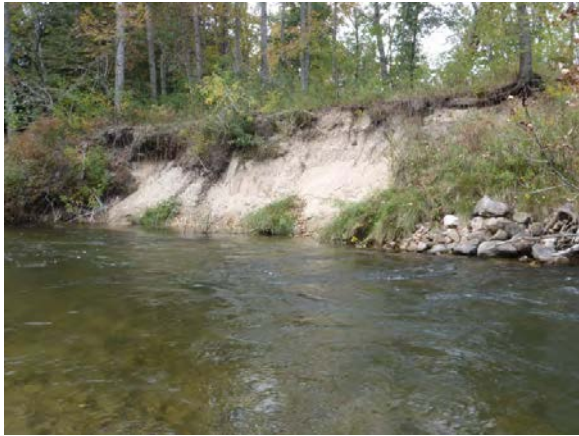
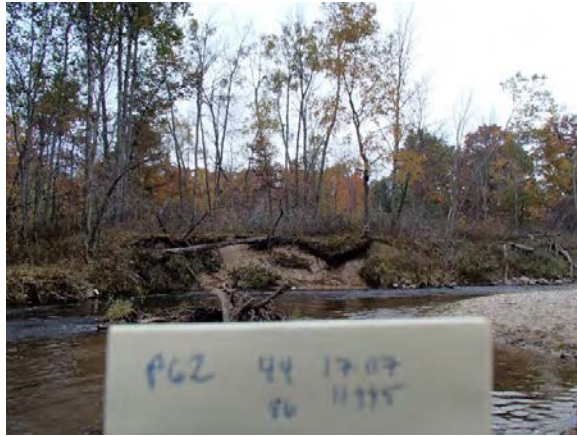
Site 55

Severity: Severe

Notes: substrate small gravel/sand/wood, depth at toe 3.5'

View downstream (2011)

View upstream (2014)

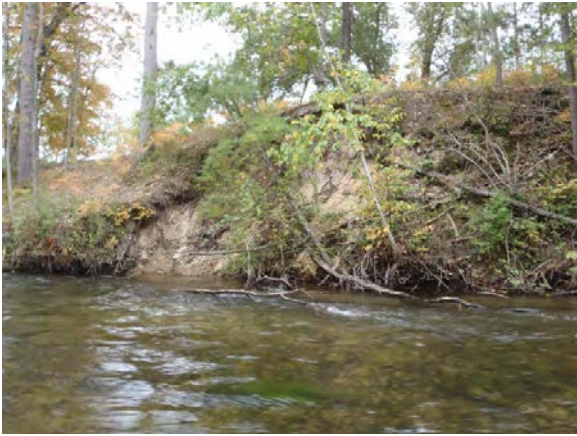
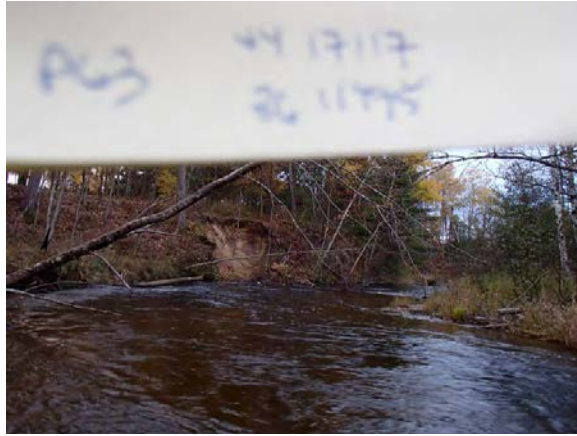
Site 56

Severity: Severe

Notes: clay ledge at toe, part of previously restored bank, substrate sand/small gravel/large wood, depth at toe 2'

View across (2011)

View downstream (2014)

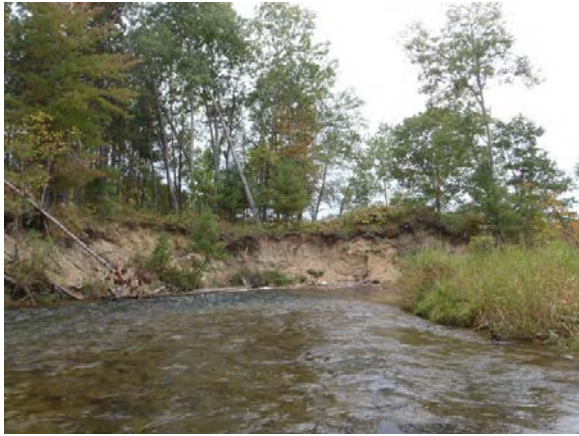
Site 57

Severity: Severe

Notes: clay ledge at toe, severity increased in intervening years

View downstream (2011)

View upstream (2014)

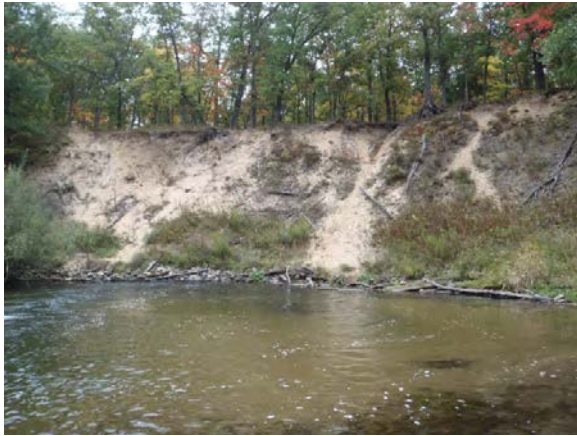
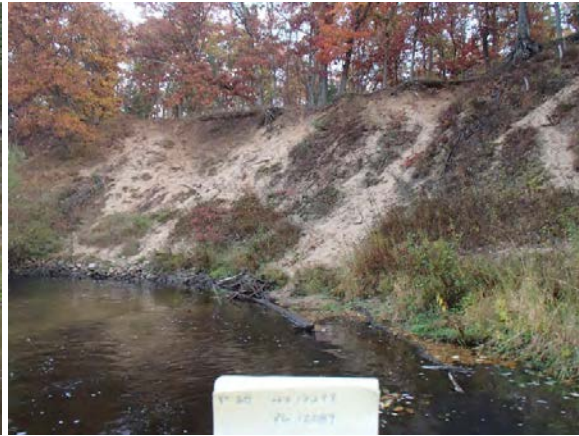
Site 58

Severity: Moderate

Notes: toe stable, prior work done, spring at toe, depth at toe 3', substrate sand/wood

View downstream (2011)

View downstream (2014)

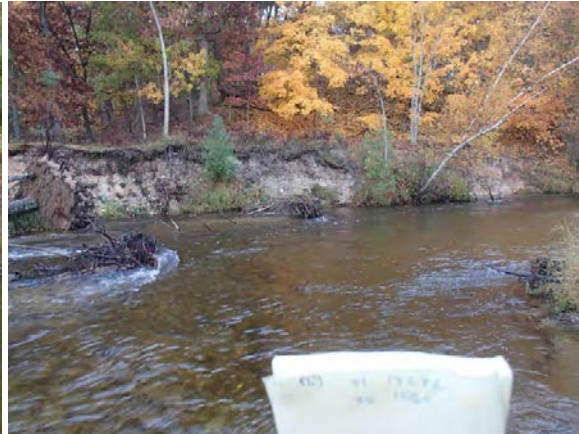
Site 59

Severity: Severe

Notes: angler access, continuation of prior site, clay exposed in bank, back eddies caused by debris jam, depth at toe 3'

View across and upstream (2014)

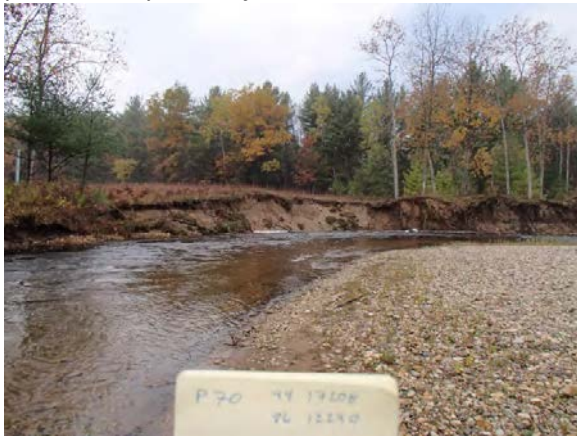
Site 60

Severity: Severe

Notes: depth at toe 2', substrate coarse gravel, rapid back eddy, large amount of gravel in bank, partly protected by debris jam

View downstream (2014)

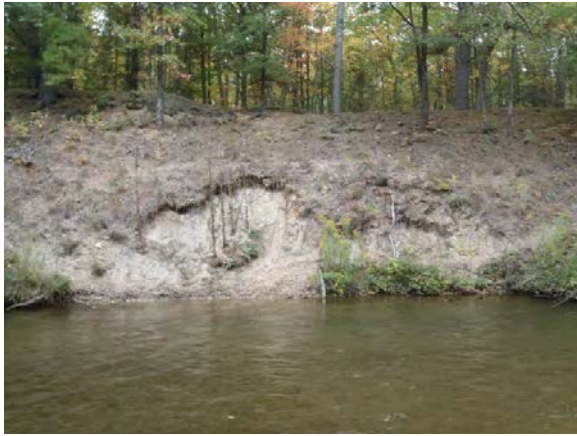
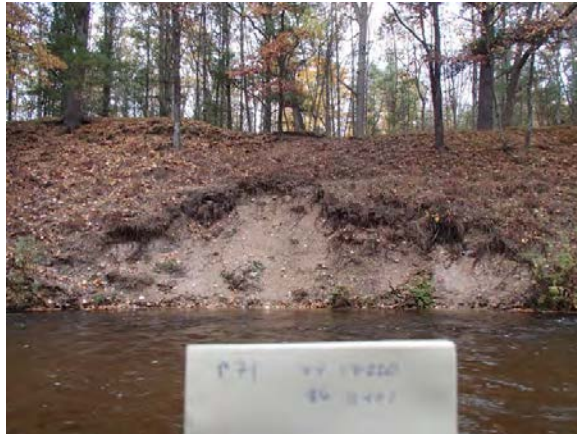
Site 61

Severity: Moderate

View across (2011)
