CONSERVATION RESOURCE ALLIANCE

Little Manistee River Eroding Stream Bank Assessment

Carrieville (Kings Highway) Bridge to Old Stronach Rd. Bridge

12/31/2014

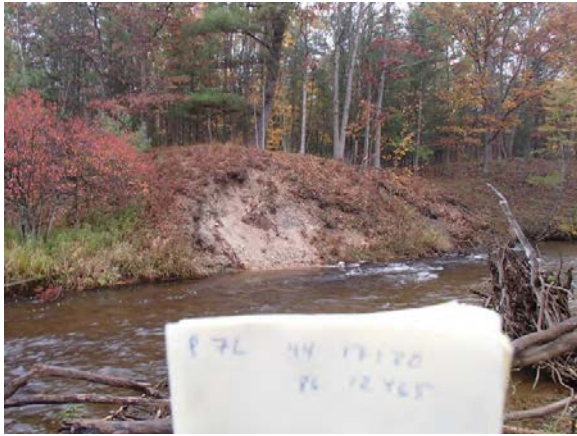
Site 62

Severity: Moderate

View upstream and across (2014)

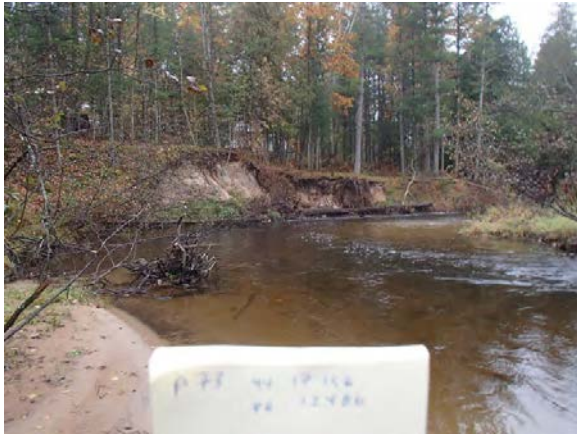
Site 63

View downstream (2014)

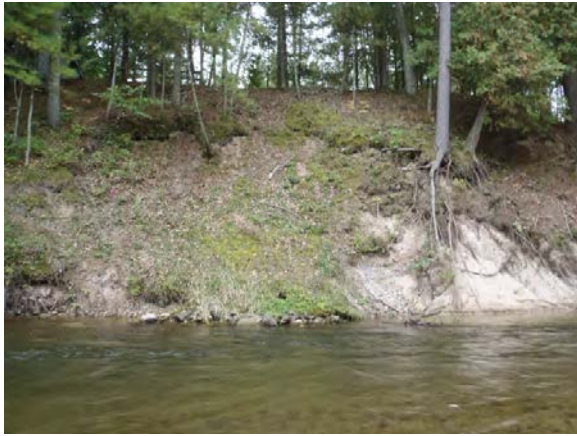
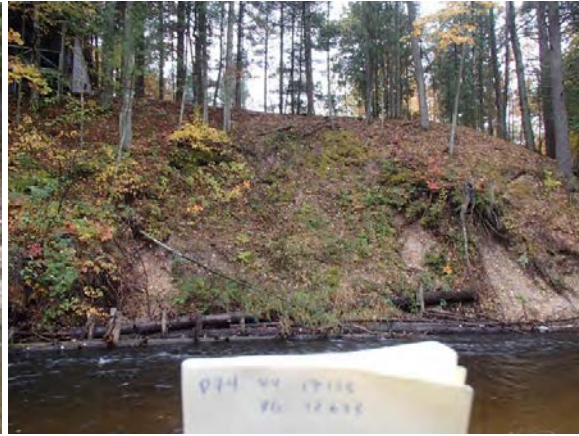
Site 64

Notes: substrate gravel/sand, depth at toe 3', back-eddy causing toe erosion, landowner dropped trees in 2011 frame and placed at toe for protection

View straight on (2011)

View straight on (2014)

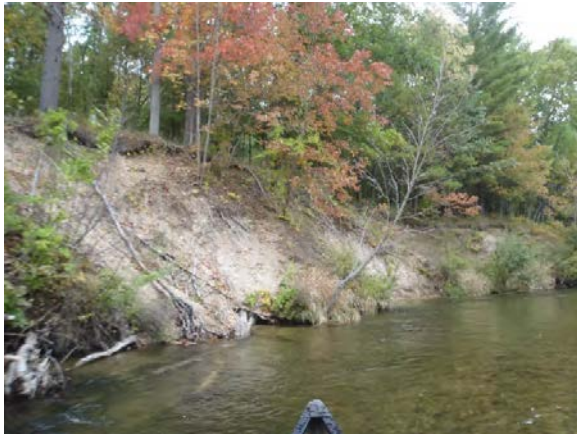
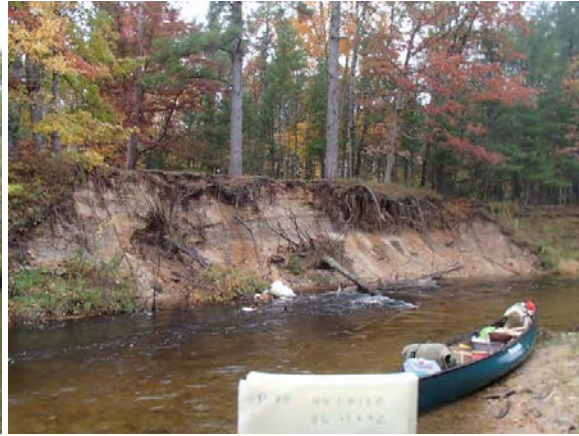
Site 65

Notes: depth at toe 3', substrate gravel/sand, erosion resulting from boiling and eddying from current deflecting off relic structure into toe

View upstream (2011)

View upstream (2014)

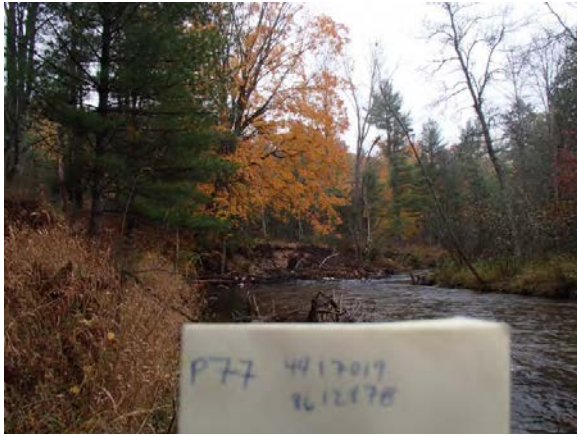
Site 66

View downstream (2014)

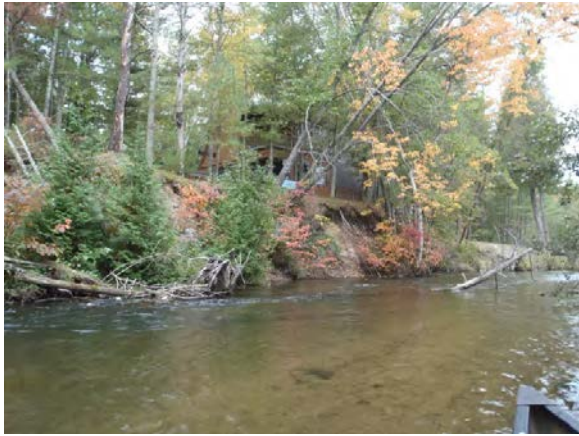
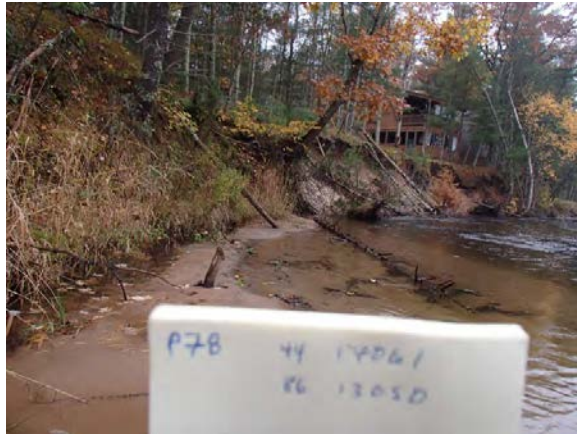
Site 67

Notes: substantial change in severity in intervening years

View downstream (2011)

View downstream (2014)

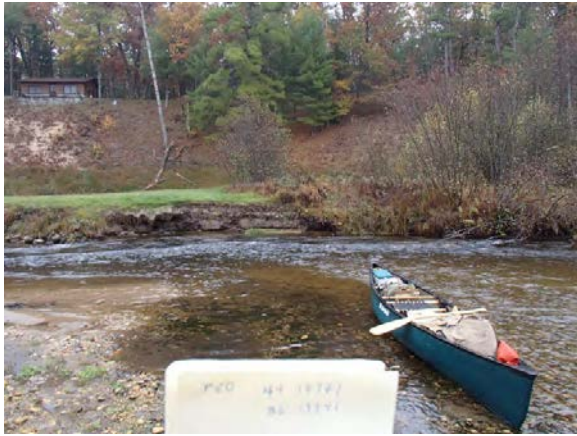
Site 69

Notes: a pond is located on the up-country side of the bank

View across (2014)

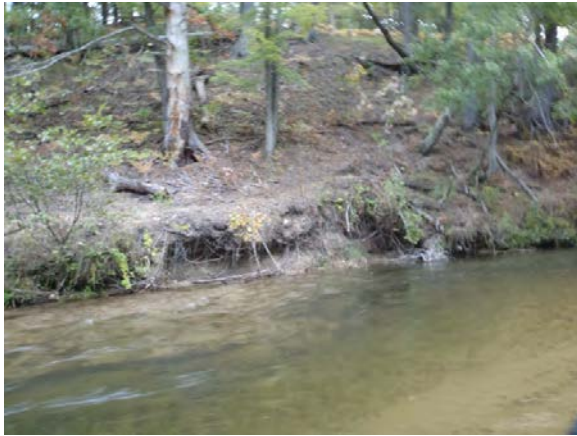
Site 70

Notes: angler path at top, substrate gravel/clay at toe

View across (2011)

View across (2014)

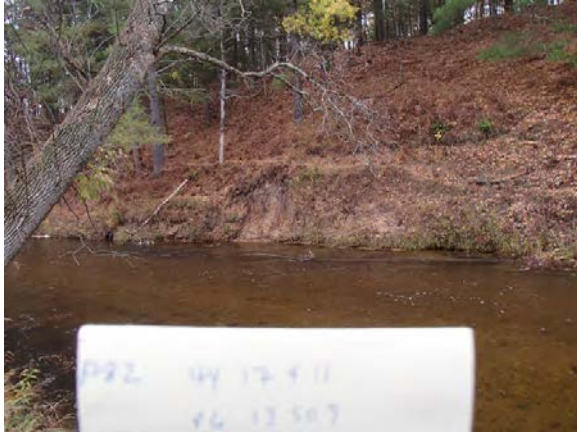
Site 71

Severity: Minor

Notes: angler path at top, substrate gravel/clay at toe

View downstream and across (2014)

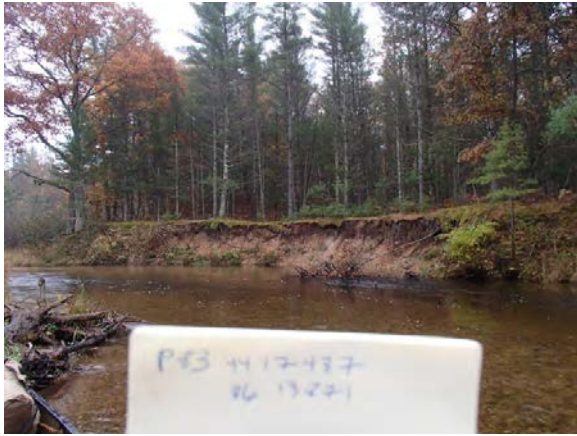
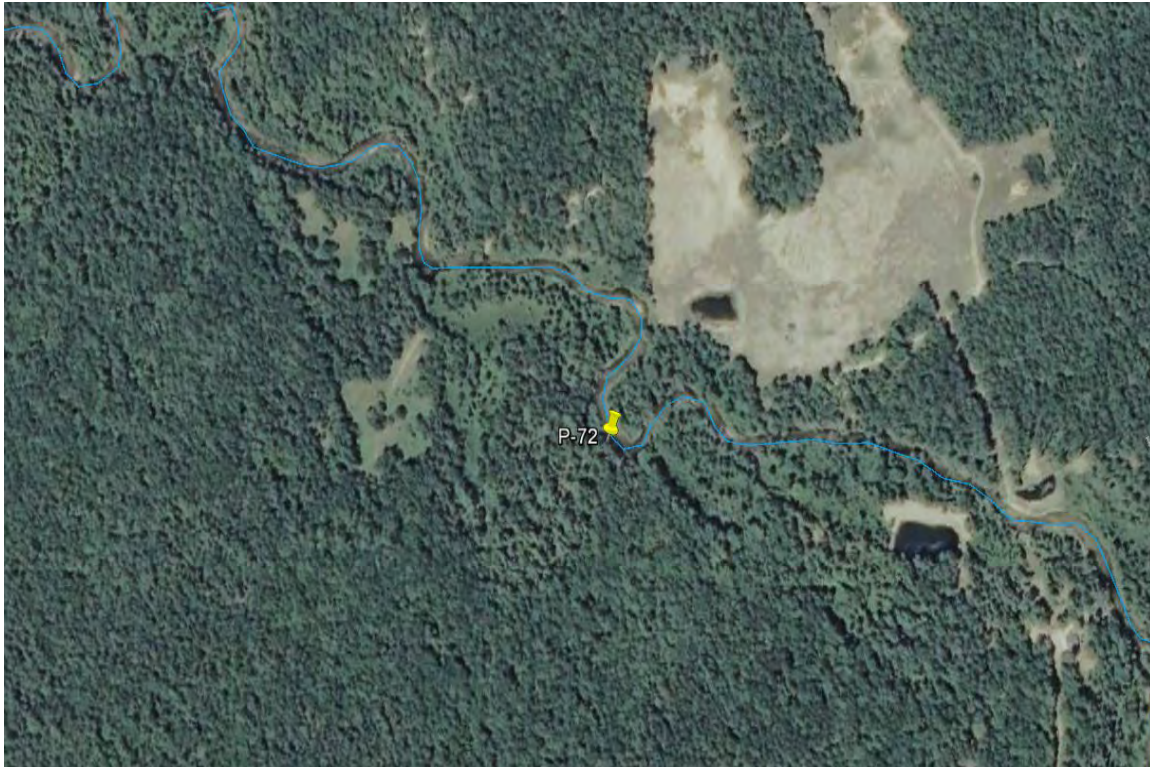
Site 72

Severity: Severe

Notes: new as of 2014 survey

View upstream and across (2014)

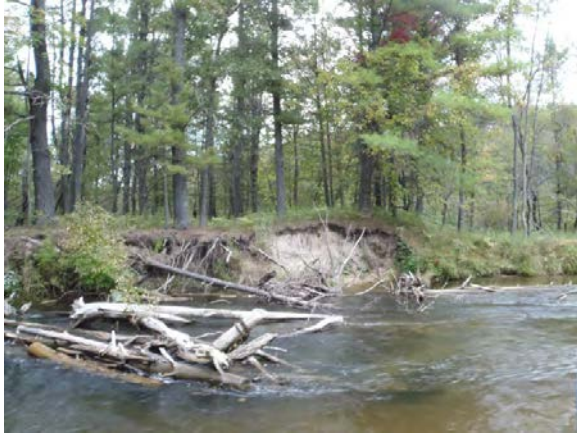
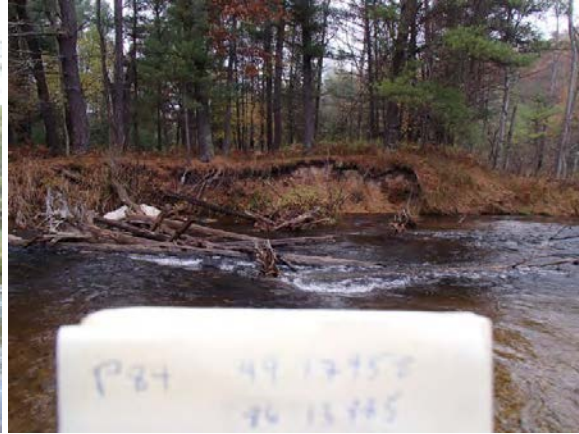
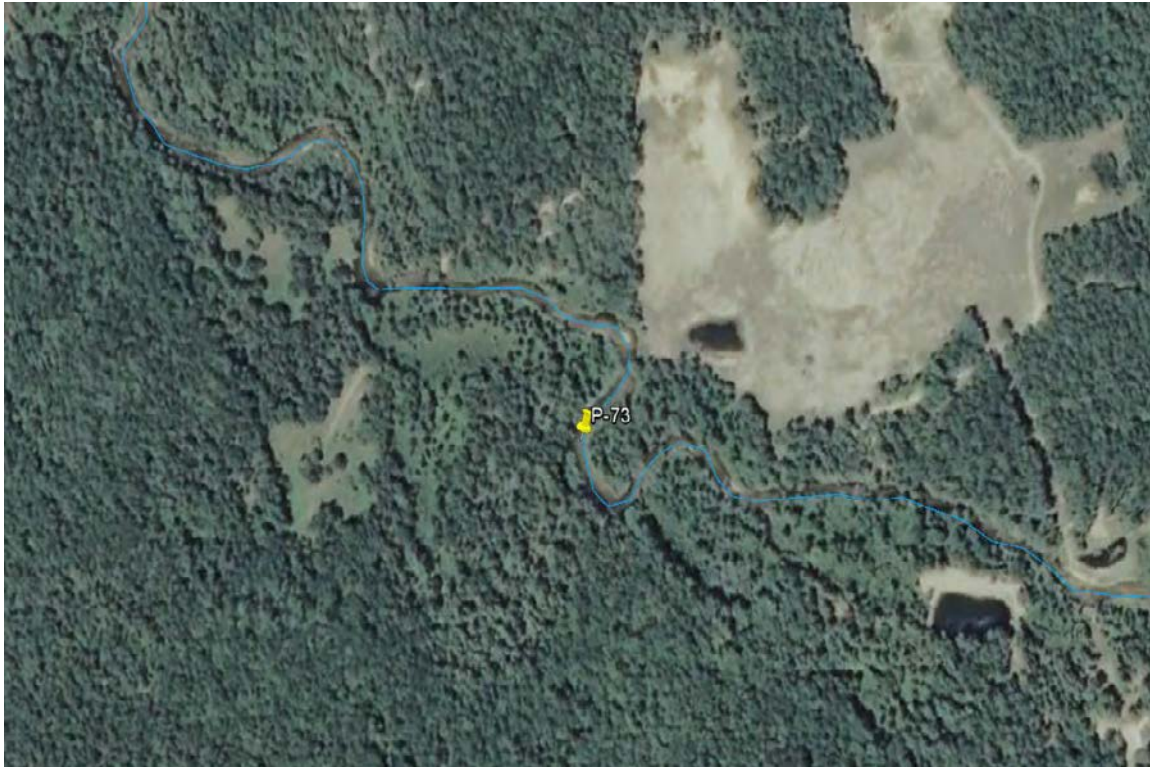
Site 73

Severity: Moderate

Notes: substrate gravel/sand/wood, depth at toe 3'

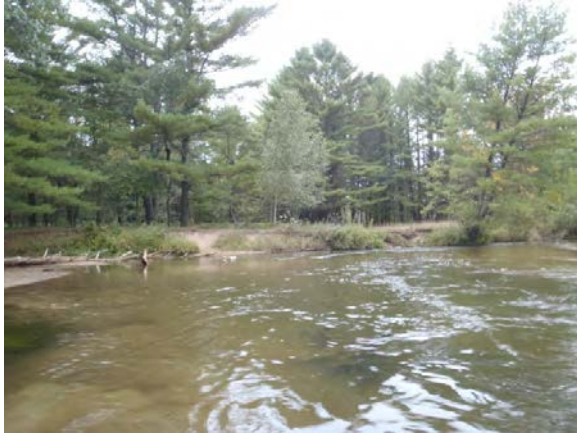
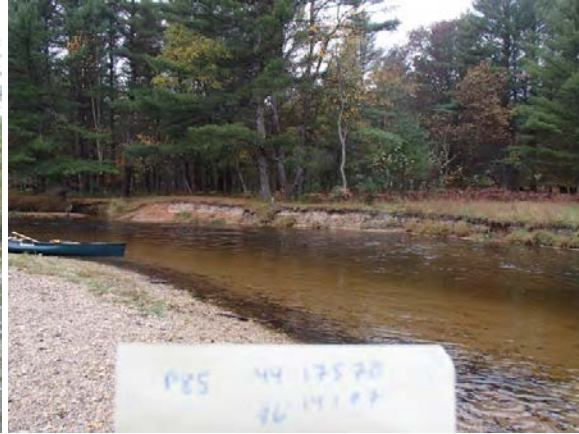
Site 74

Severity: Minor (2011), Moderate (2014)

Notes: angler campsite and access, depth at toe 2', substrate gravel/cobble

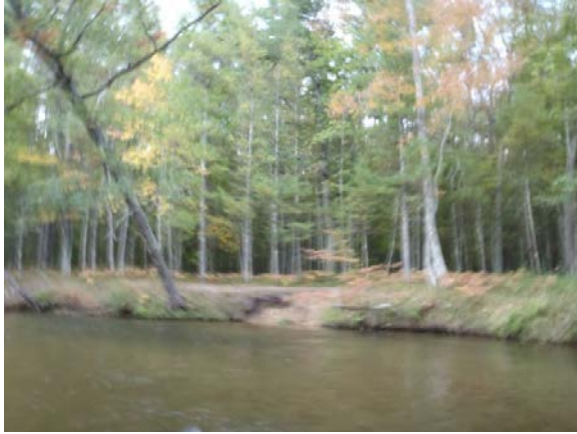
Site 75

Severity: Moderate

Notes: depth at toe 2', substrate gravel, downstream of tributary confluence, angler access trail adjacent

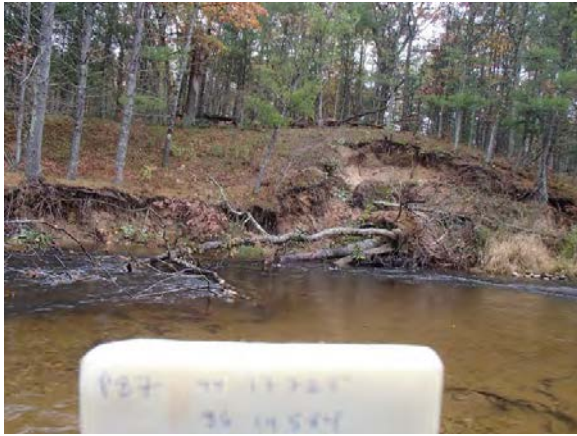
Site 76

Severity: Severe

Notes: stabilization efforts in past (toe-stone), calving of bank with tree slumping

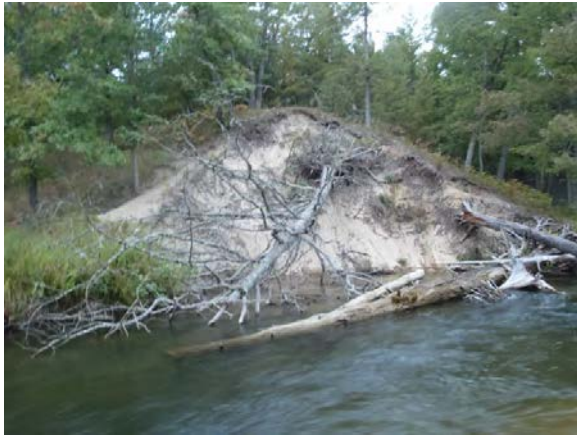
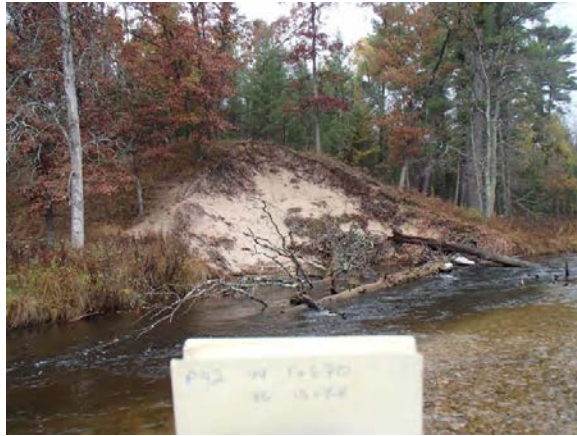
Site 77

Severity: Moderate

Notes: substrate gravel/sand, water depth 3'

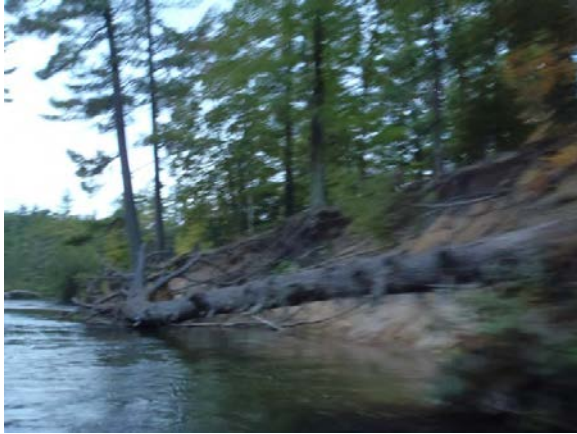
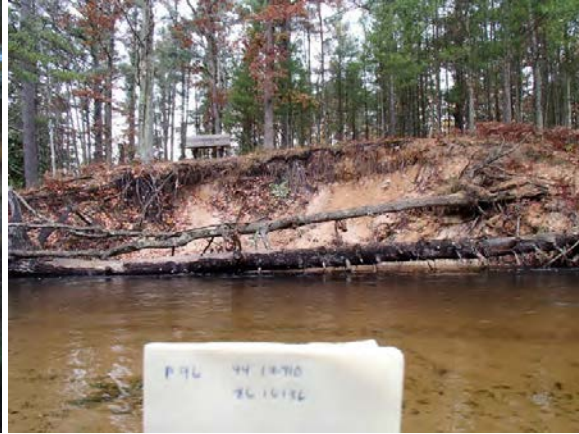
Site 78

Severity: Severe

Notes: "Clyde's" bench, substrate small gravel, depth at toe 3.5'

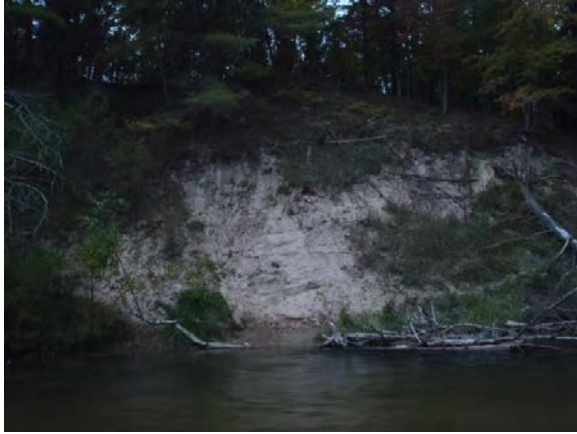
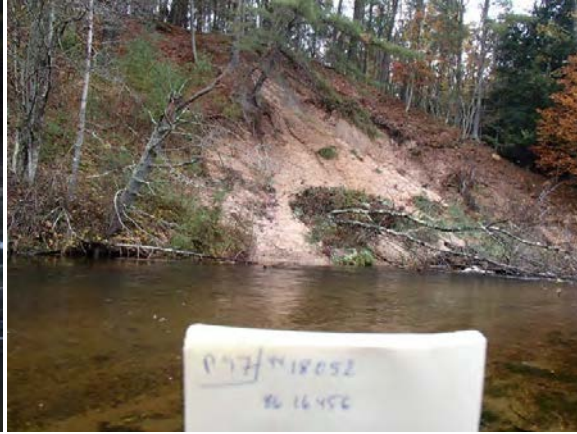
Site 79

Severity: Severe

Notes: last site upstream of 6 Mile Bridge

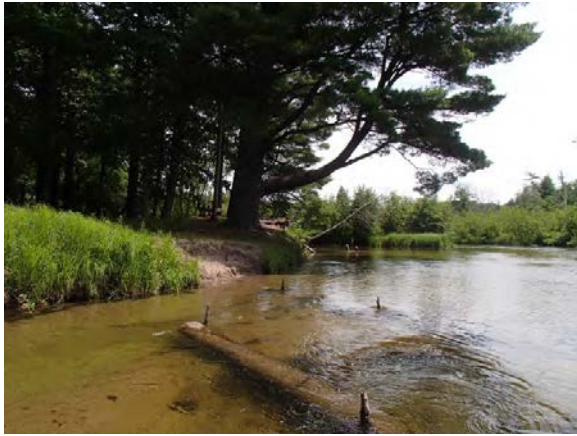
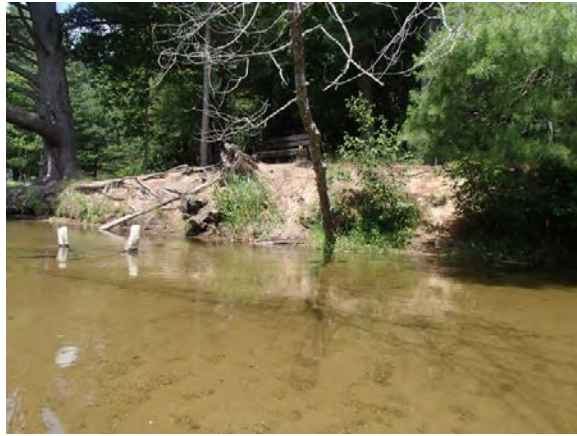
Site 80

Severity: Moderate

Notes: recreational access, depth at toe 1.5', substrate sand, relic structure present

View upstream, erosion extends around corner (2013)

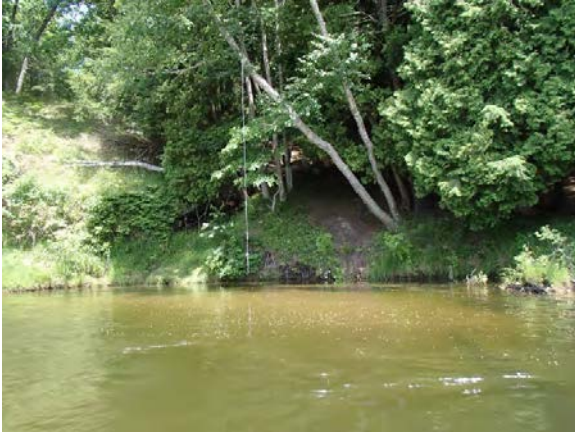
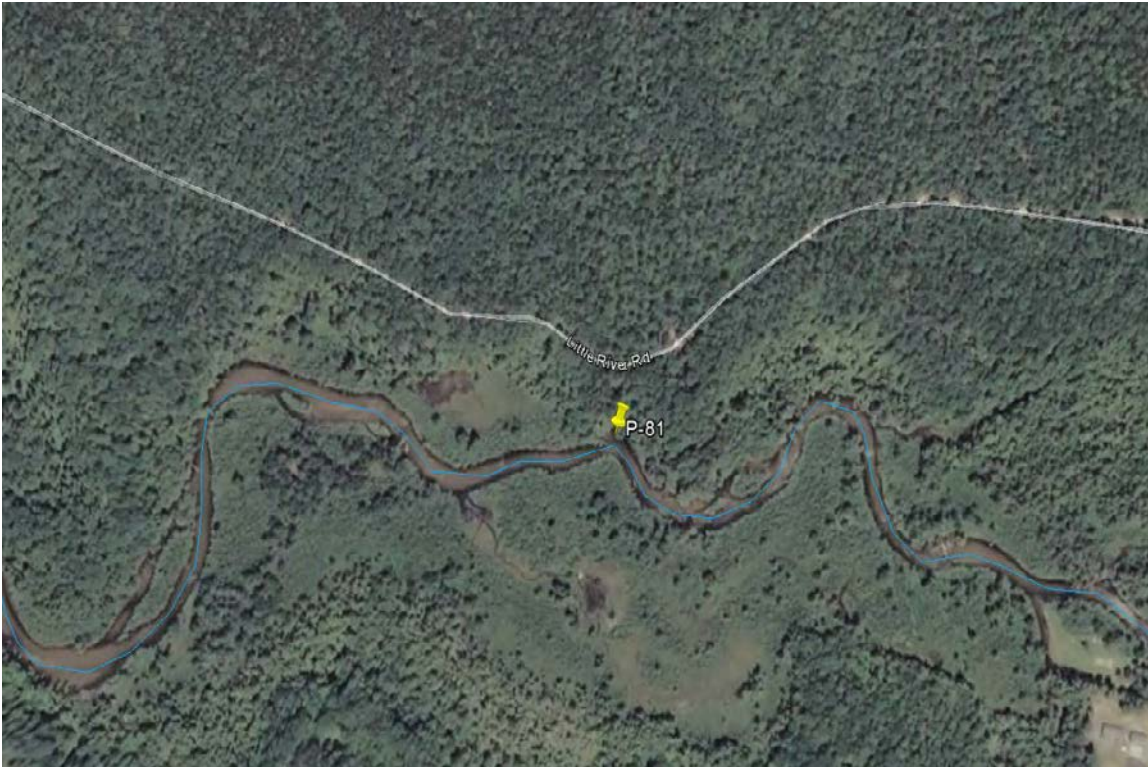
Site 81

Severity: Moderate

Notes: depth at toe 1.75', substrate clay/sand, swimming hole (12' deep) adjacent

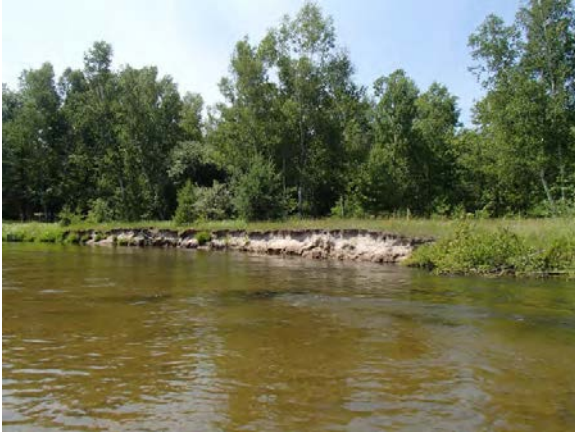
Site 82

Severity: Severe

Notes: depth at toe 3.5', substrate gravel/sand
