2021 Little Manistee River Eroding Stream Bank Assessment

Carrieville (Kings Highway) Bridge to Old Stronach Rd. Bridge

Nate Winkler, Biologist

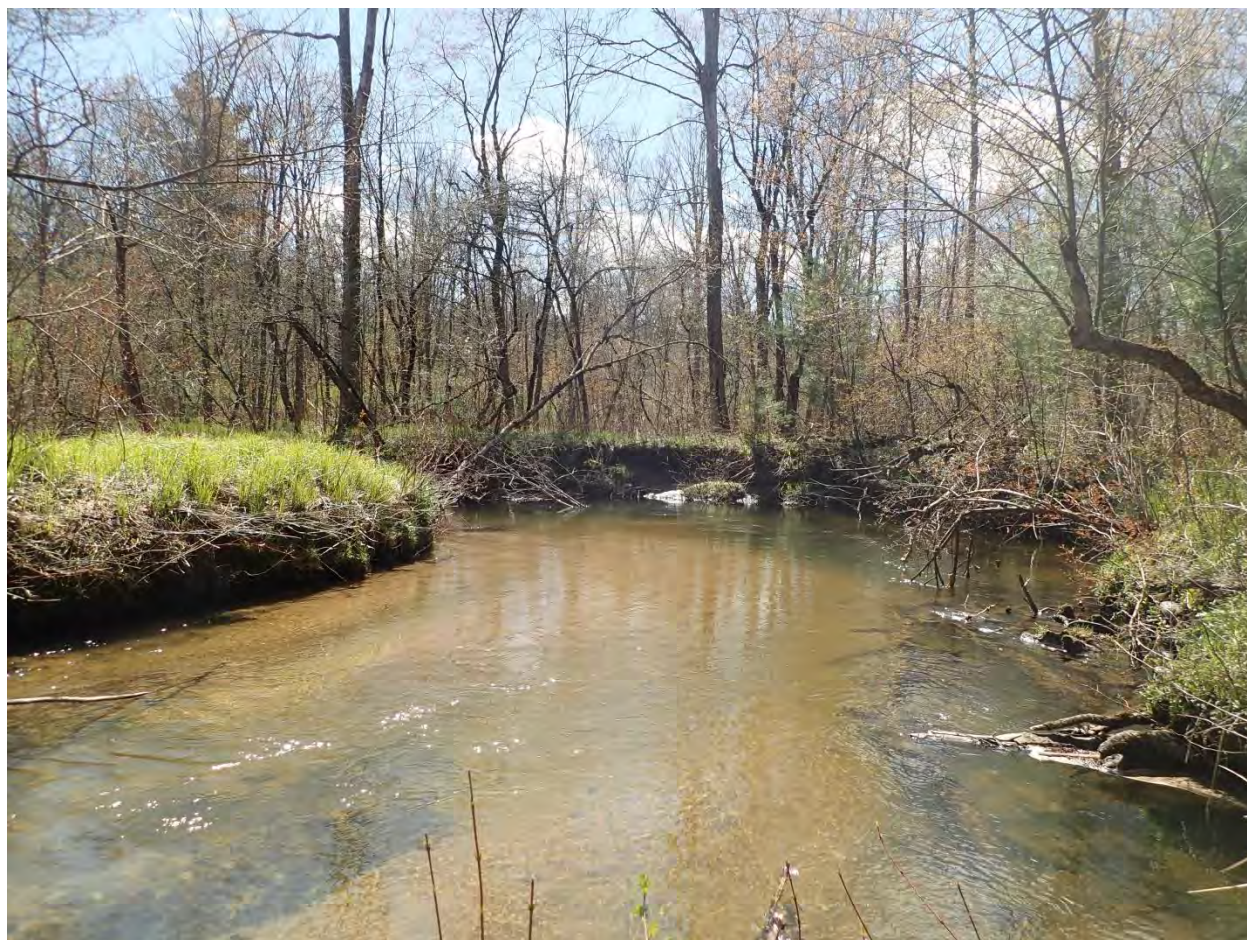
LM#1-2021

dimensions: 6' l x 4' h

river right

depth at toe: 3'

[moderate](#)

substrate: sand

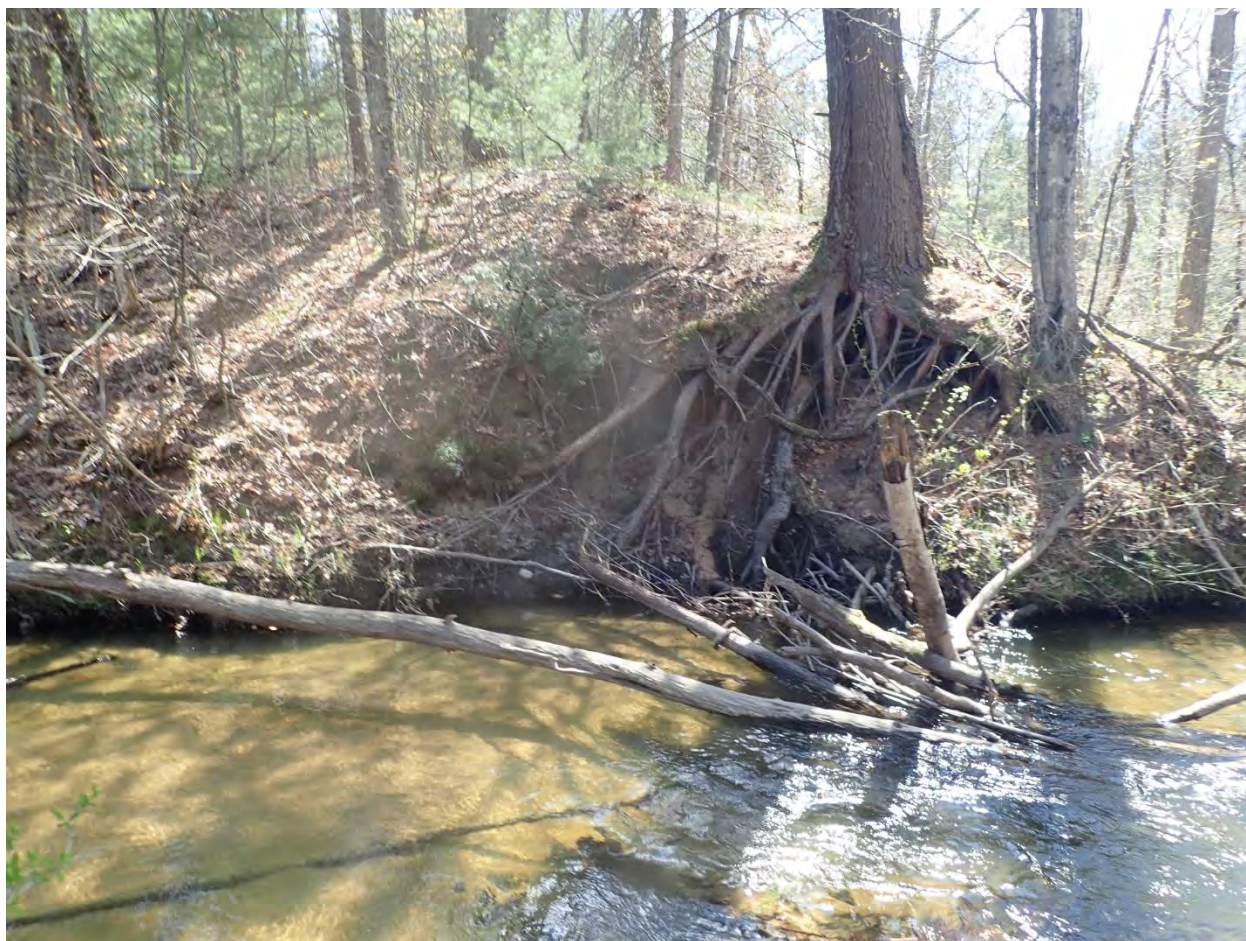
LM#2-2021

dimensions: 8' l x 8' h

river left

depth at toe: 2'

minor

substrate: sand

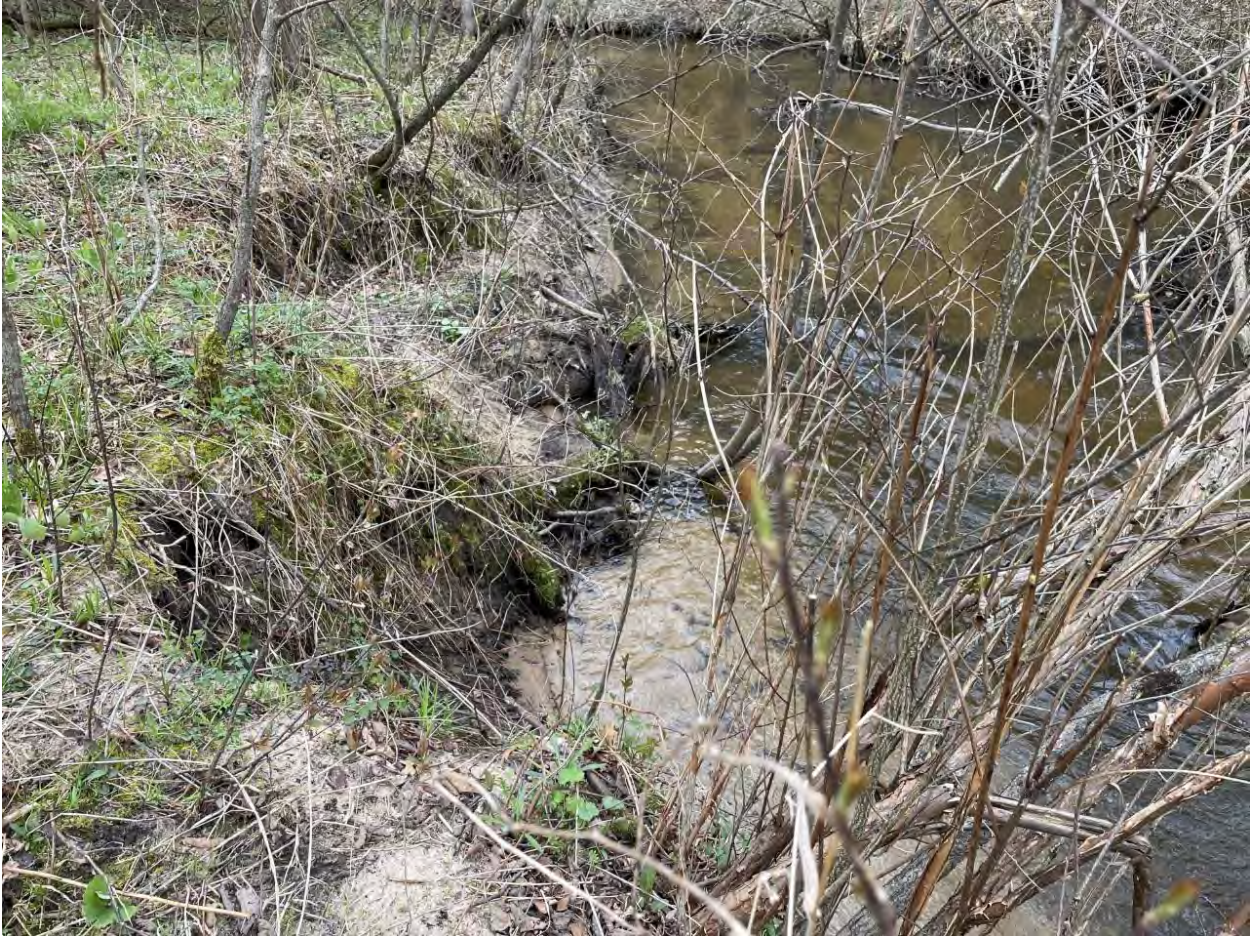
LM#4-2021 (downstream)

dimensions: 50' l x 4' h

river right

depth at toe: .5'

[moderate](#)

substrate: sand

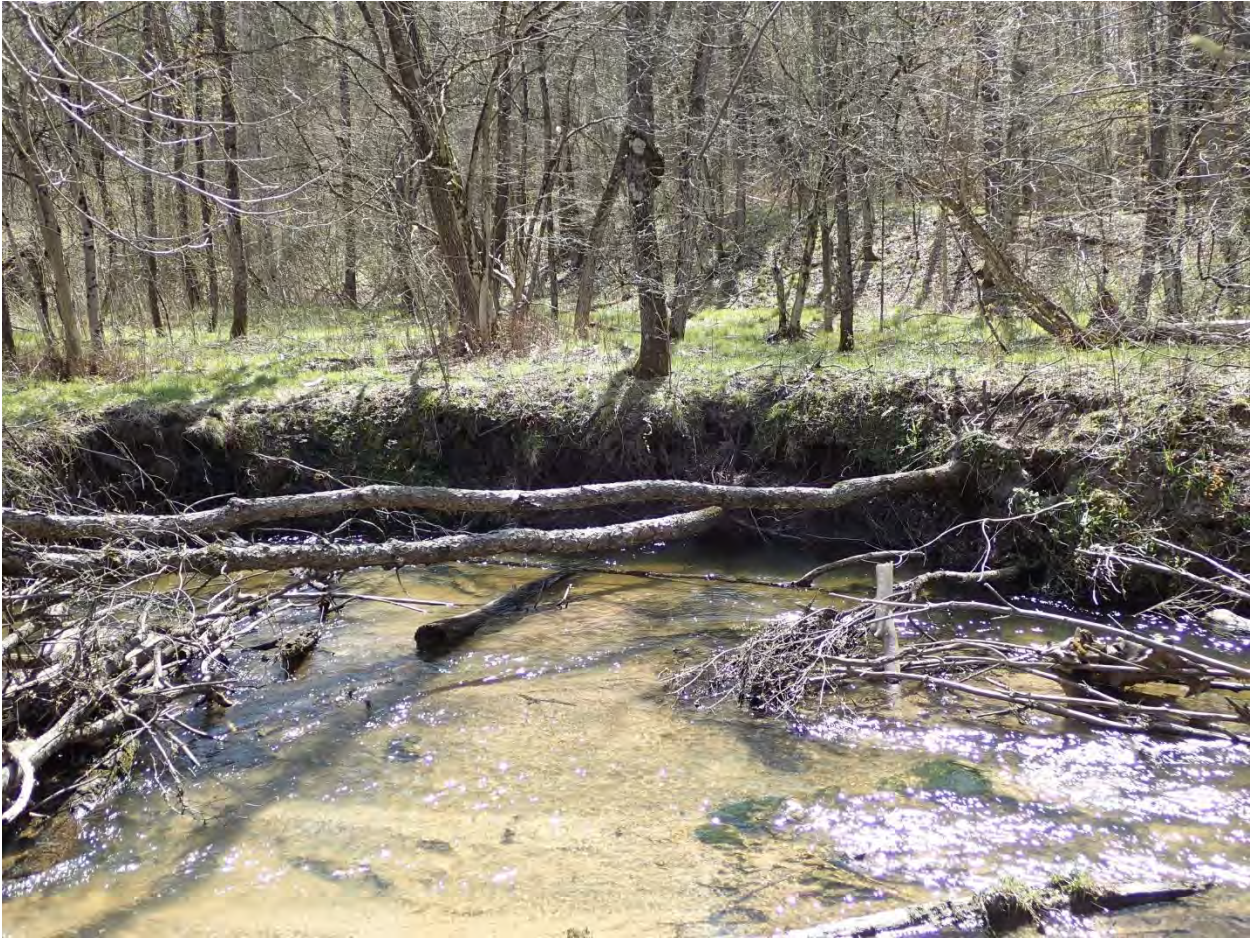
LM#6-2021

dimensions: 20' l x 5' h

river left

depth at toe: 2.5'

moderate

substrate: sand

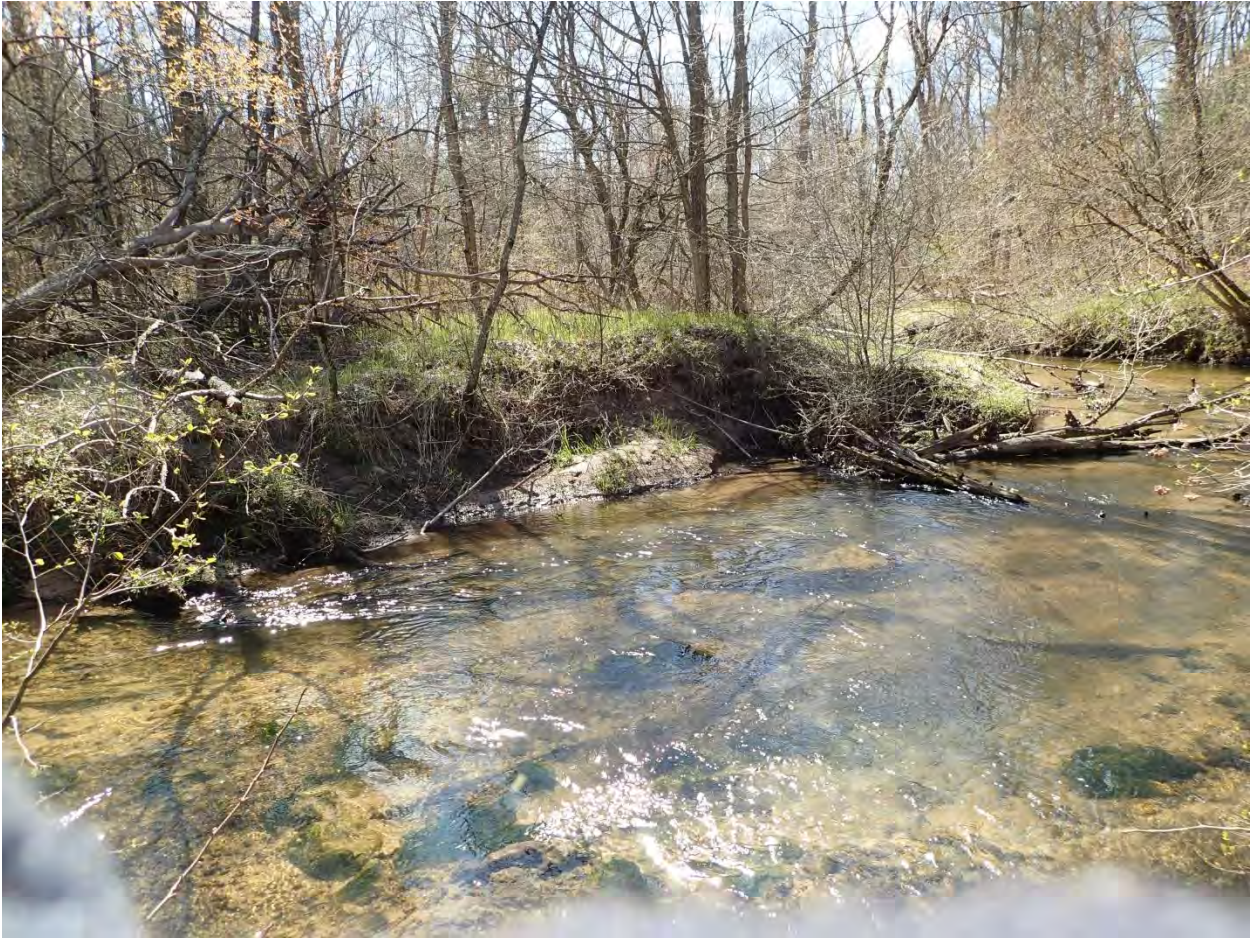
LM#7-2021

dimensions: 20' l x 5' h

river left

depth at toe: .5'

[moderate](#)

substrate: sand

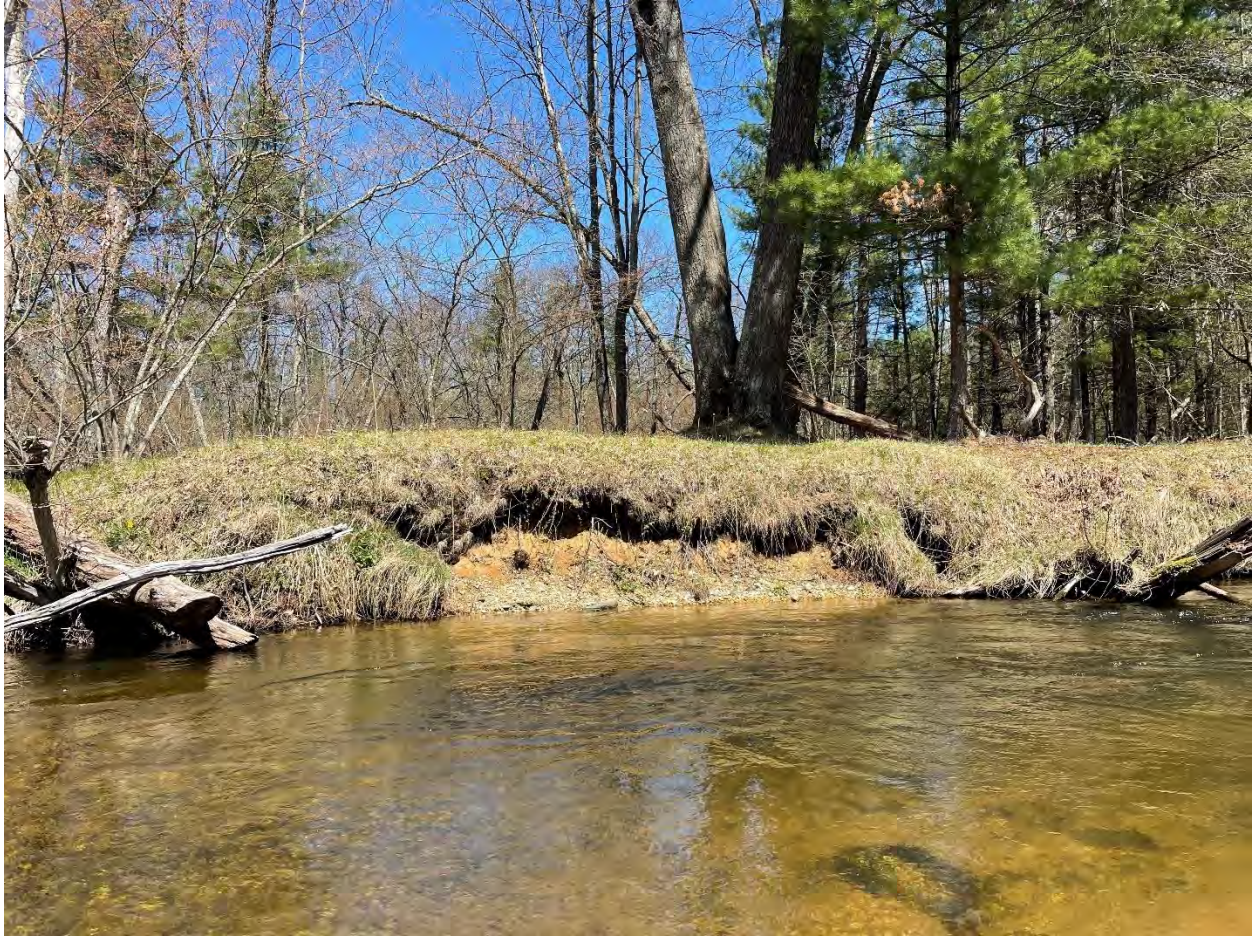
LM#36-2021

substrate: sand, gravel

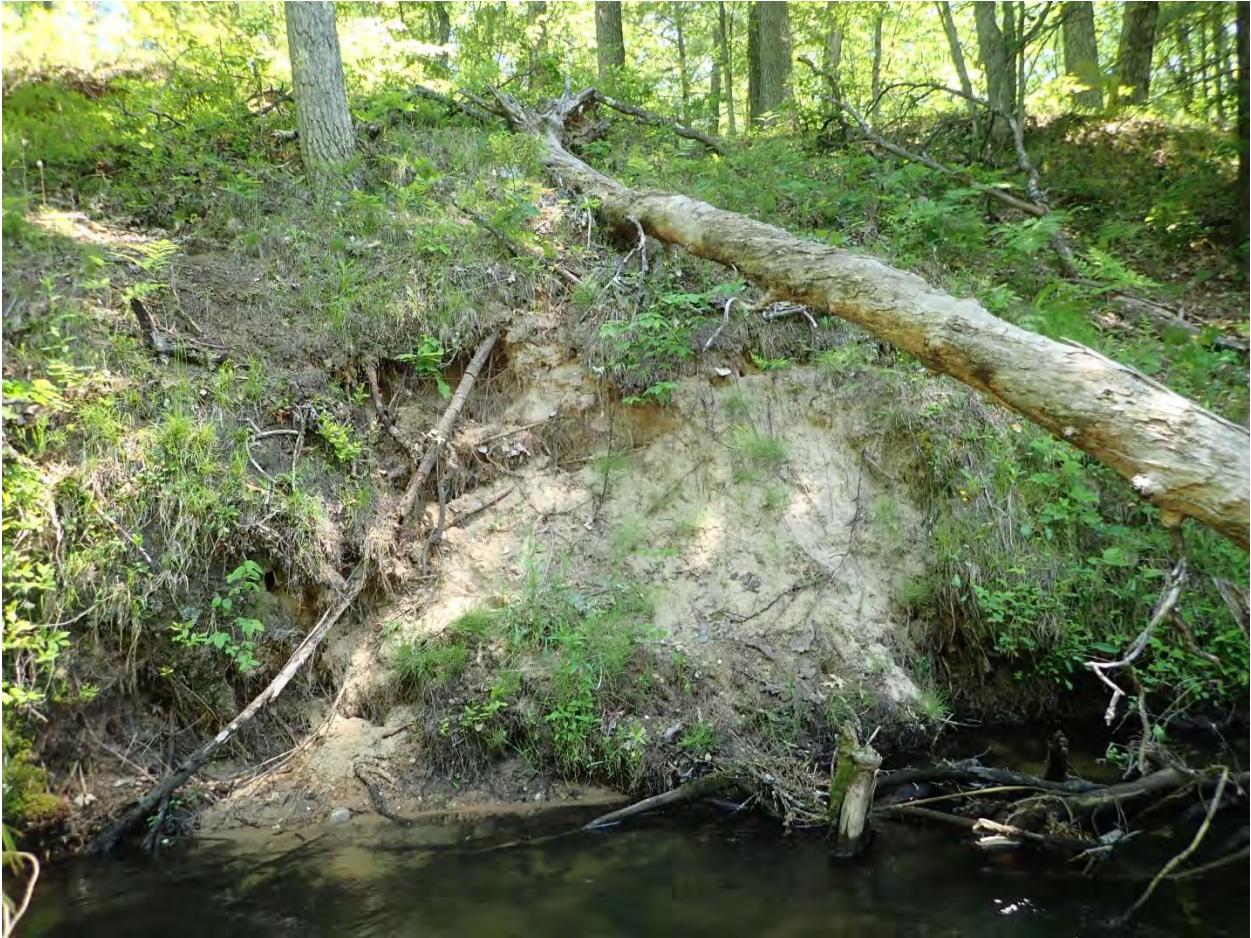
LM#40-2021

substrate: sand, medium gravel, boulders

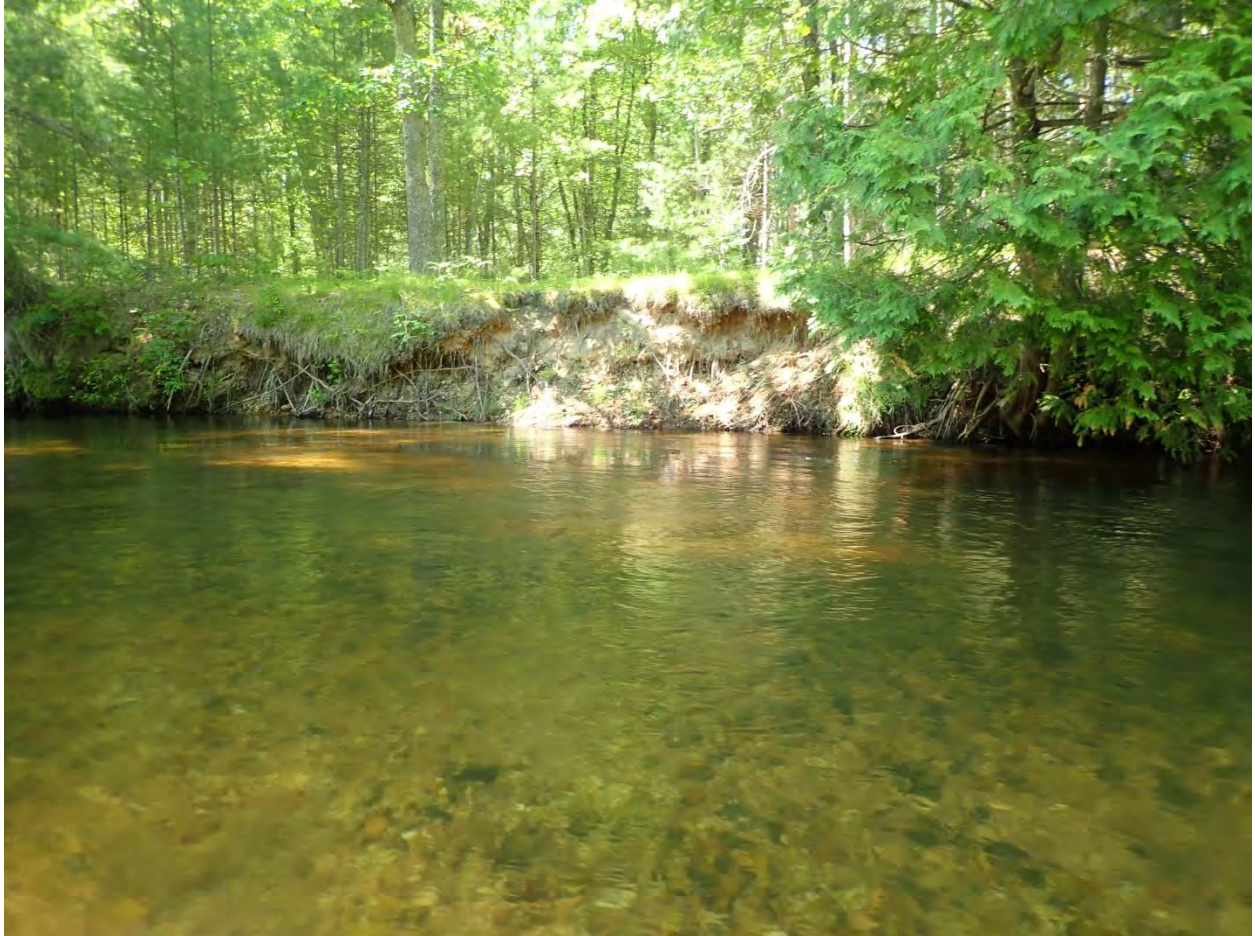
LM#43-2021

substrate: medium-small gravel

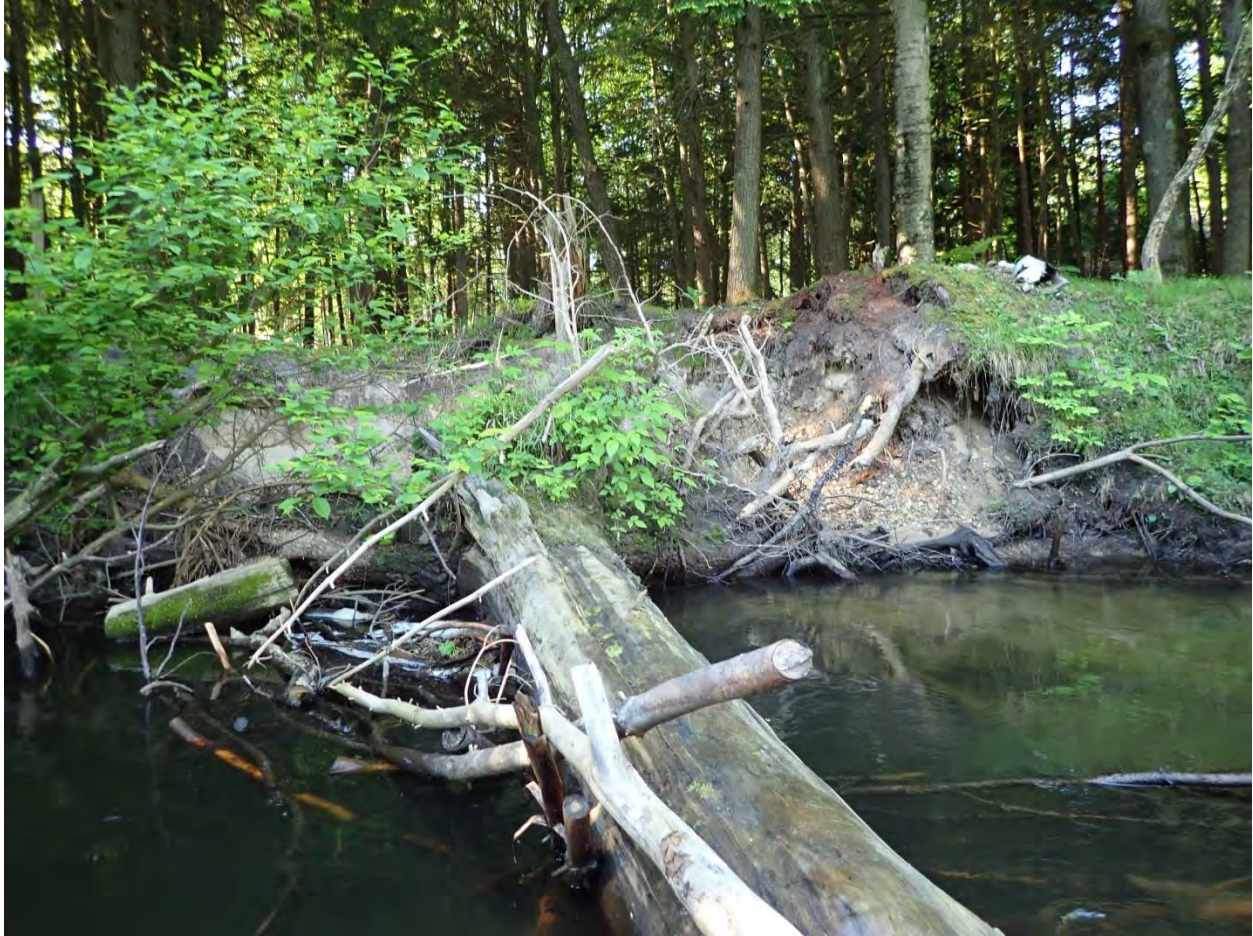
LM#47-2021

substrate: sand

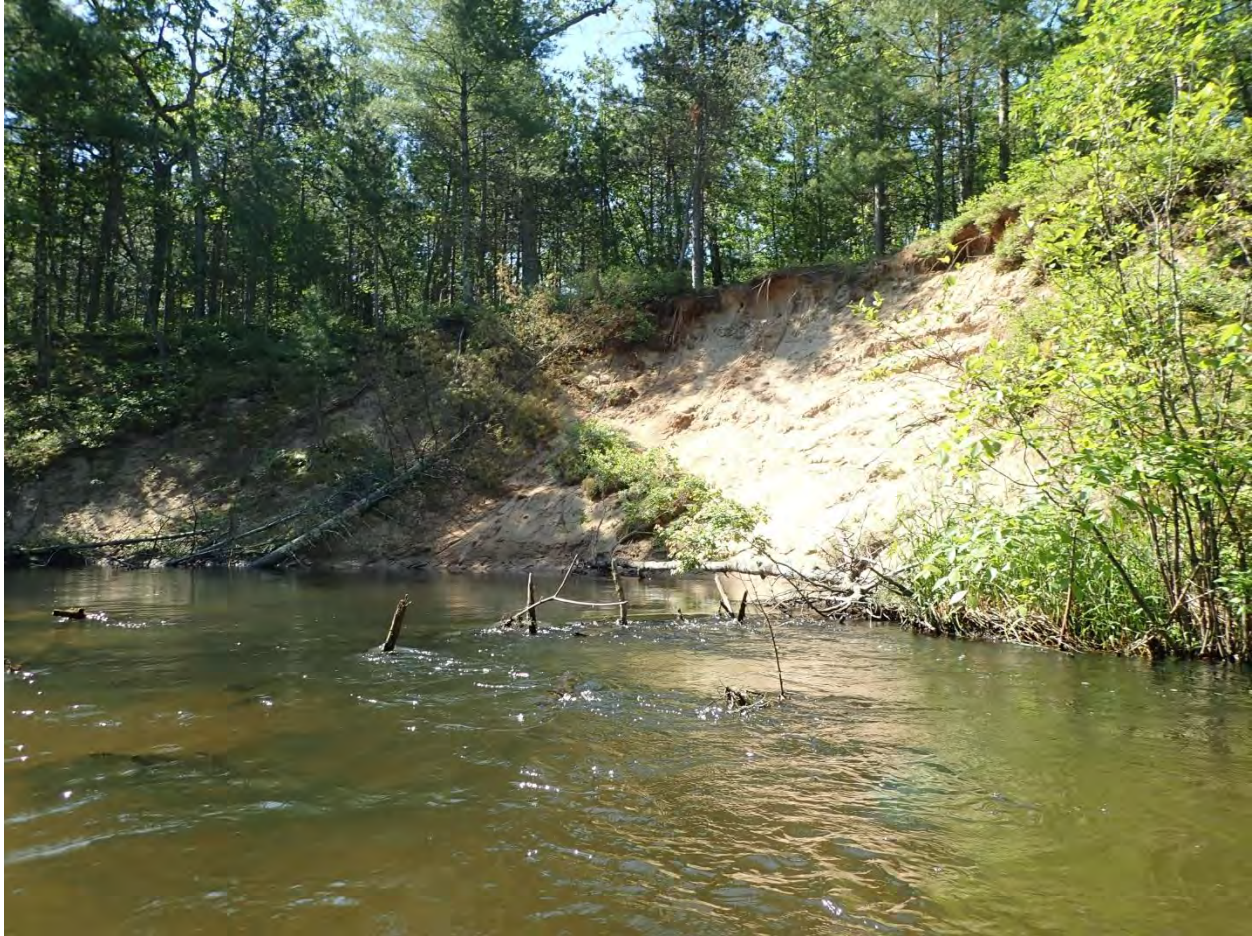
**LM#49-2021**

substrate: sand

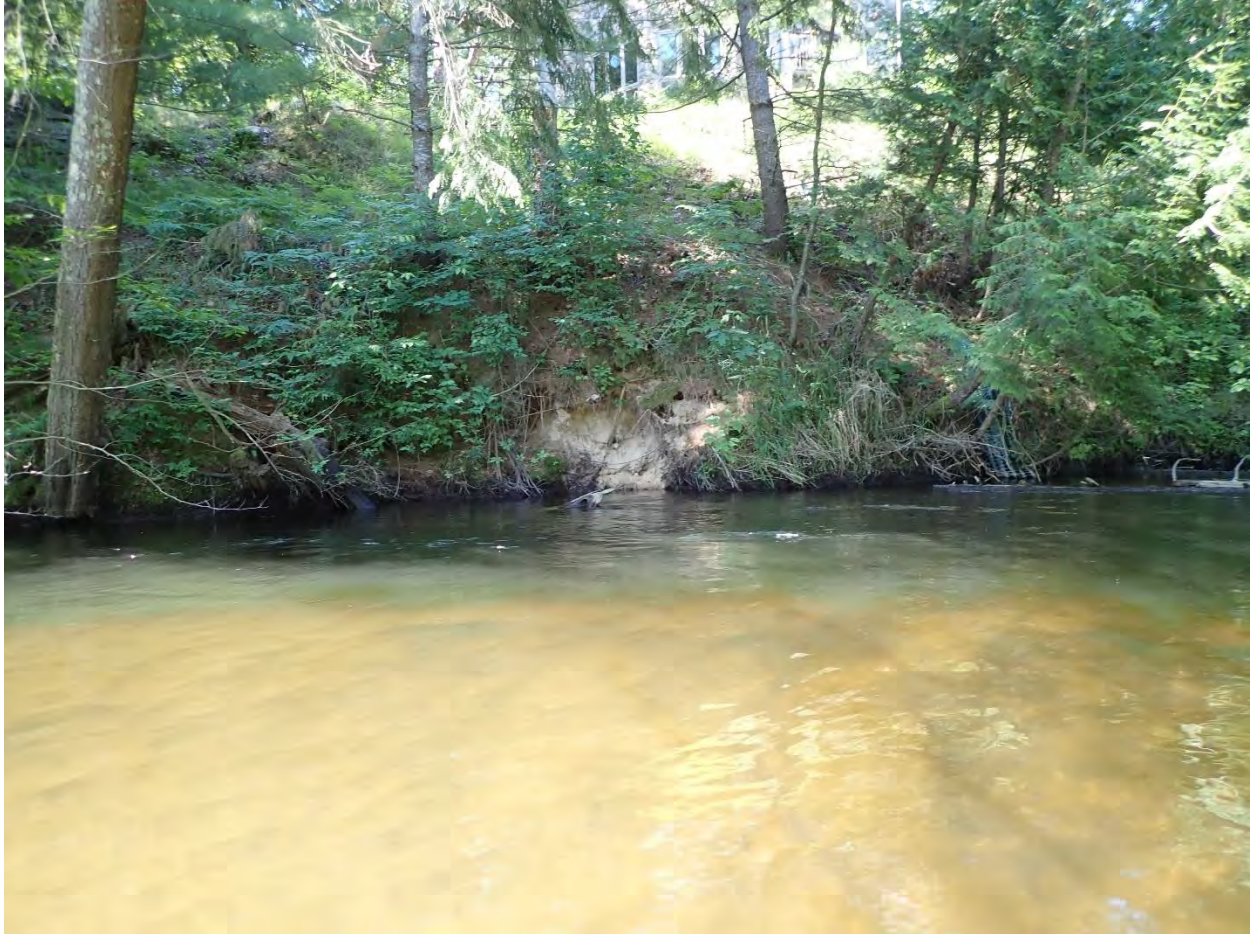
LM#50-2021

substrate: sand

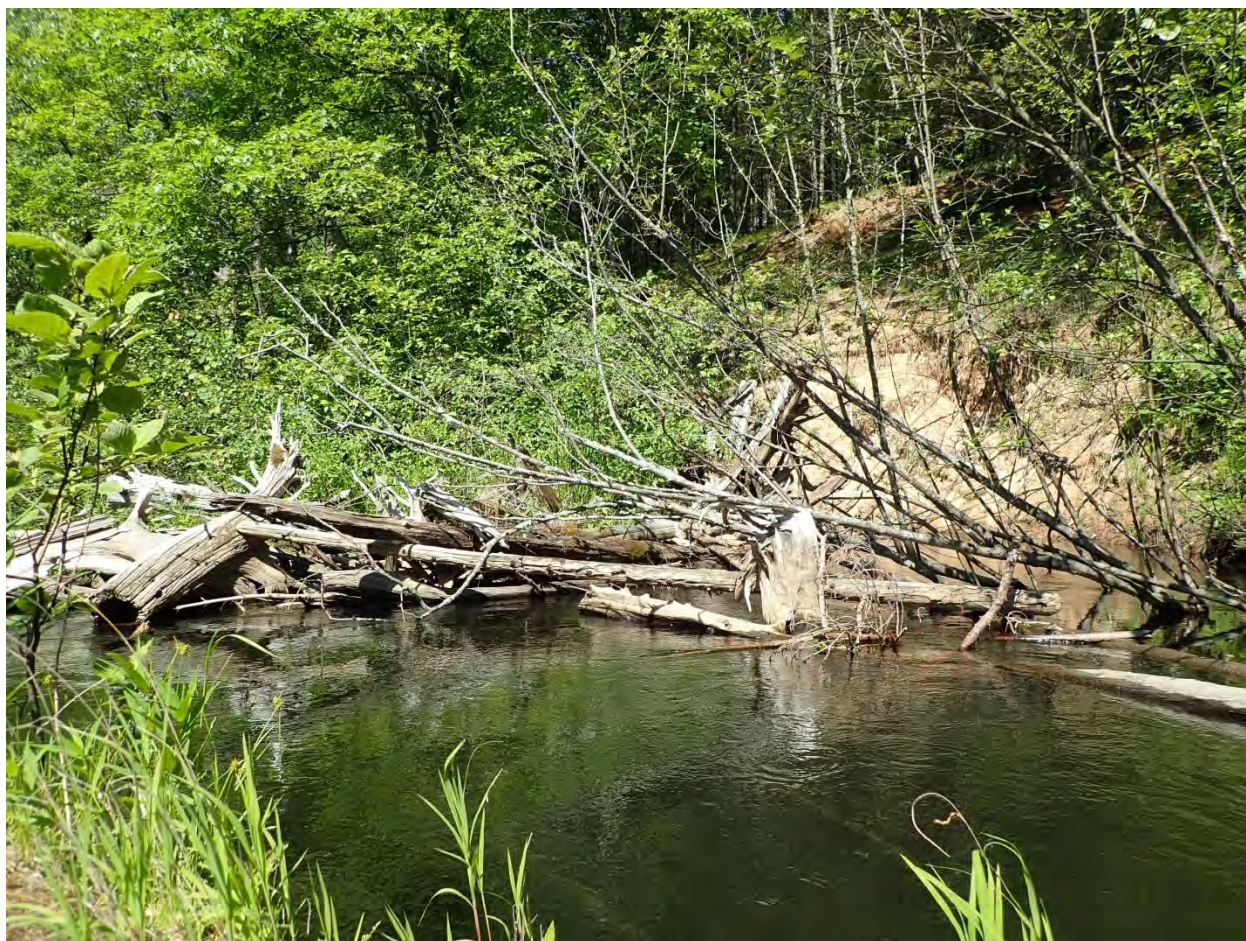
LM#51-2021

substrate: unknown

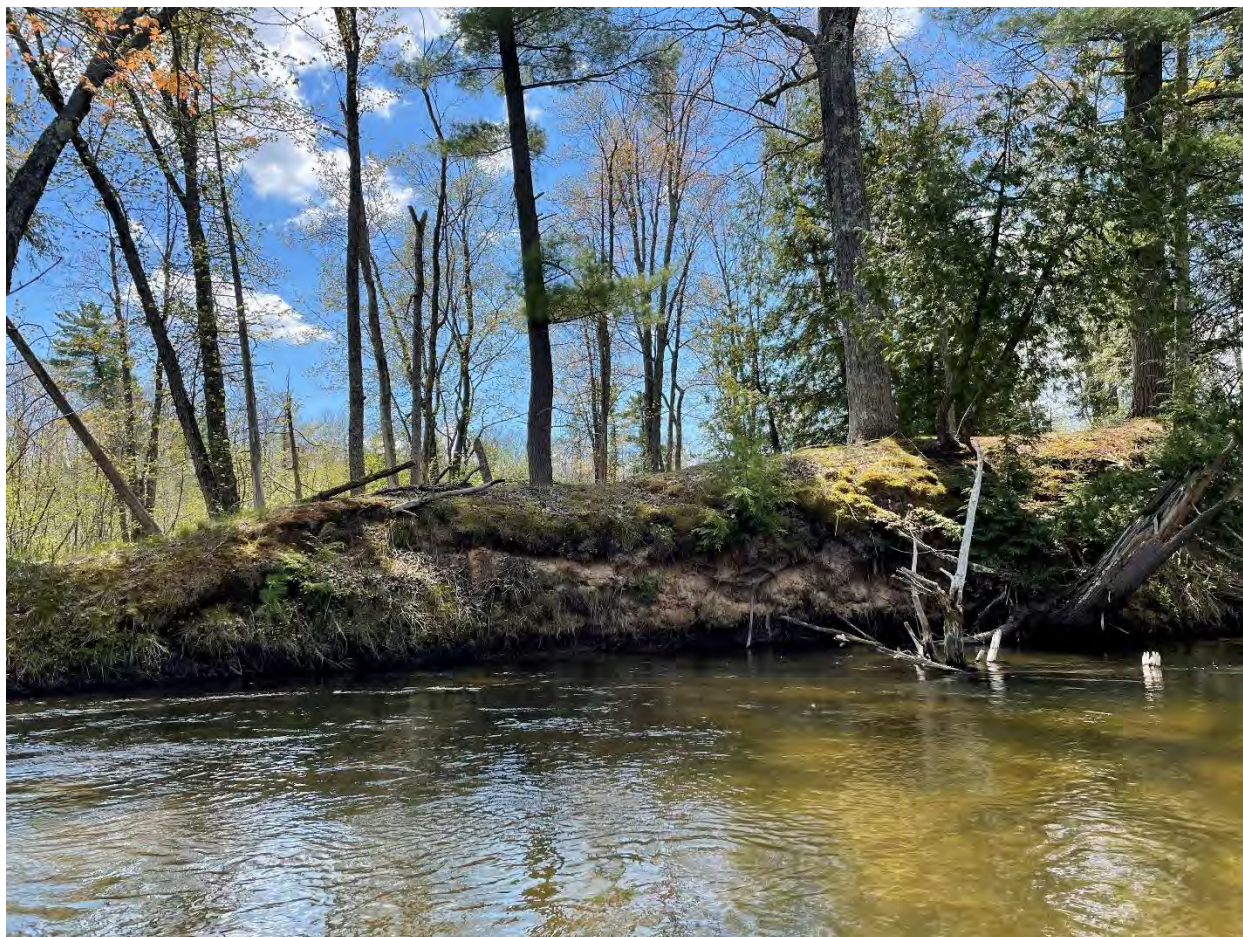
LM#52-2021

substrate: sand

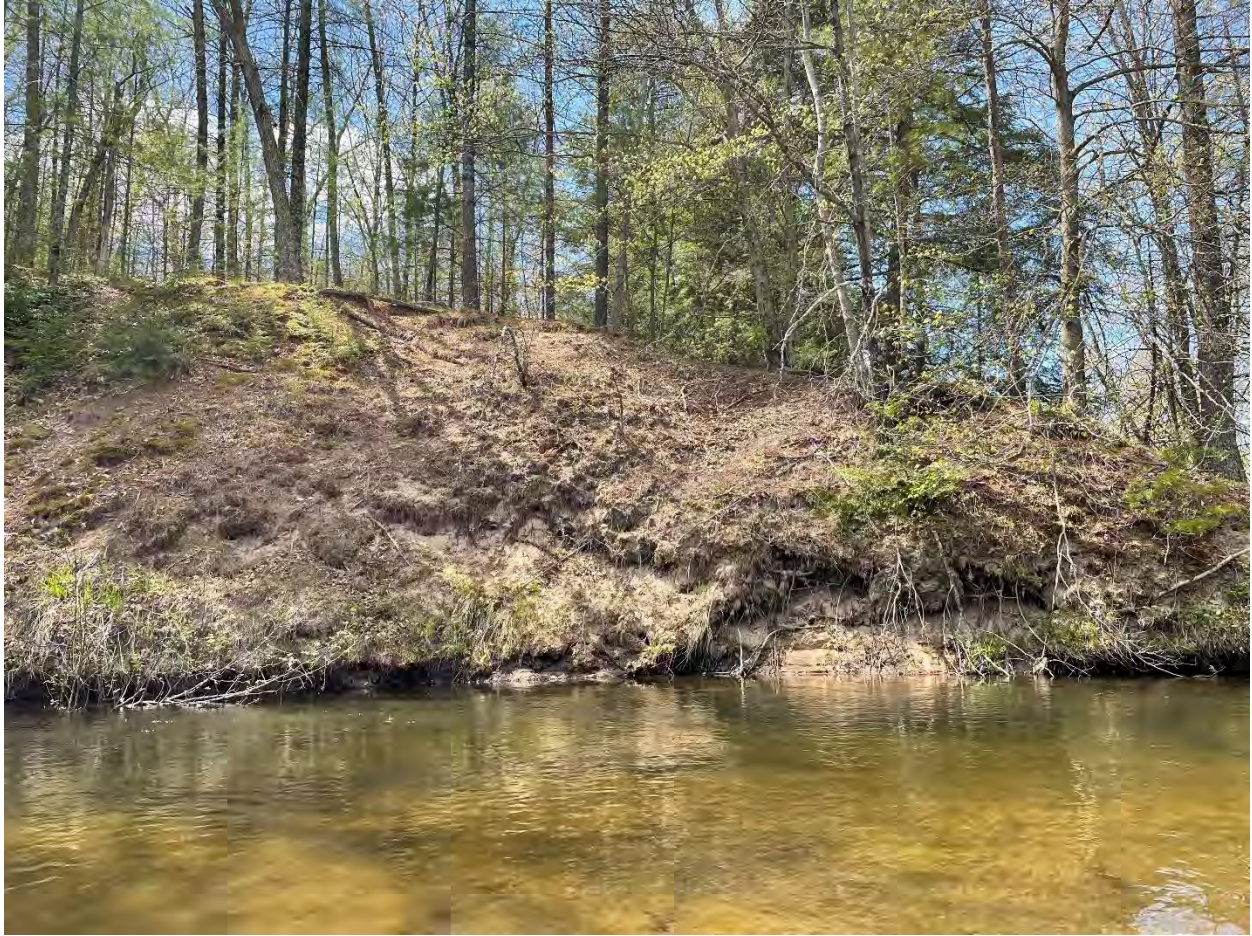
LM#53-2021

substrate: sand

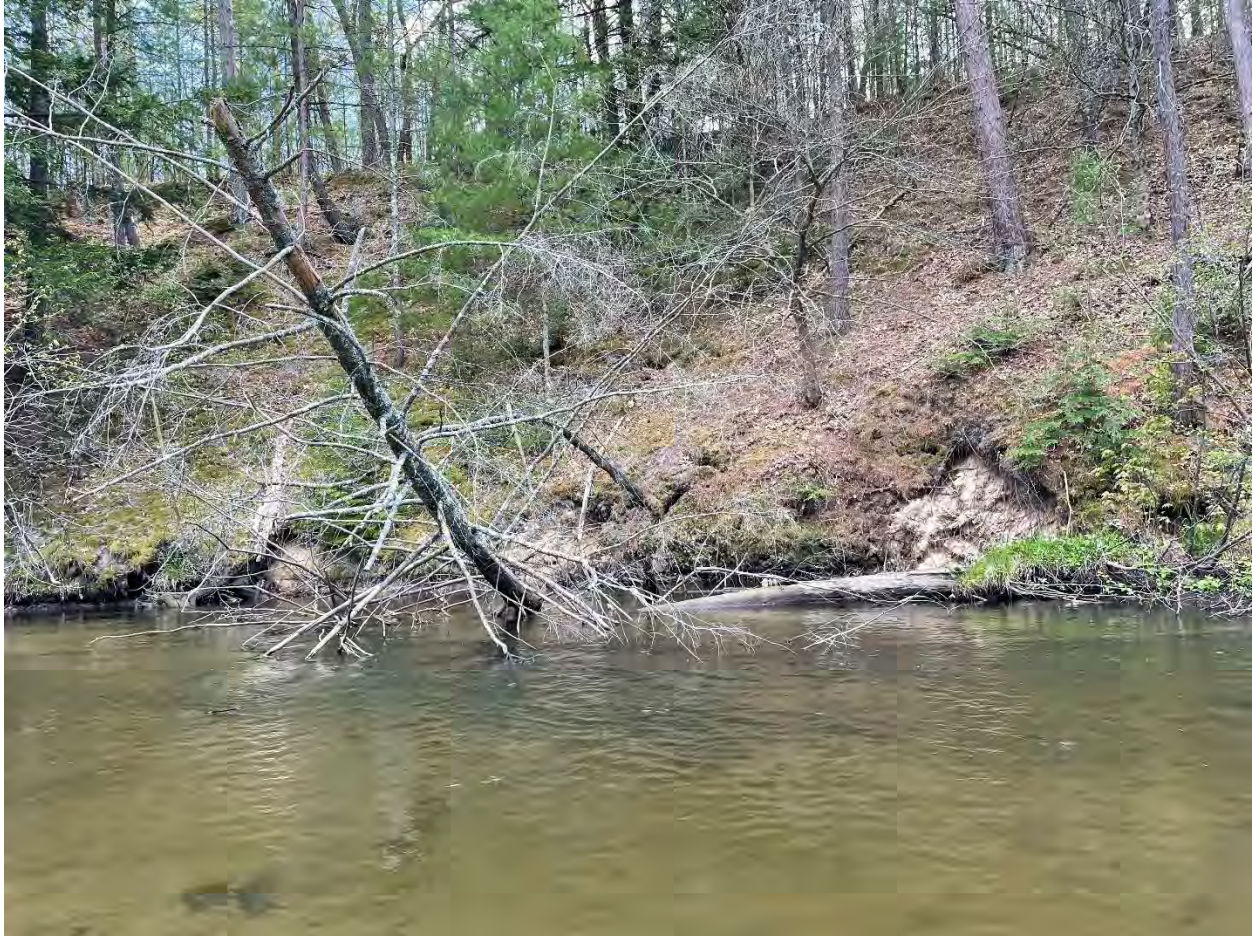
LM#54-2021

substrate: sand

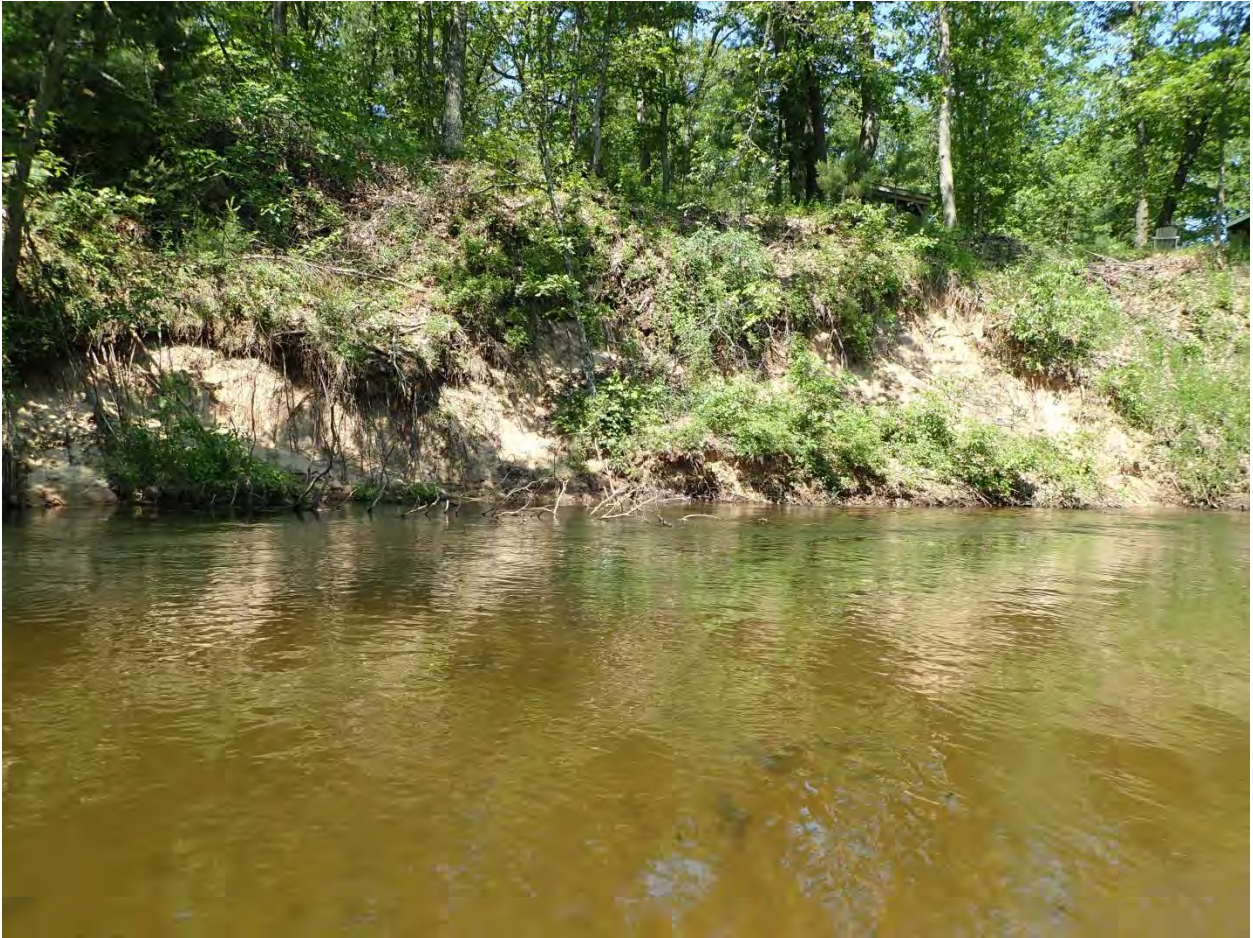
LM#55-2021

substrate: sand

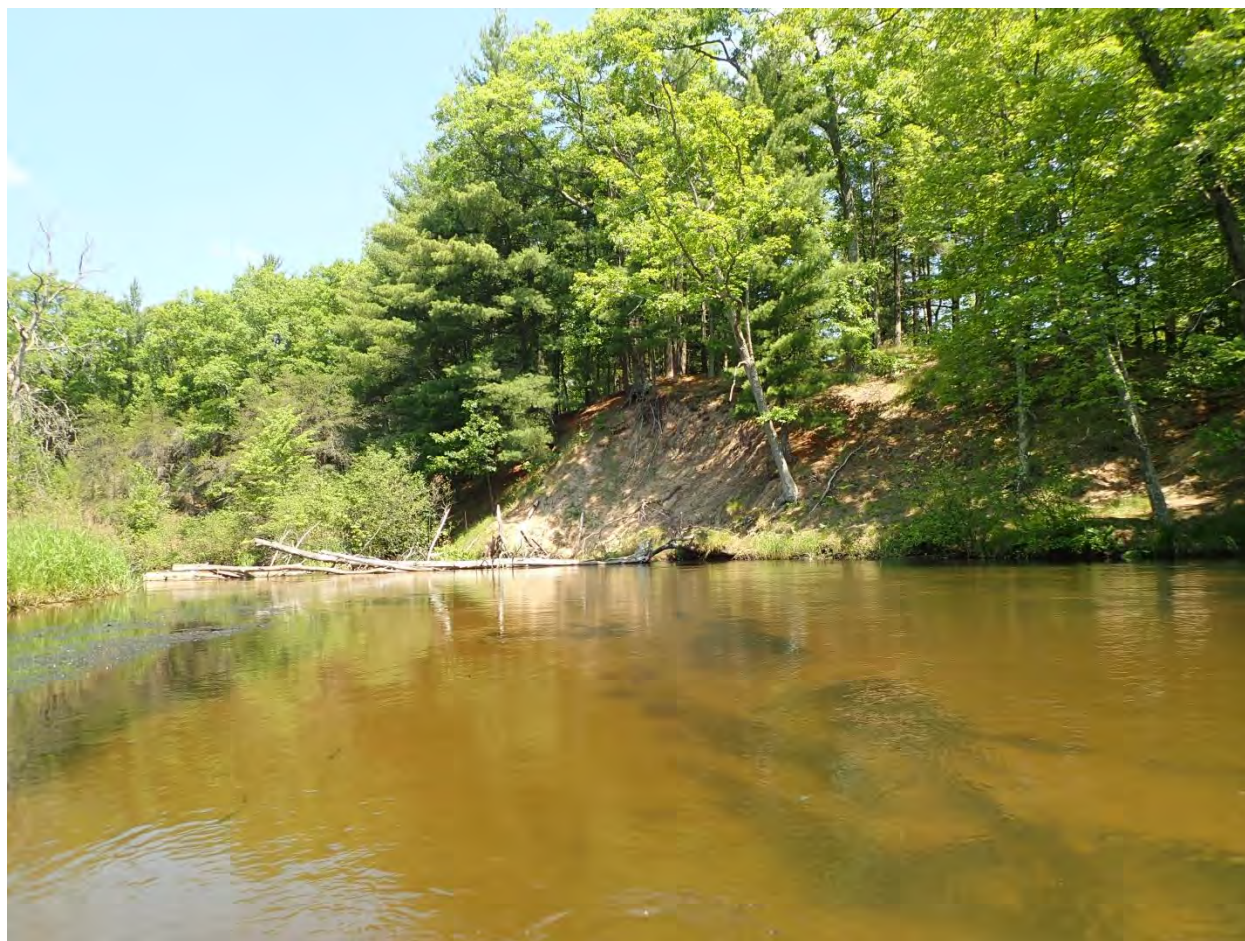
LM#56-2021

substrate: sand

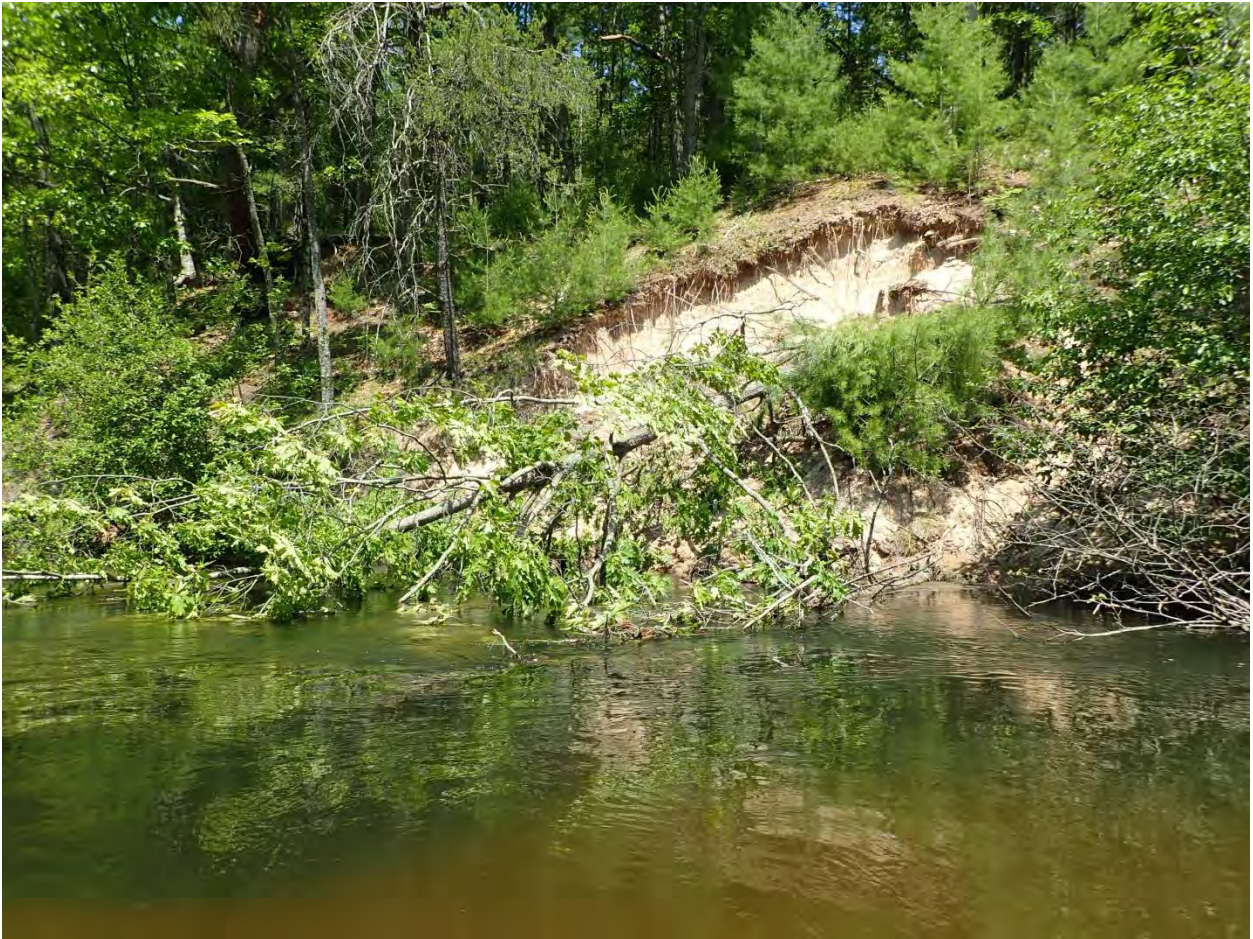
LM#57-2021

substrate: sand

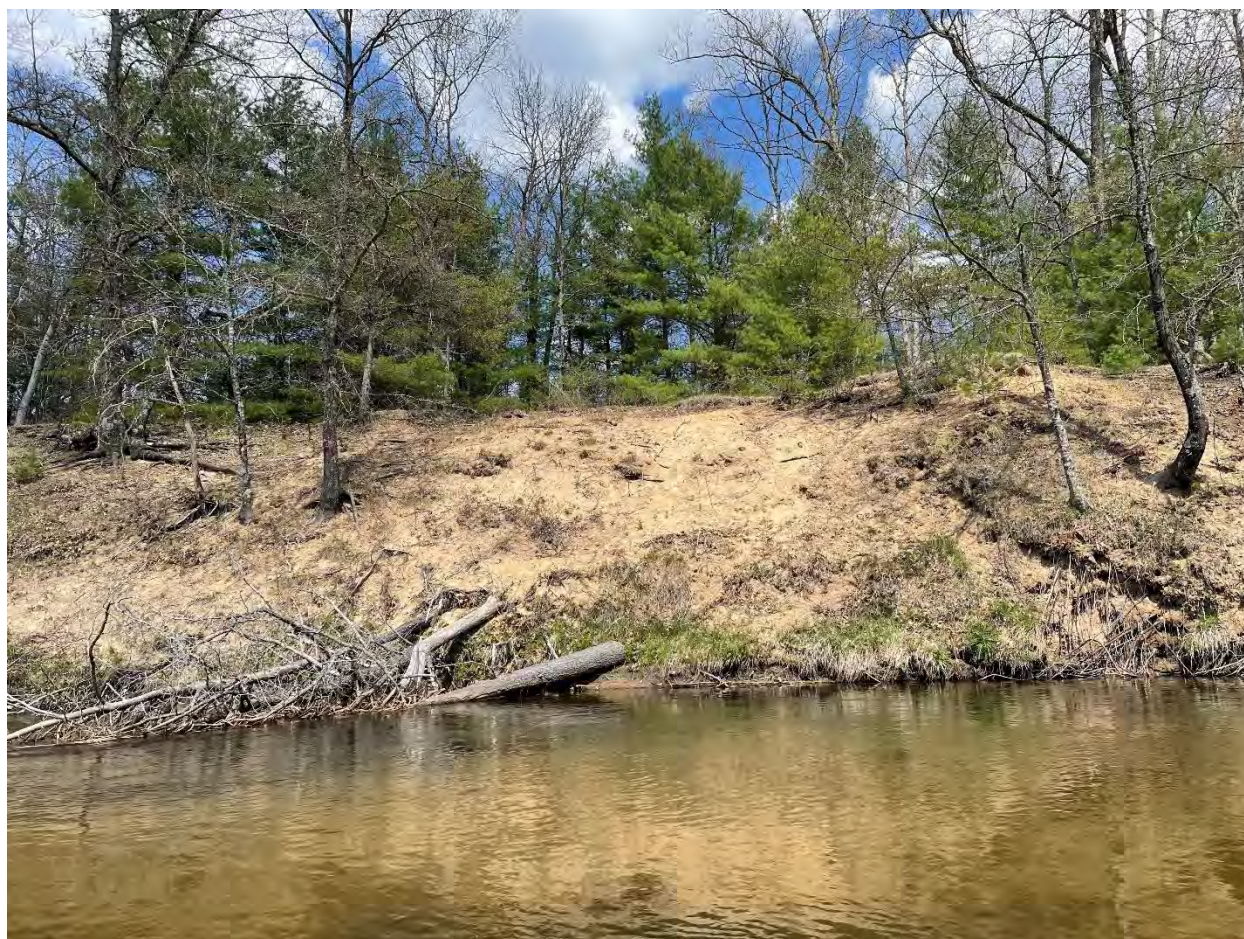
LM#58-2021

substrate: sand
