2021 Little Manistee River Eroding Stream Bank Assessment

Carrieville (Kings Highway) Bridge to Old Stronach Rd. Bridge

Nate Winkler, Biologist

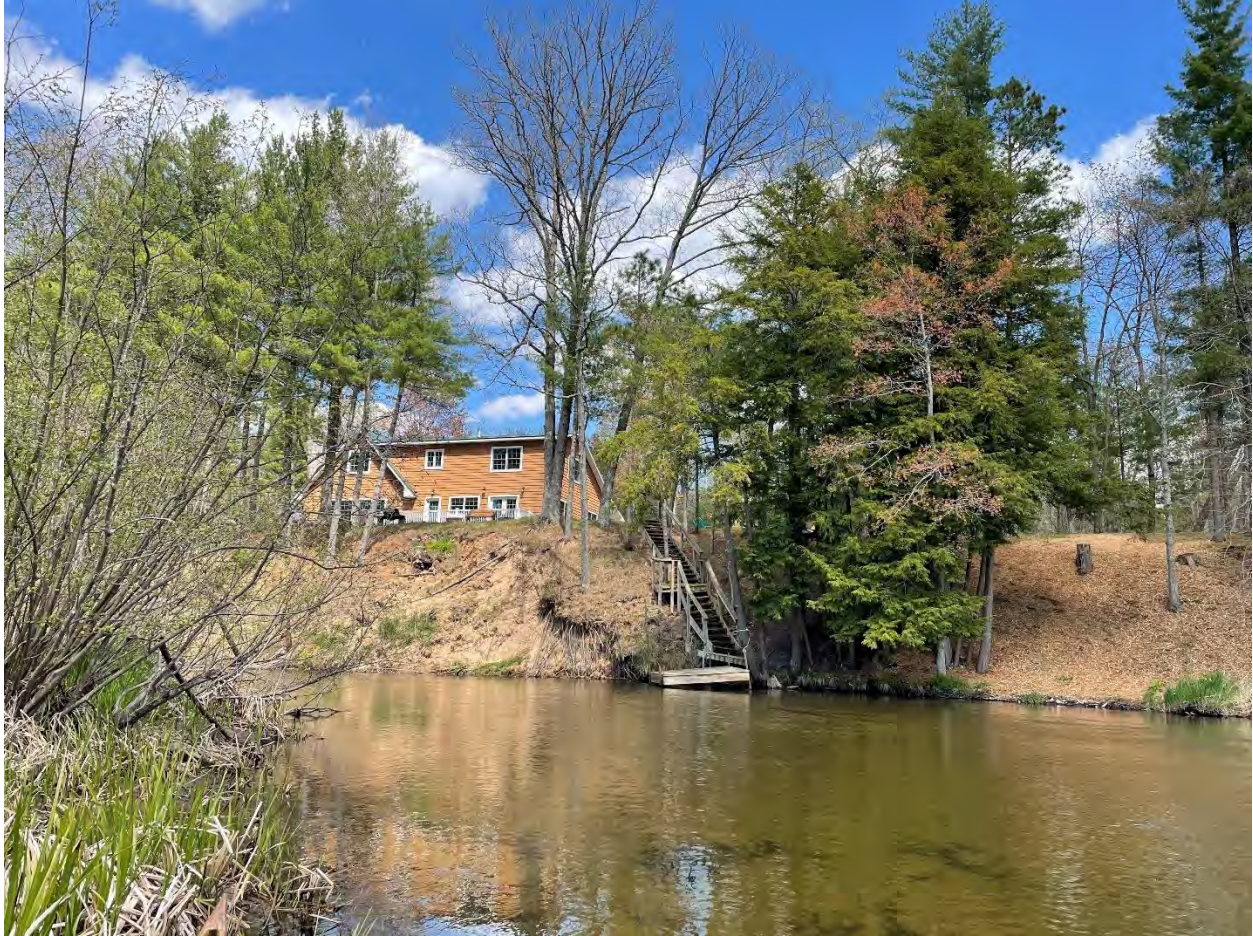
LM#59-2021

substrate: submerged wood, sand

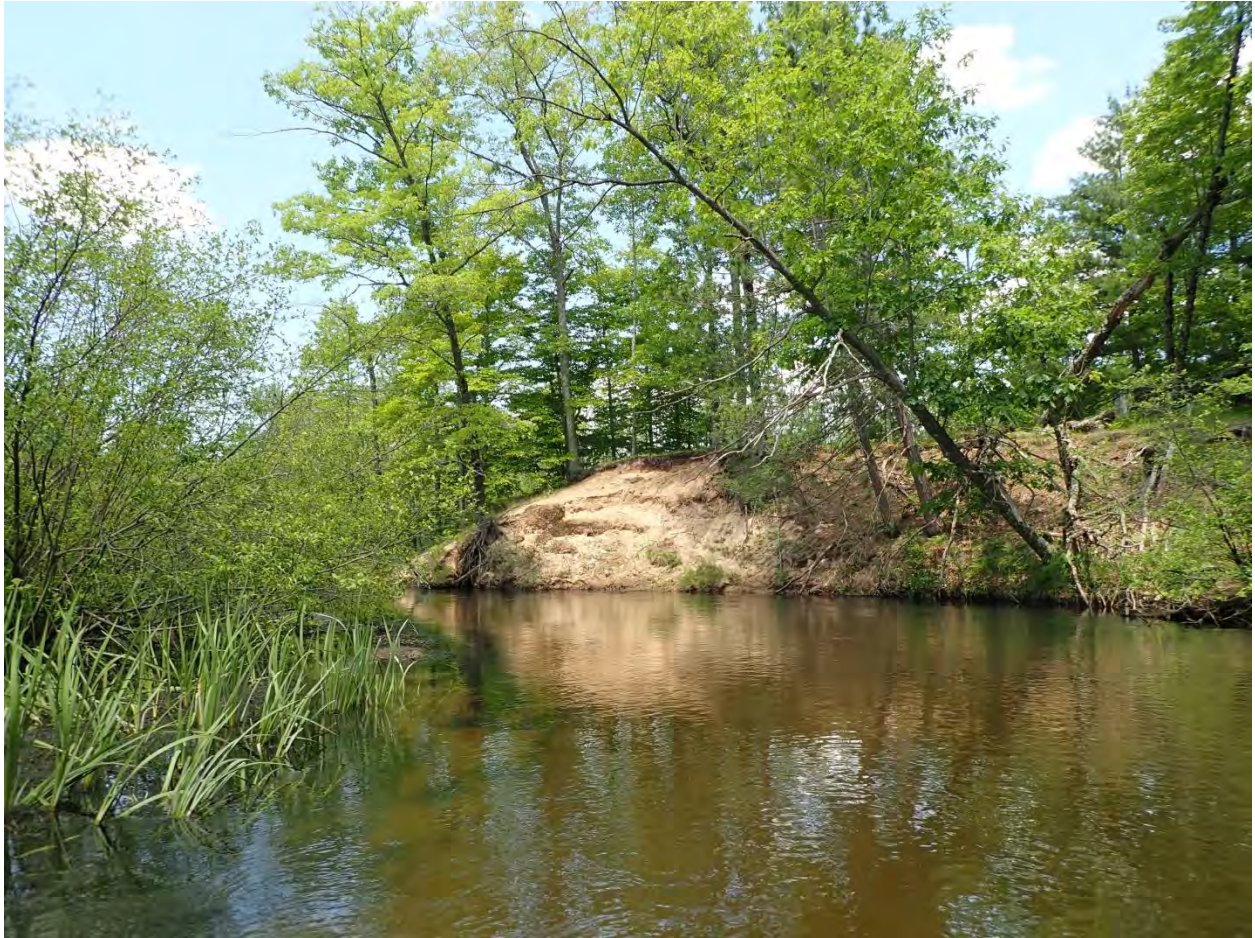
LM#60-2021

substrate: sand

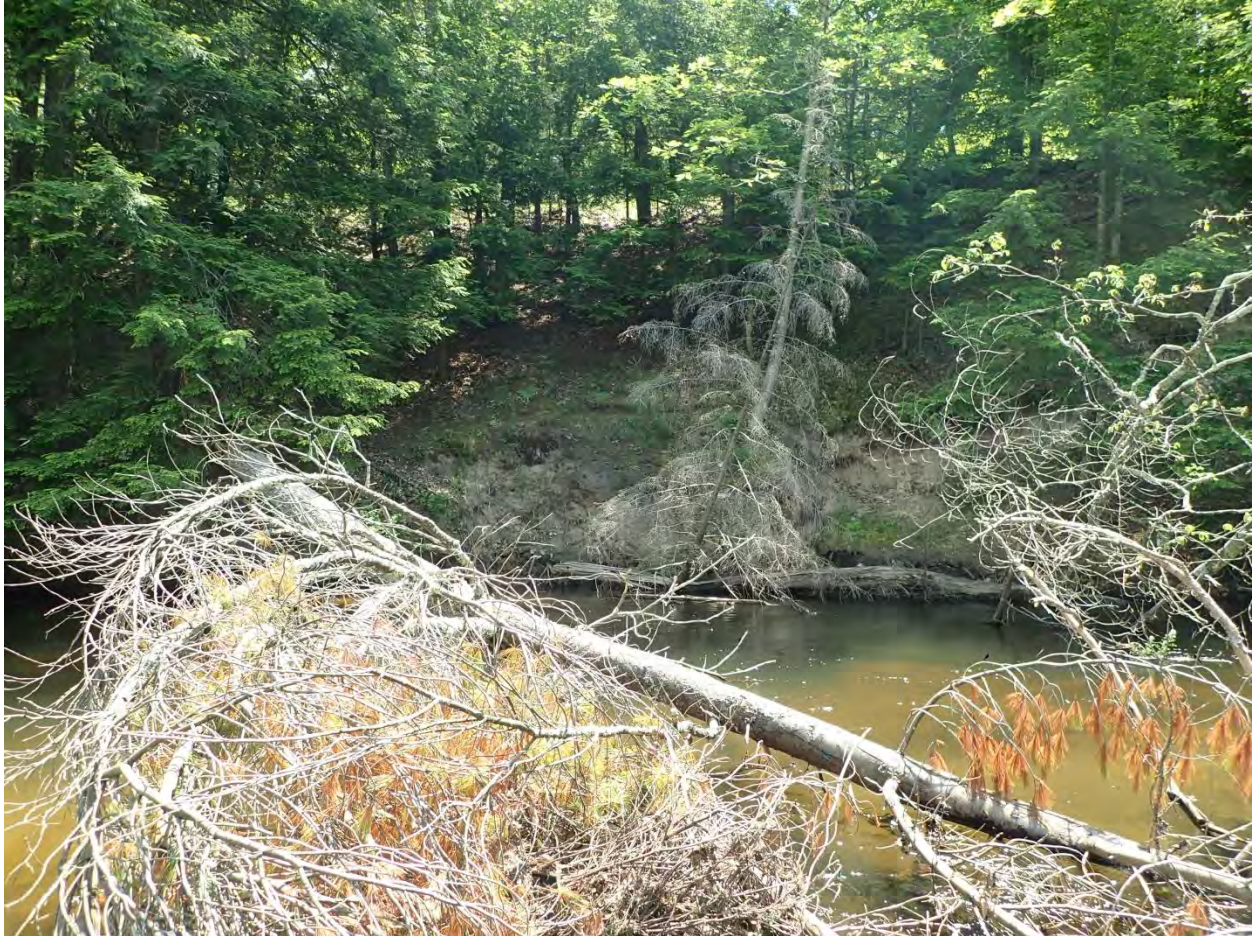
**LM#62-2021**

substrate: sand, medium gravel

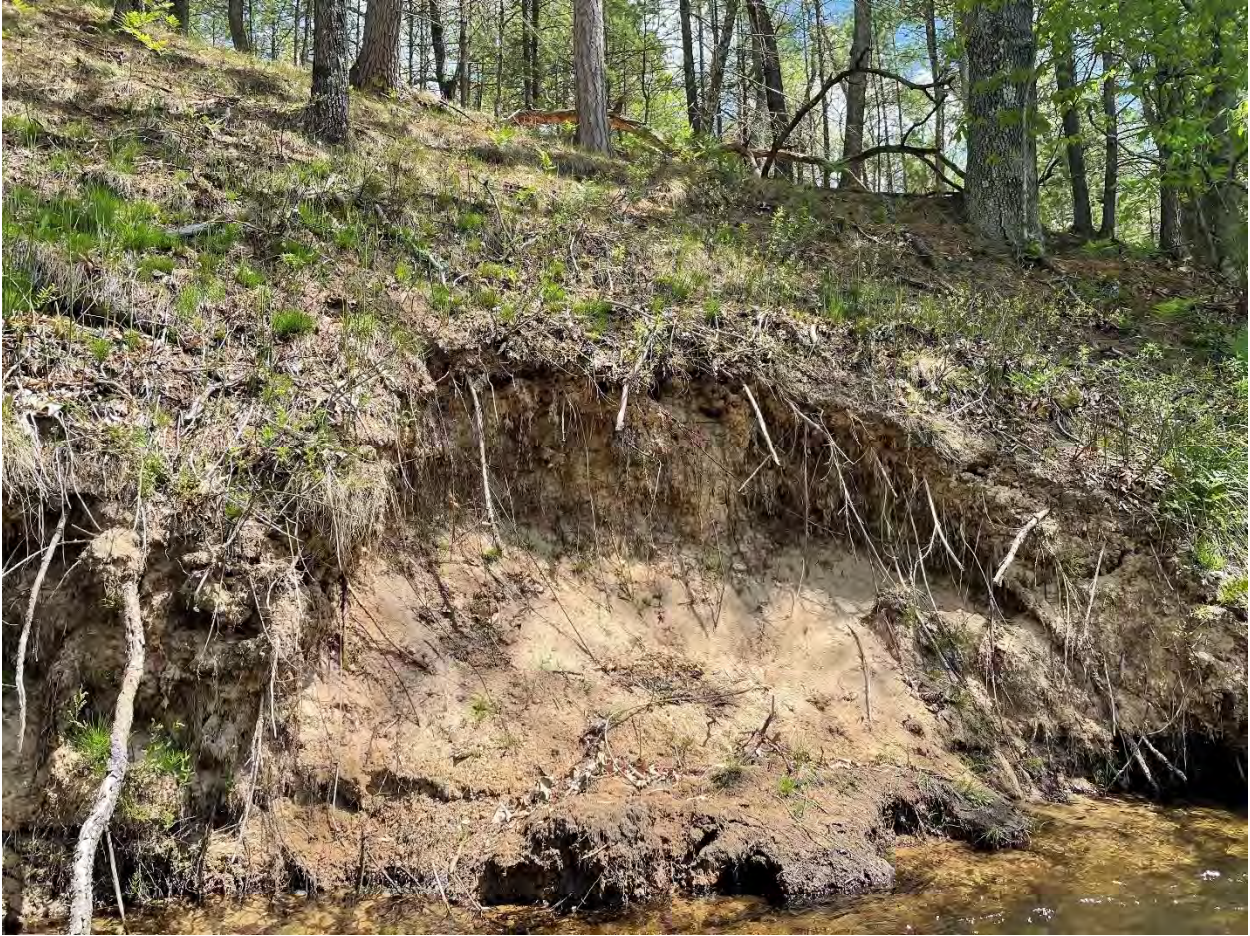
LM#64-2021

44.17327, -86.10602

dimensions: 6' l x 6' h

river right

depth at toe: 3'

severe

substrate: sand

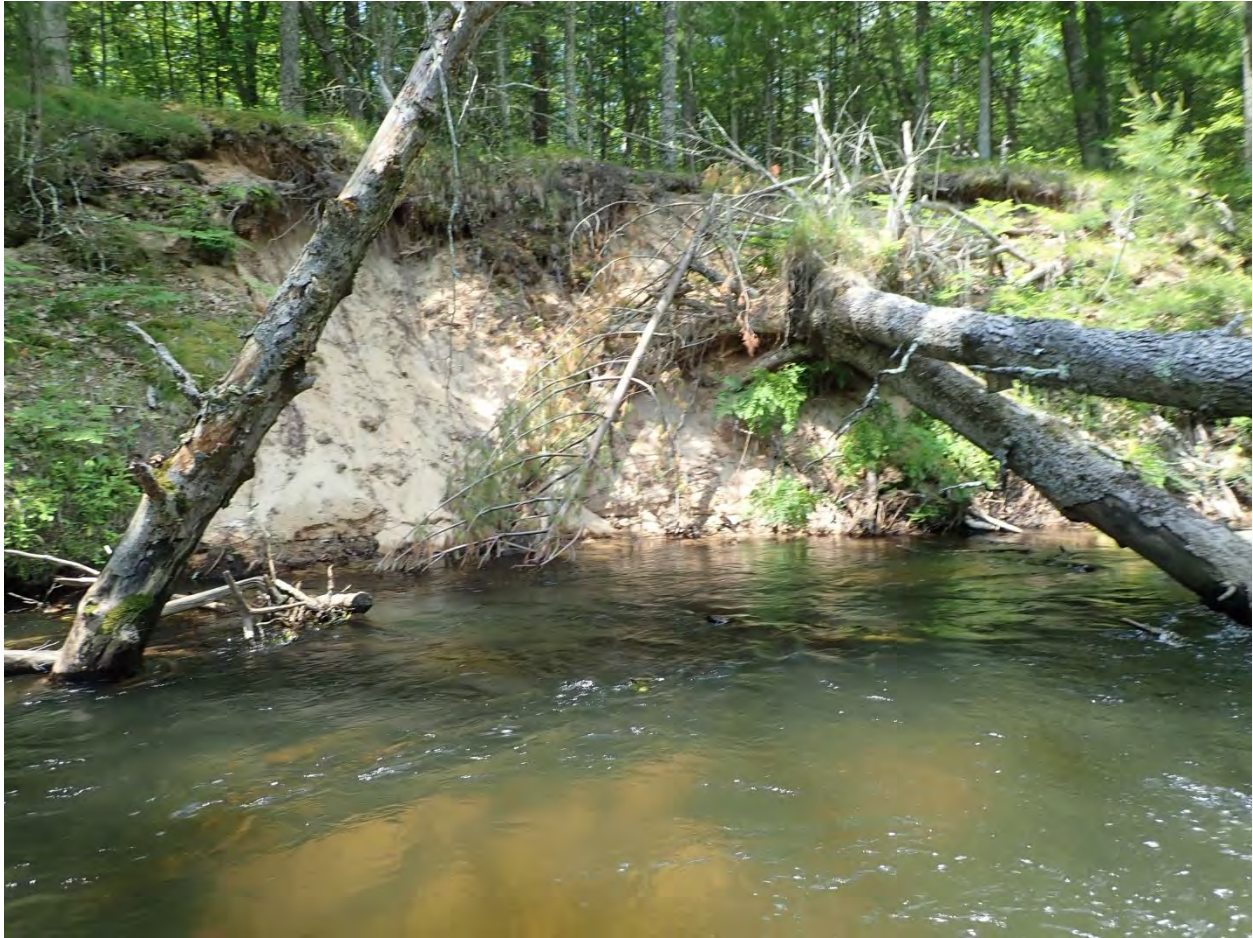
LM#65-2021

44.17337, -86.11163

dimensions: 12' l x 2' h

river right

depth at toe: 3'

severe

substrate: sand, some gravel

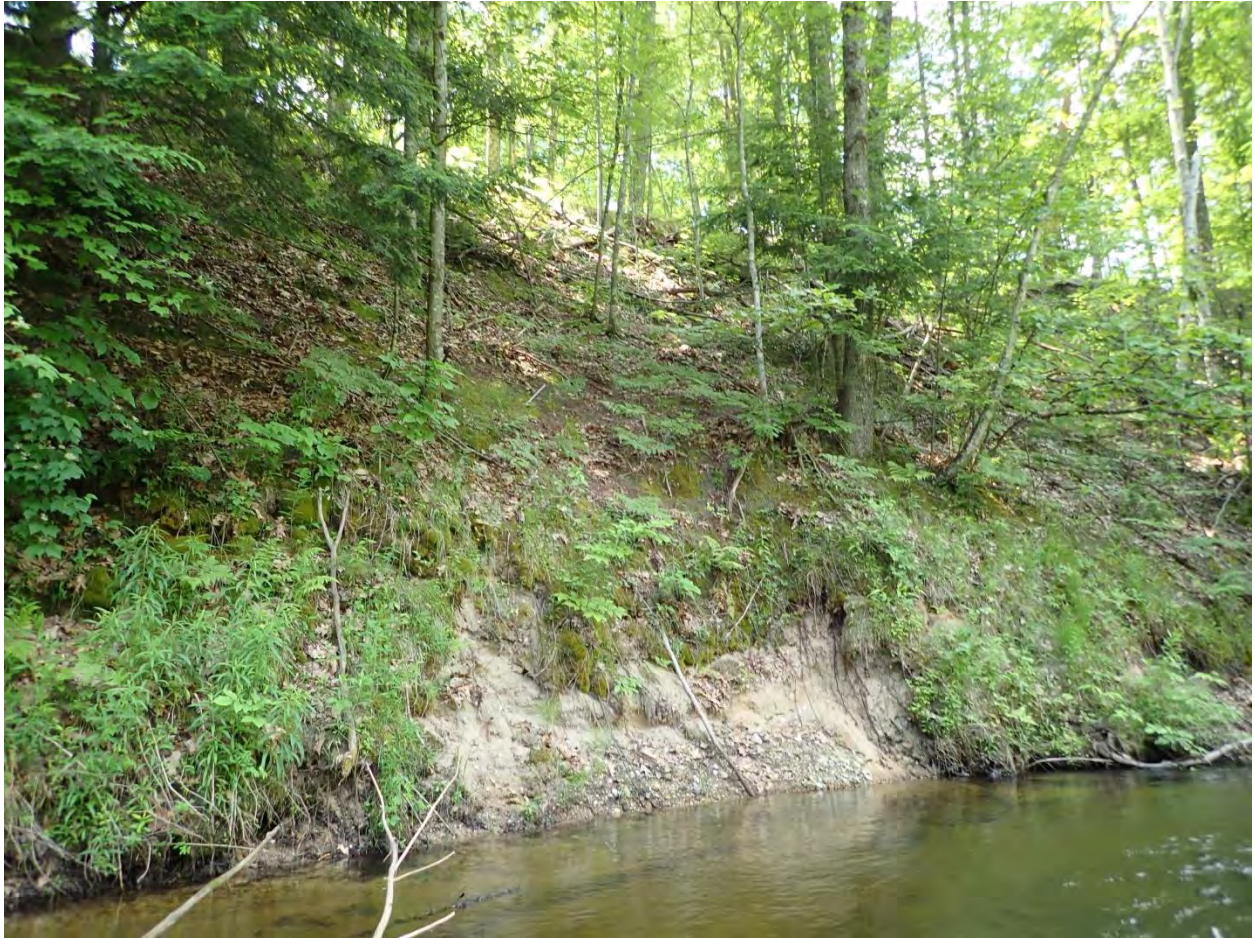
LM#66-2021

44.16893, -86.11646

dimensions: 8' l x 5' h

river left

depth at toe: 1.5'

minor

substrate: sand, medium gravel

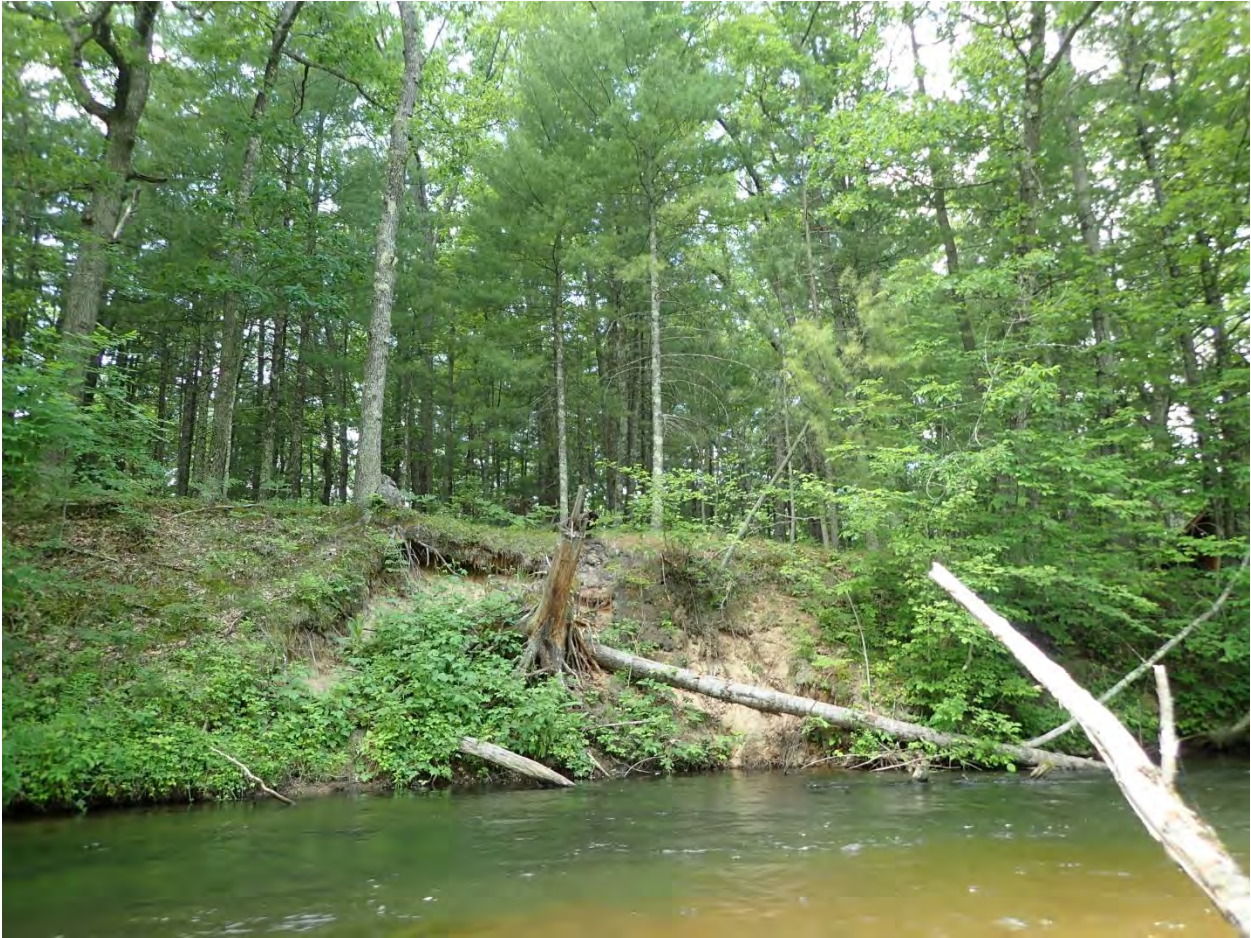
LM#67-2021

44.17026, -86.11784

dimensions: 10" l x 8' h

river left

depth at toe: 3'

minor

substrate: sand, coarse gravel

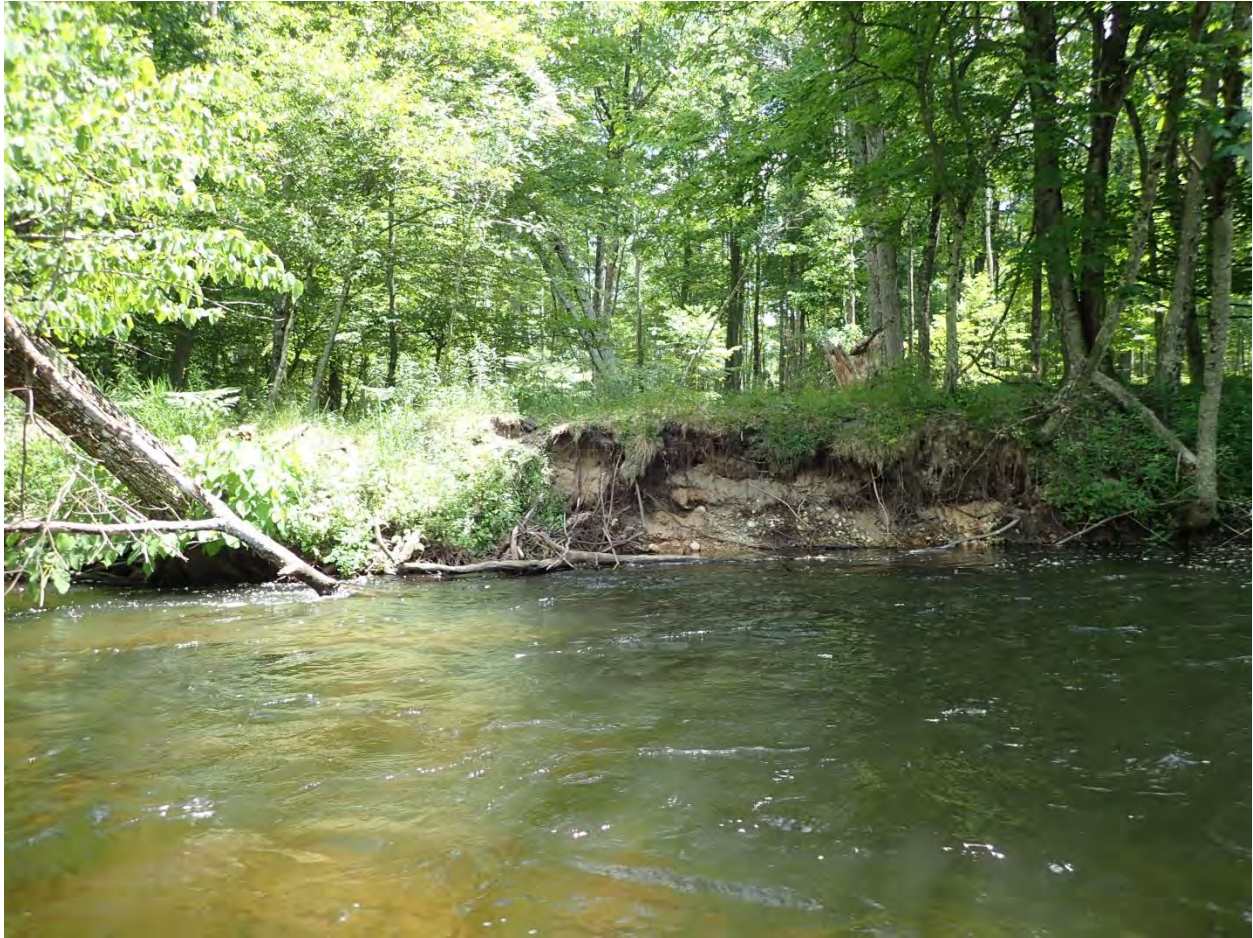
LM#68-2021

44.17180, -86.11626

dimensions: 100' l x 5' h

river right

depth at toe: 3'

[moderate](#)

substrate: coarse gravel

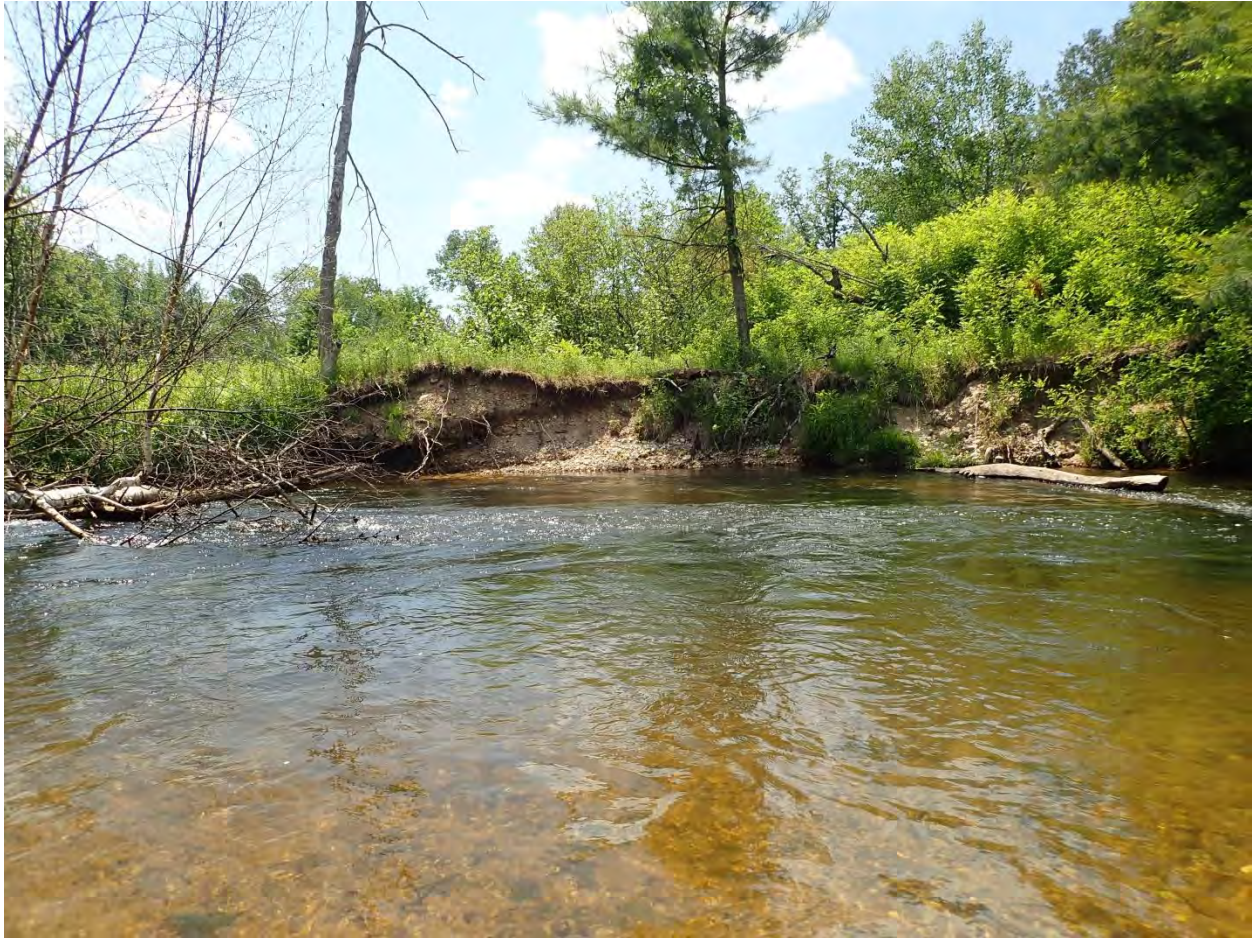
LM#69-2021

44.17217, -86.11787

dimensions: 30' l x 4' h

river left

depth at toe: 3.5'

minor

substrate: various sized gravel

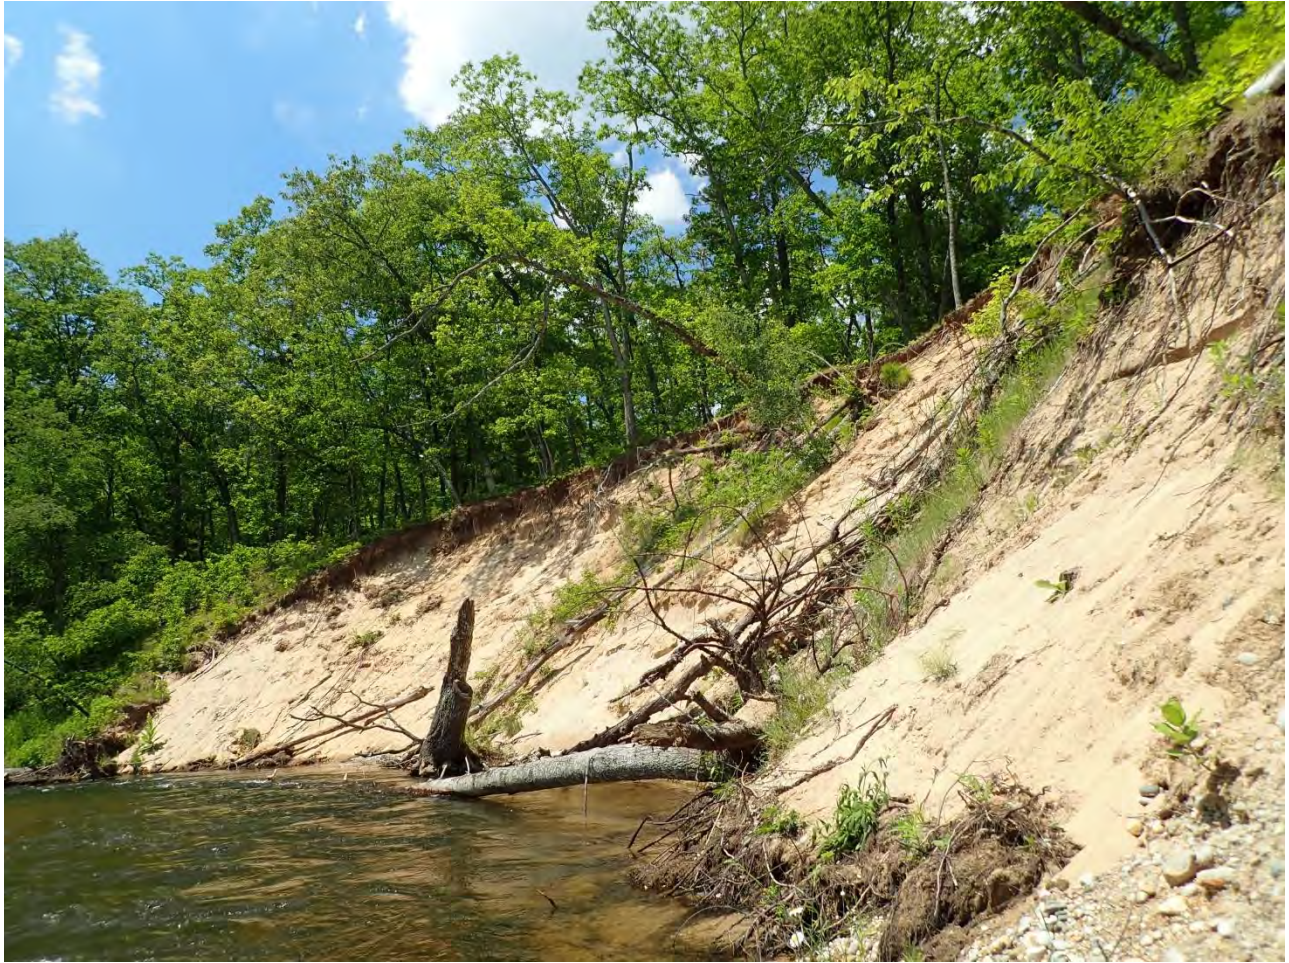
LM#70-2021

44.17279, -86.11891

dimensions: 120' l x 30' h

river right

depth at toe: 1'-5'

severe

substrate: sand, wood

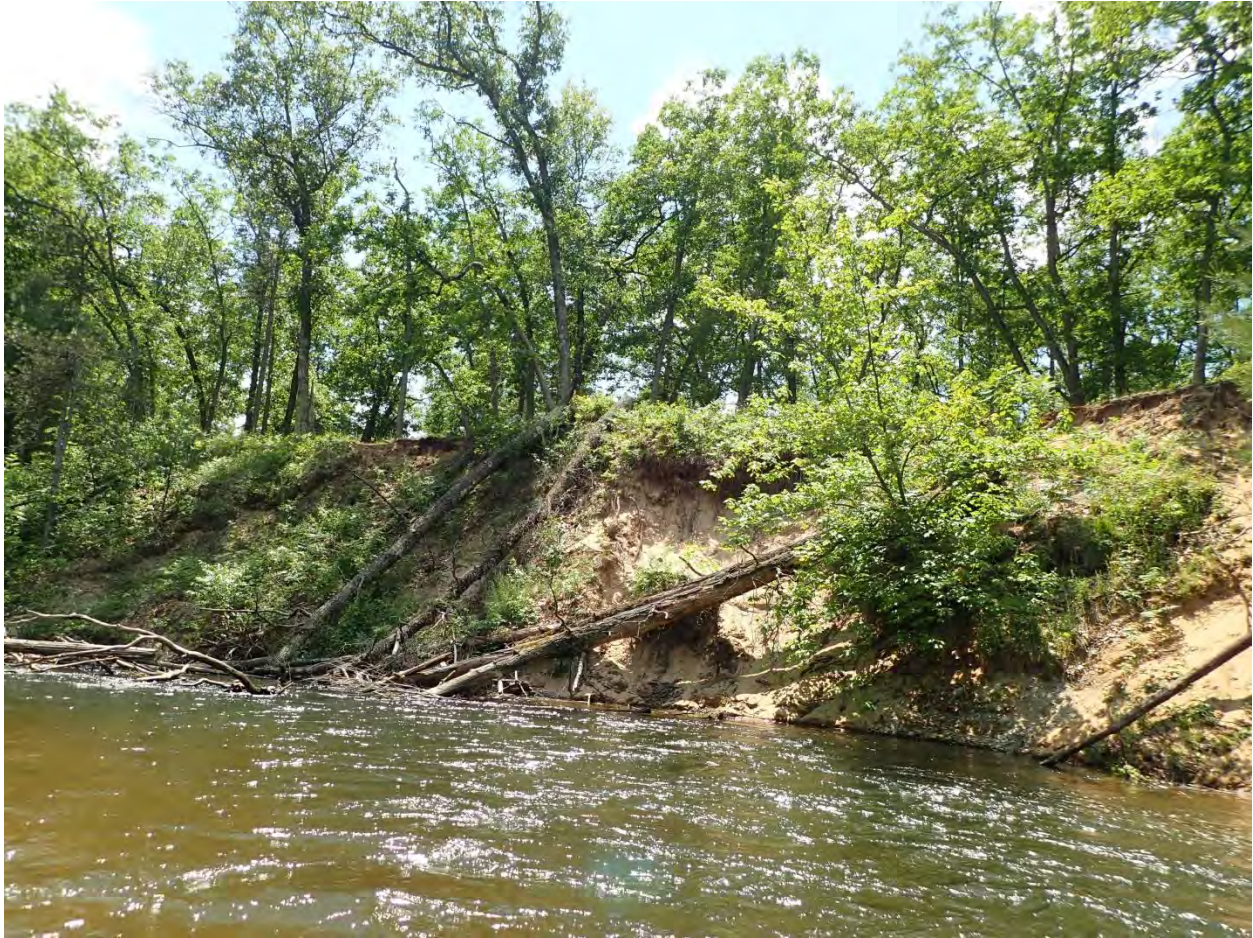
LM#71-2021

44.17253, -86.11926

dimensions: 100' l x 20' h

river right

depth at toe: 6'

severe

substrate: sand, medium and coarse gravel, cobble (fieldstone)

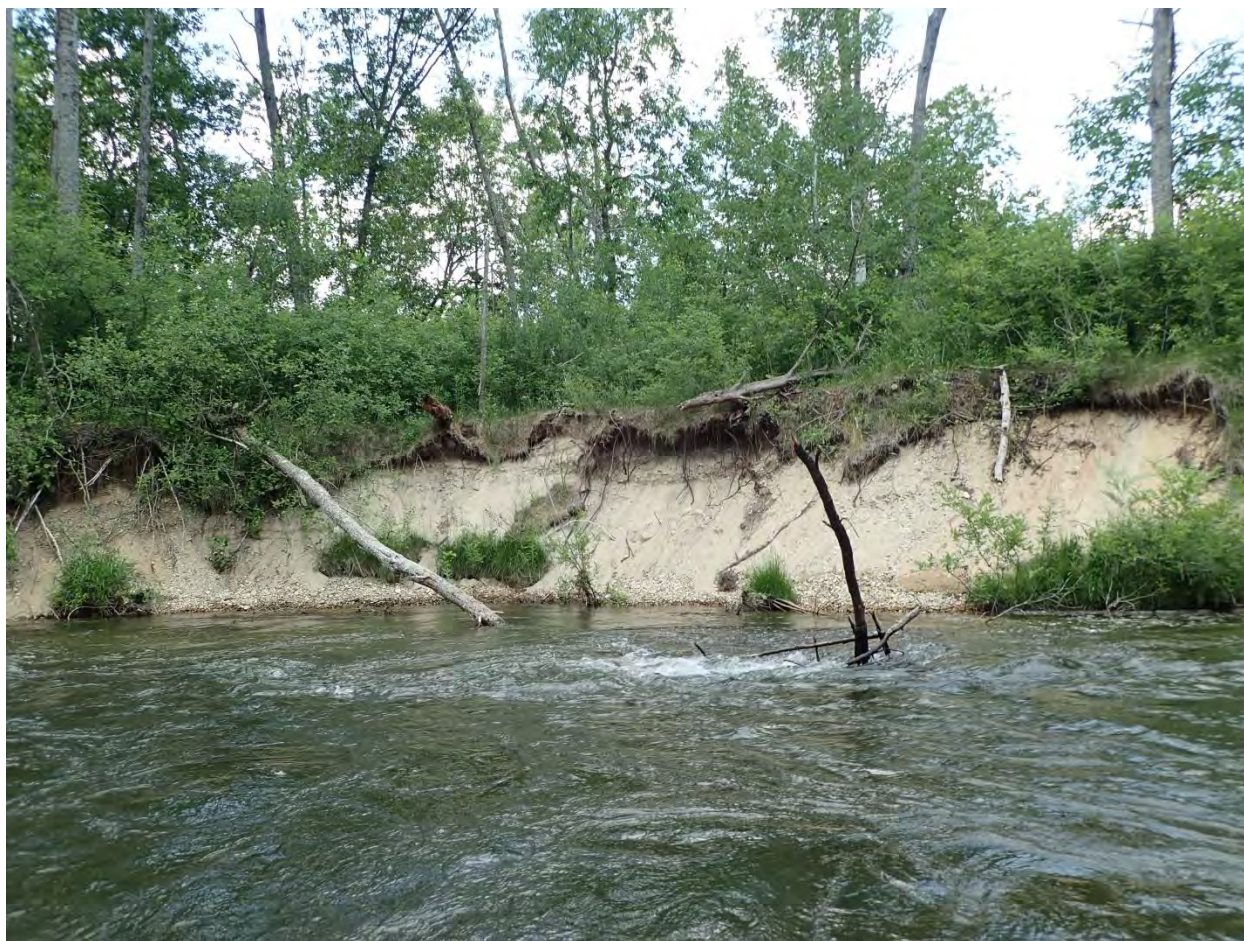
LM#72-2021

44.17134, -86.11994

dimensions: 40' l x 8' h

river right

depth at toe: 10'

severe

substrate: unknown

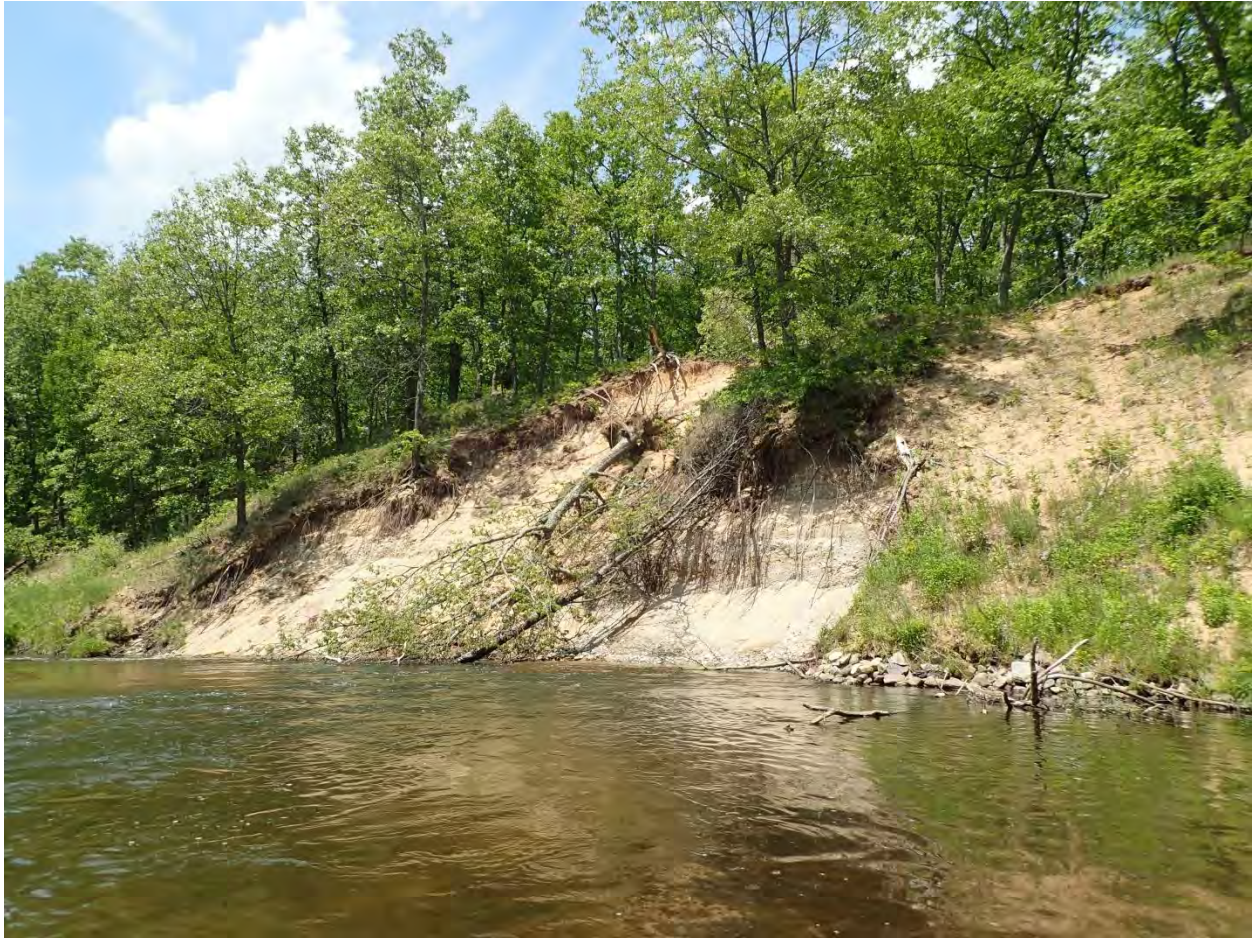
LM#73-2021

44.17249, -86.12099

dimensions: 65' l x 25' h

river right

depth at toe: 8'

severe

substrate: unknown

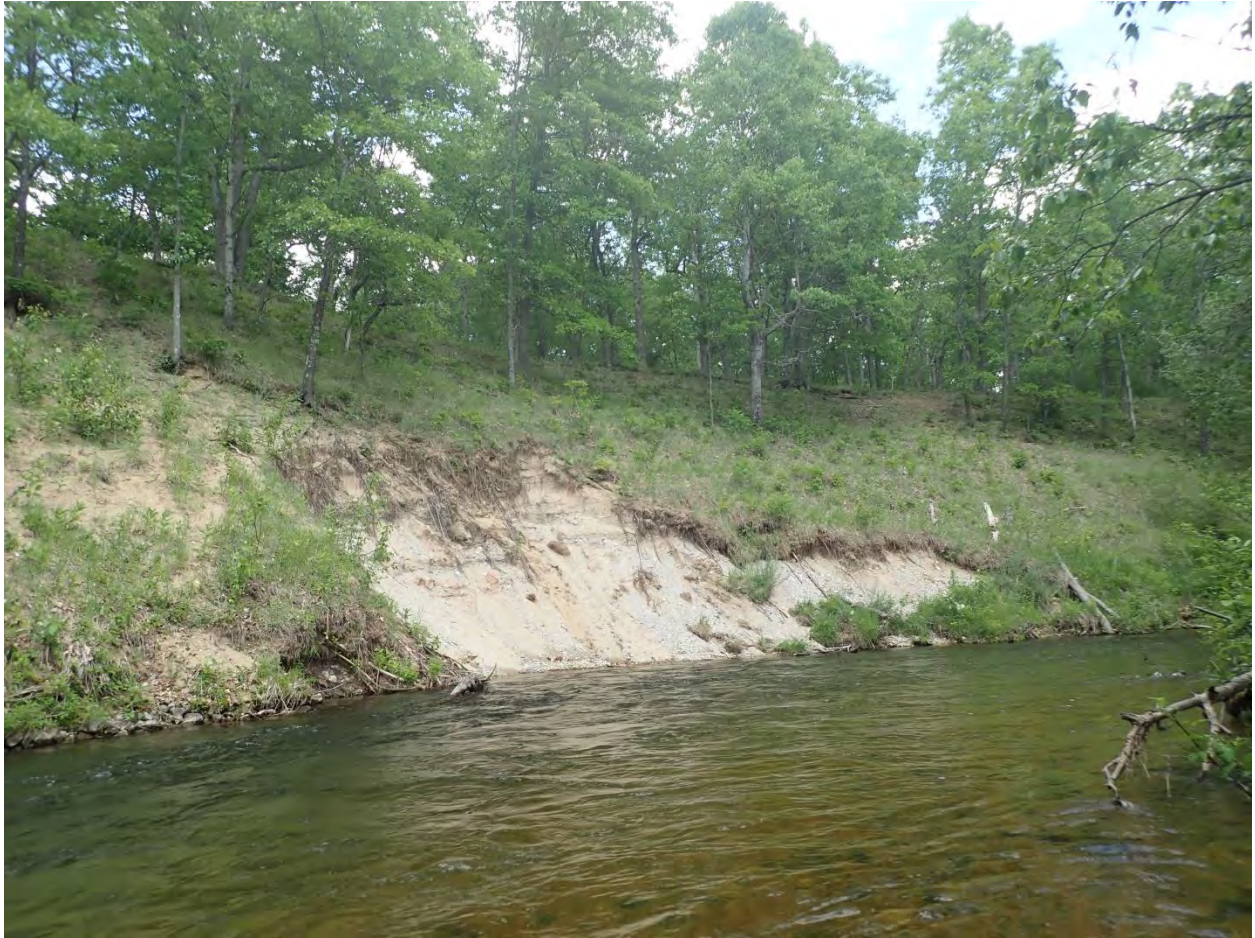
LM#74-2021

44.17287, -86.12207

dimensions: 40' l x 15' h

river right

depth at toe: 3'

severe

substrate: gravel

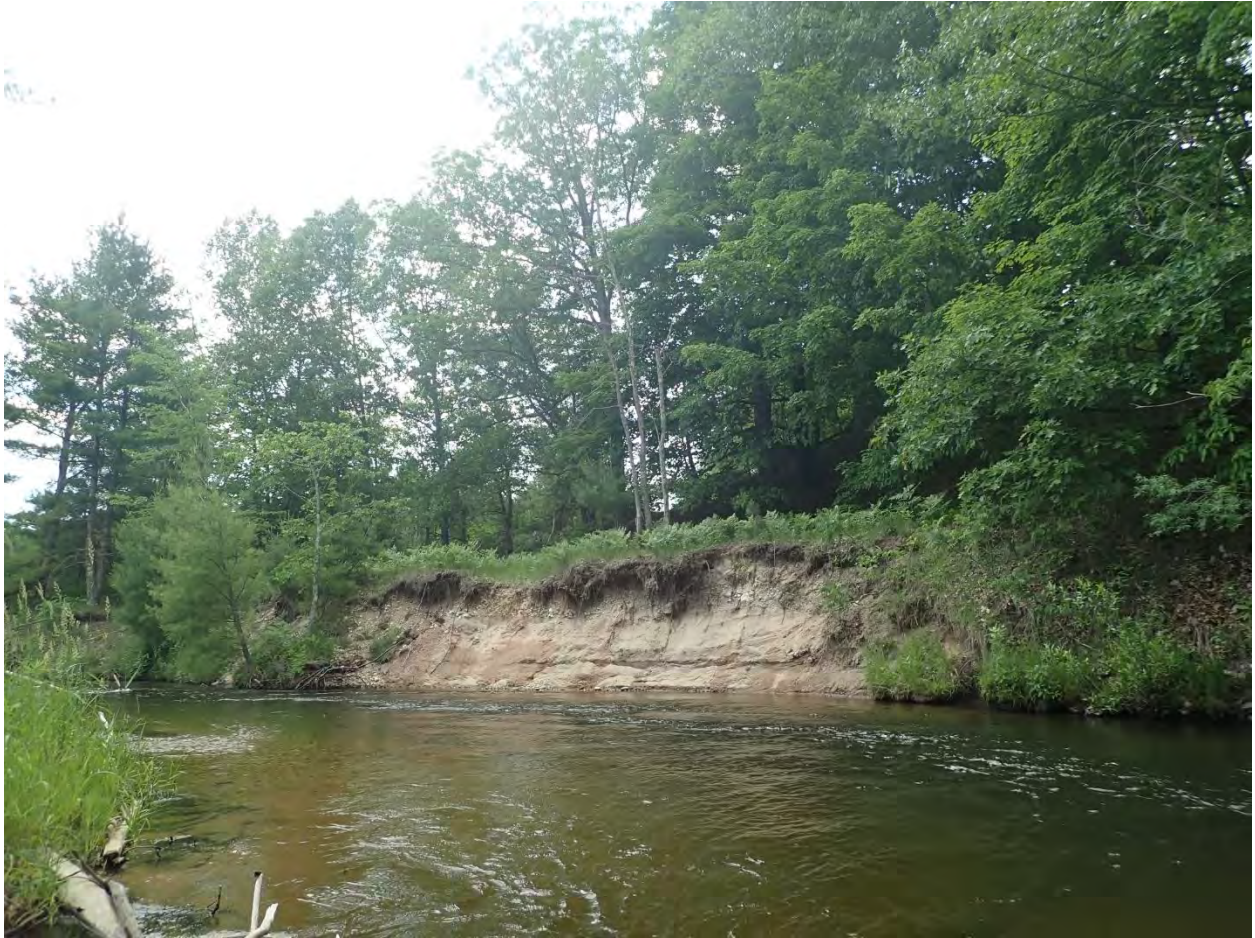
LM#75-2021

44.17275, -86.12230

dimensions: 40' l x 8' h

river right

depth at toe: 3.5'

severe

substrate: gravel

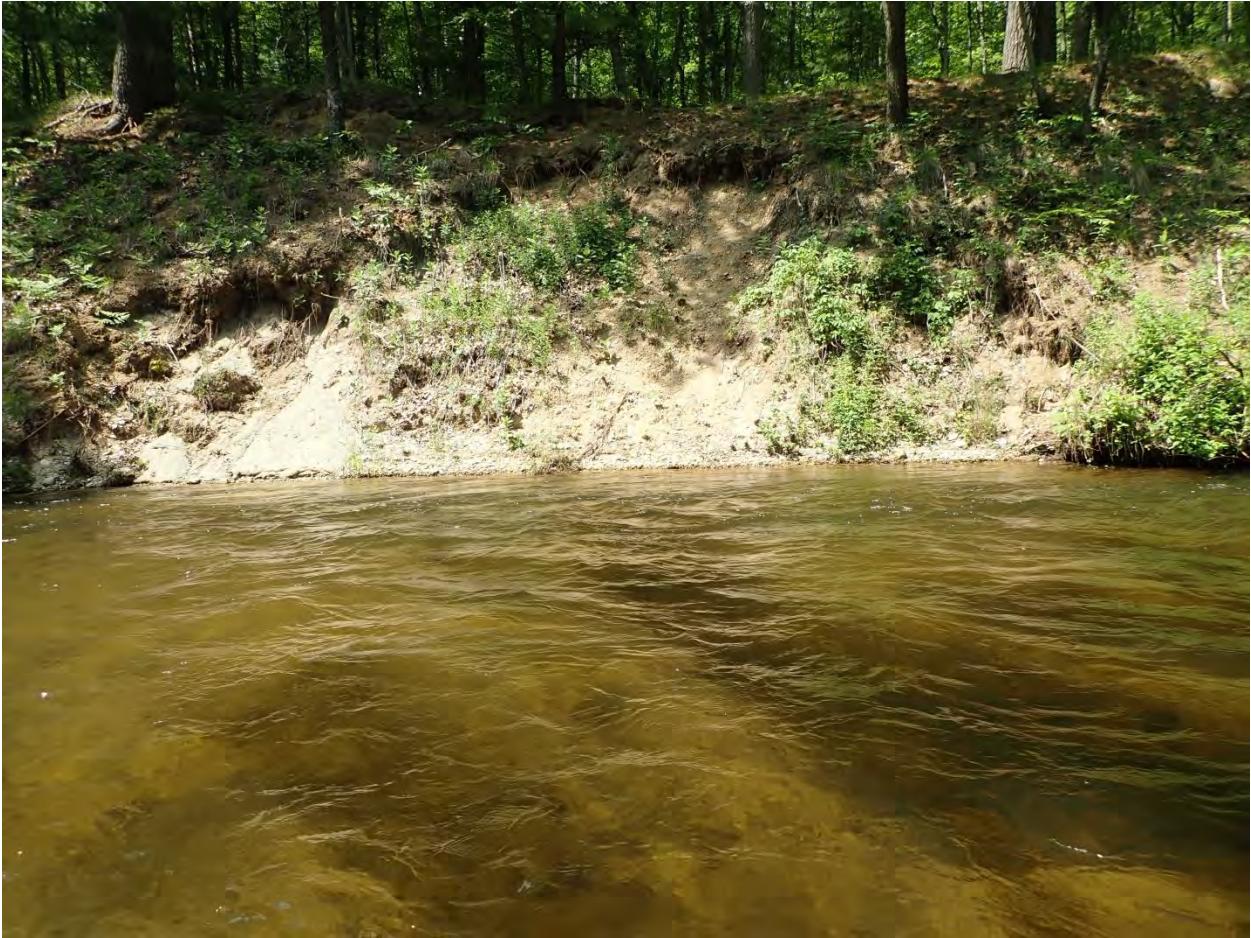
LM#76-2021

44.17204, -86.12429

dimensions: 25' l x 15' h

river right

depth at toe: 2.5'

minor

substrate: gravel

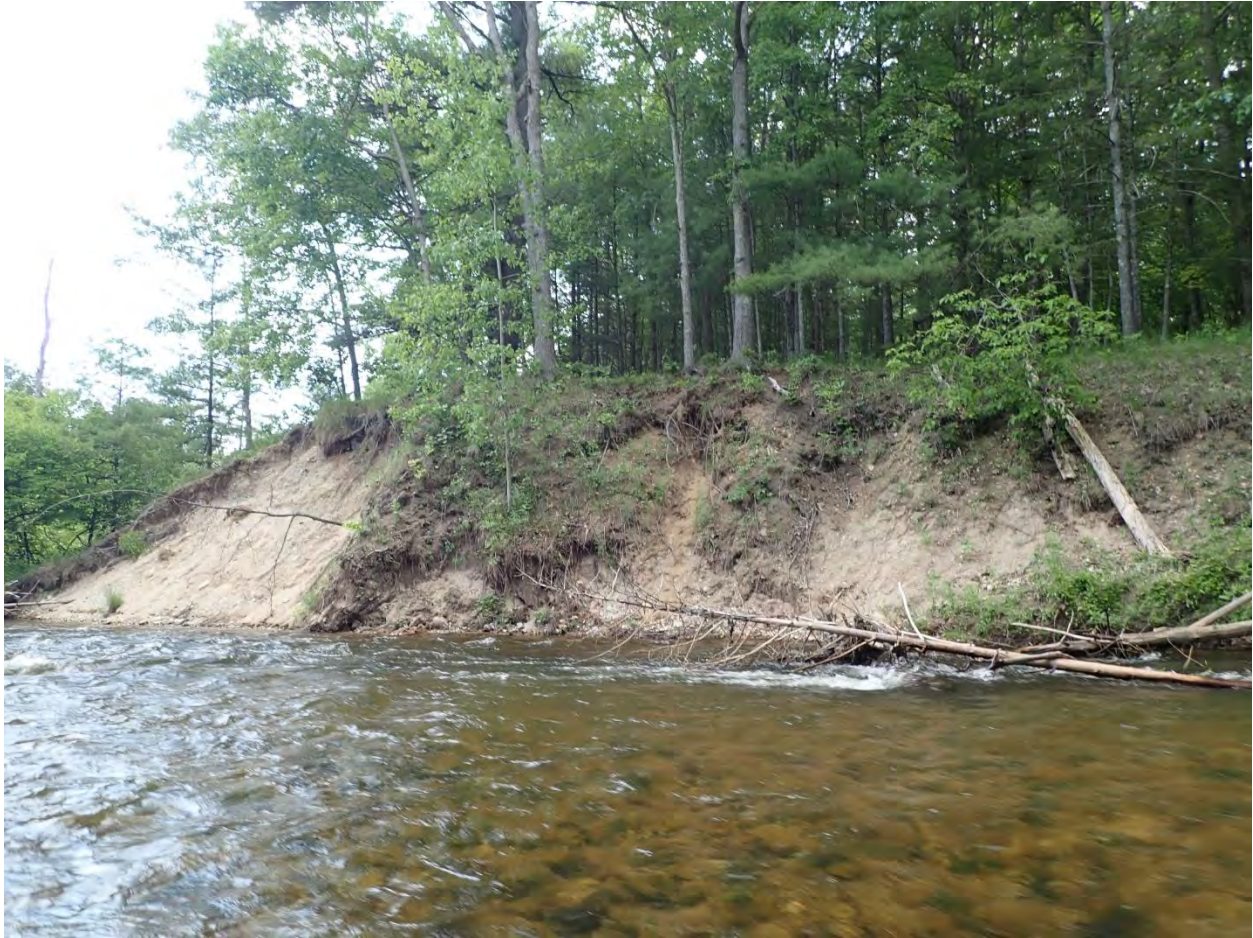
LM#77-2021

44.17204, -86.12449

dimensions: 50' l x 12' h

river right

depth at toe: 2.5'

severe

substrate: gravel

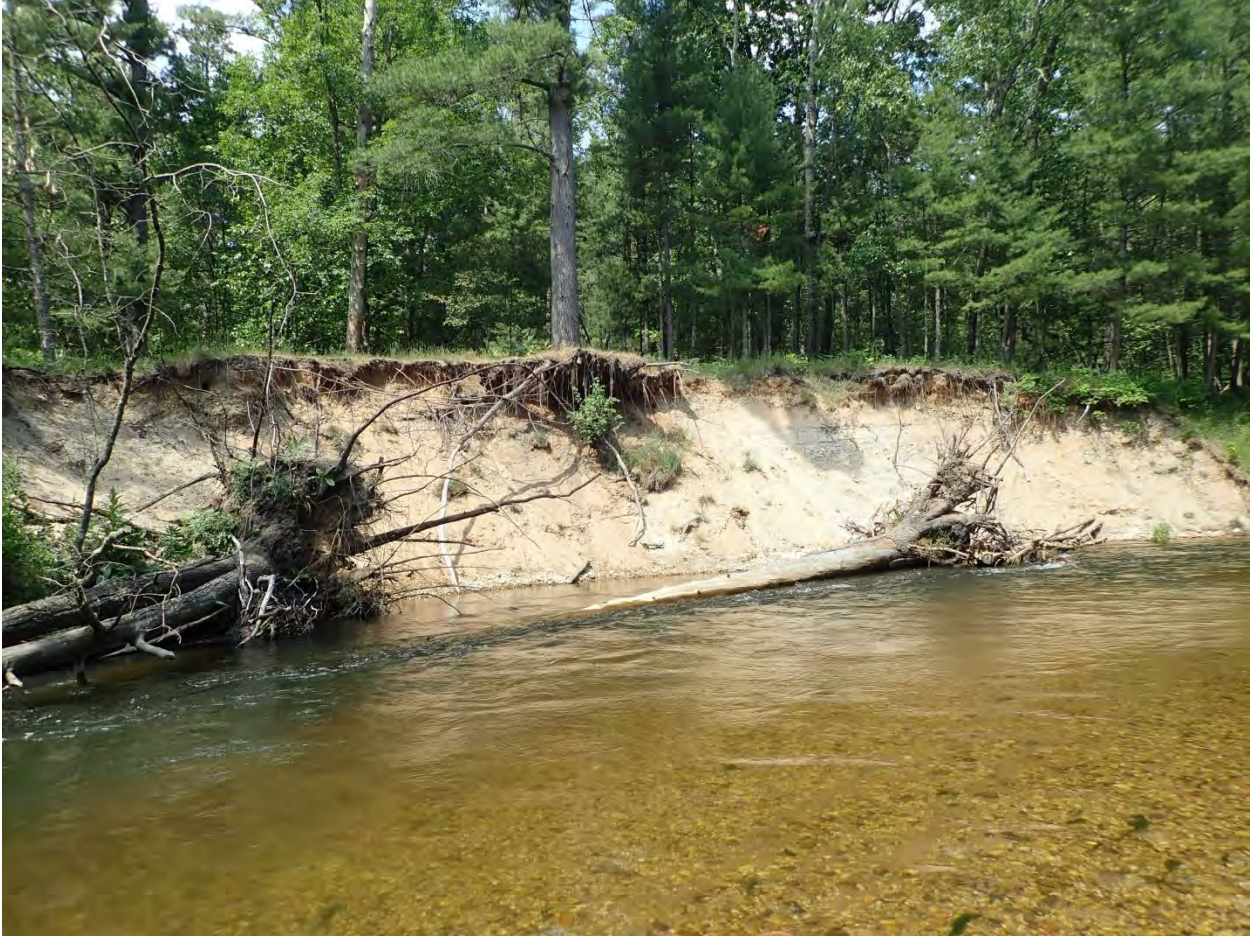
LM#78-2021

44.17141, -86.12701

dimensions: 50' l x 15' h

river right

depth at toe: 4'

severe

substrate: gravel

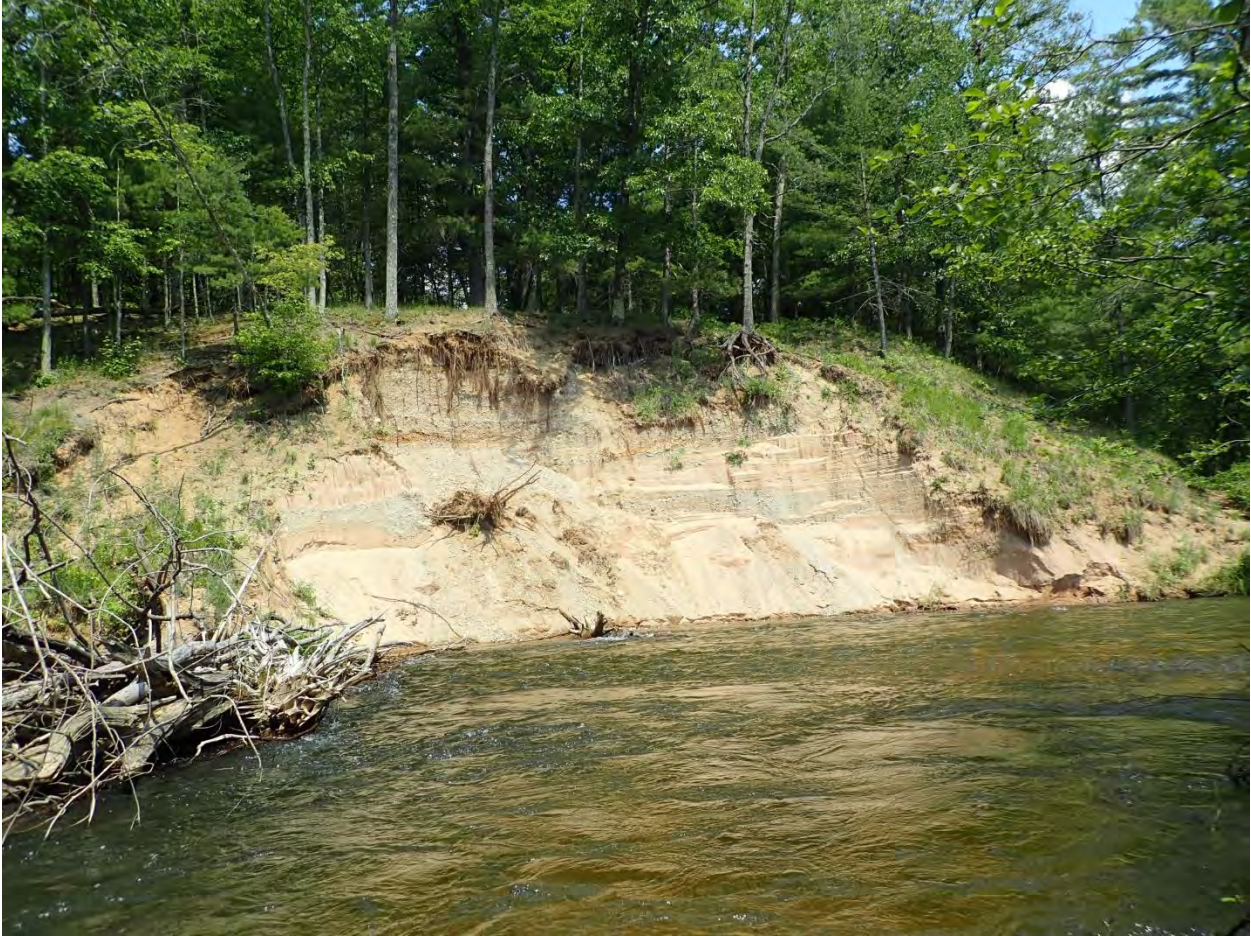
LM#79-2021

44.17144, -86.13126

dimensions: 40' l x 35' h

river right

depth at toe: 1'

substrate: gravel
