2021 Little Manistee River Eroding Stream Bank Assessment

Carrieville (Kings Highway) Bridge to Old Stronach Rd. Bridge

Nate Winkler, Biologist

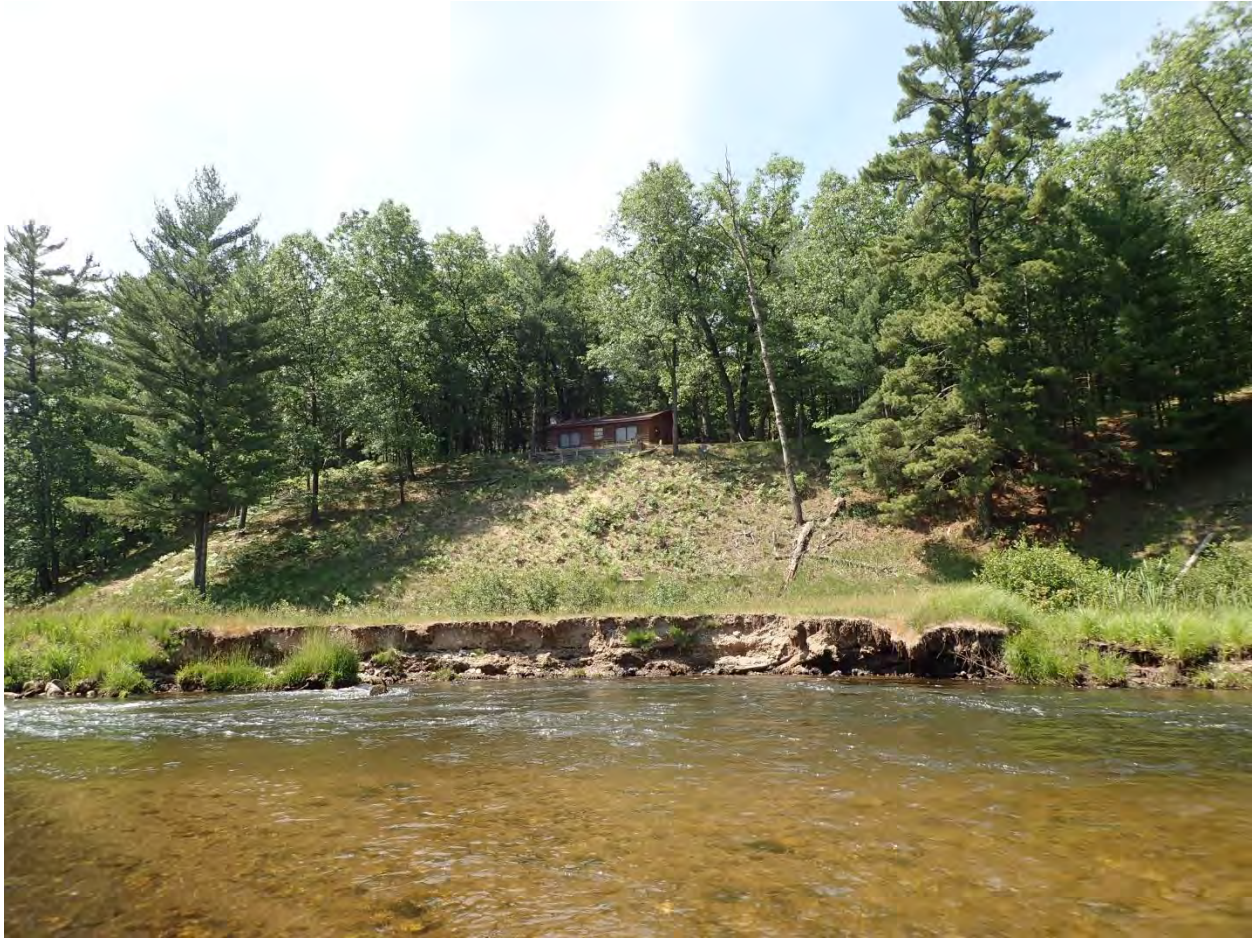
LM#80-2021

44.17383, -86.13348

substrate: gravel, cobble (fieldstone)

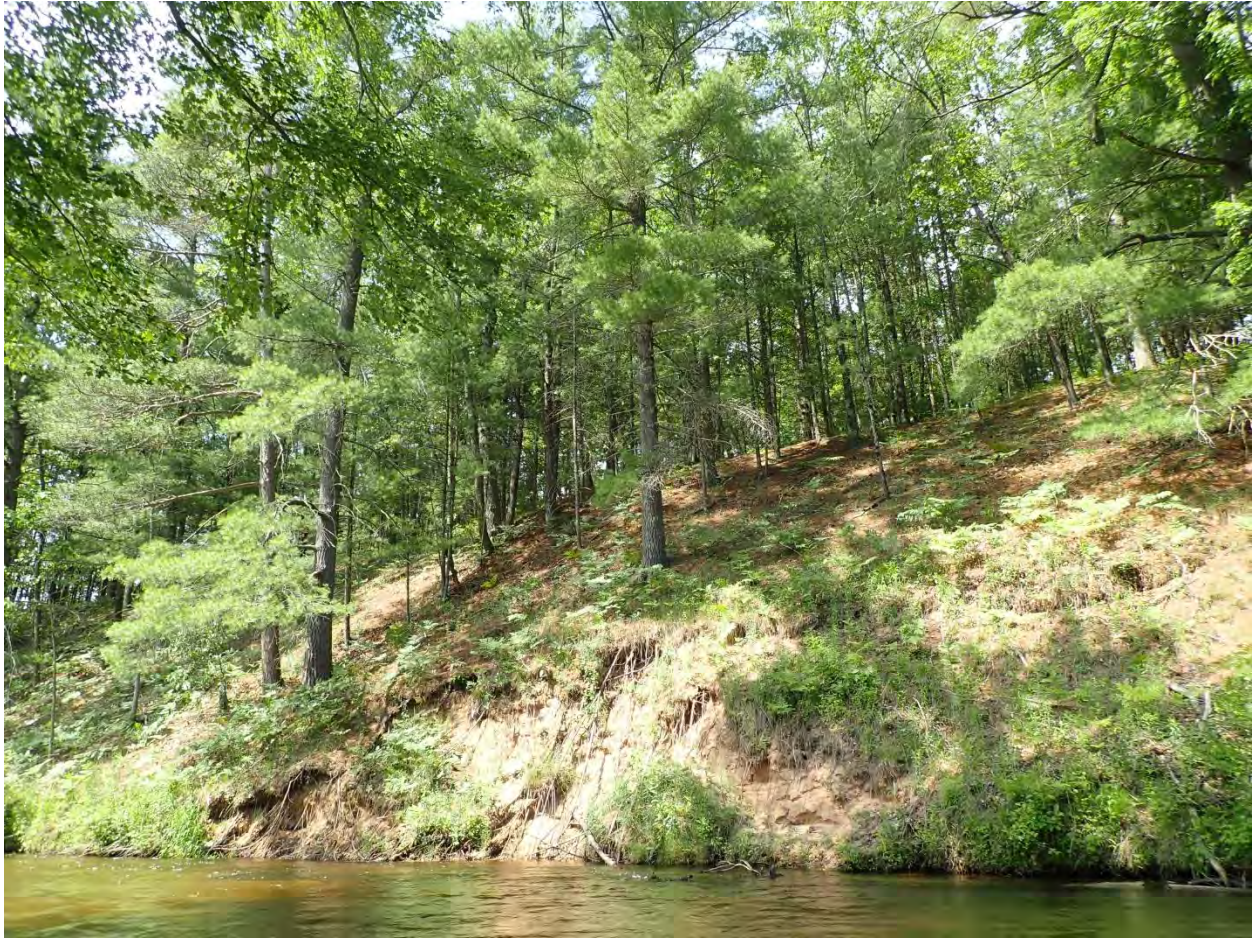
LM#81-2021

44.17423, -86.13521

substrate: gravel, wood

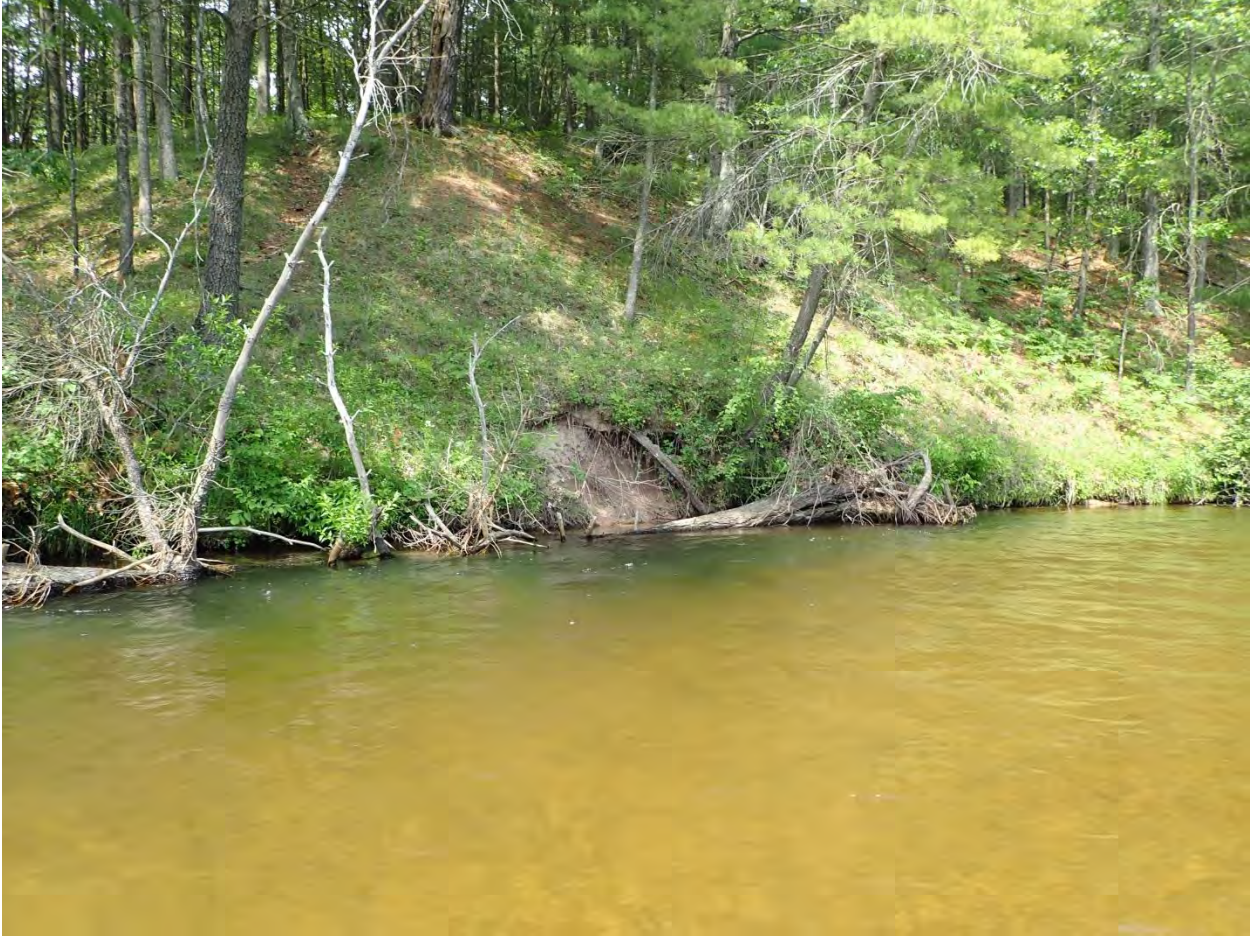
LM#82-2021

44.17426, -86.13592

substrate: sand, gravel

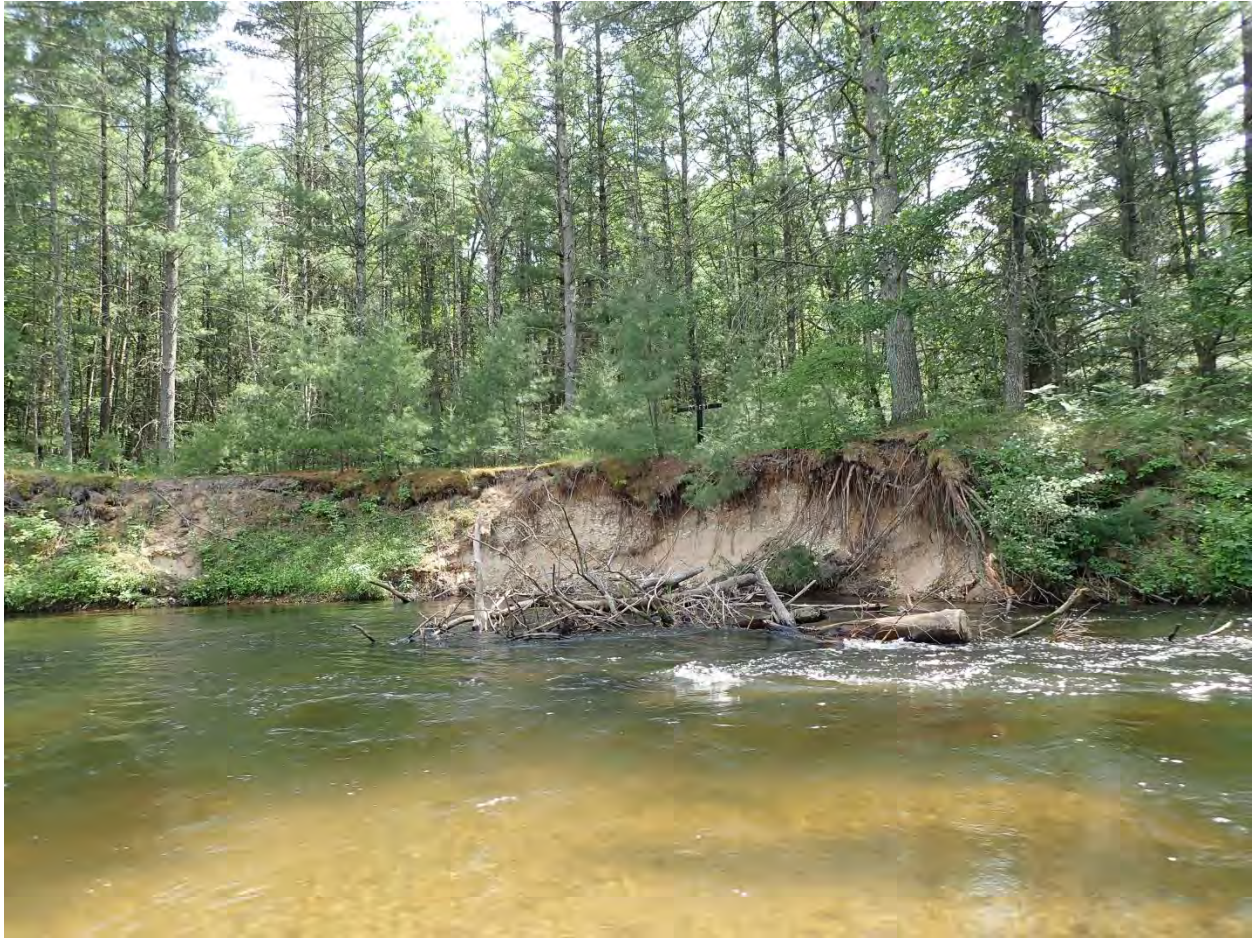
LM#83-2021

44.17419, -86.13862

substrate: gravel

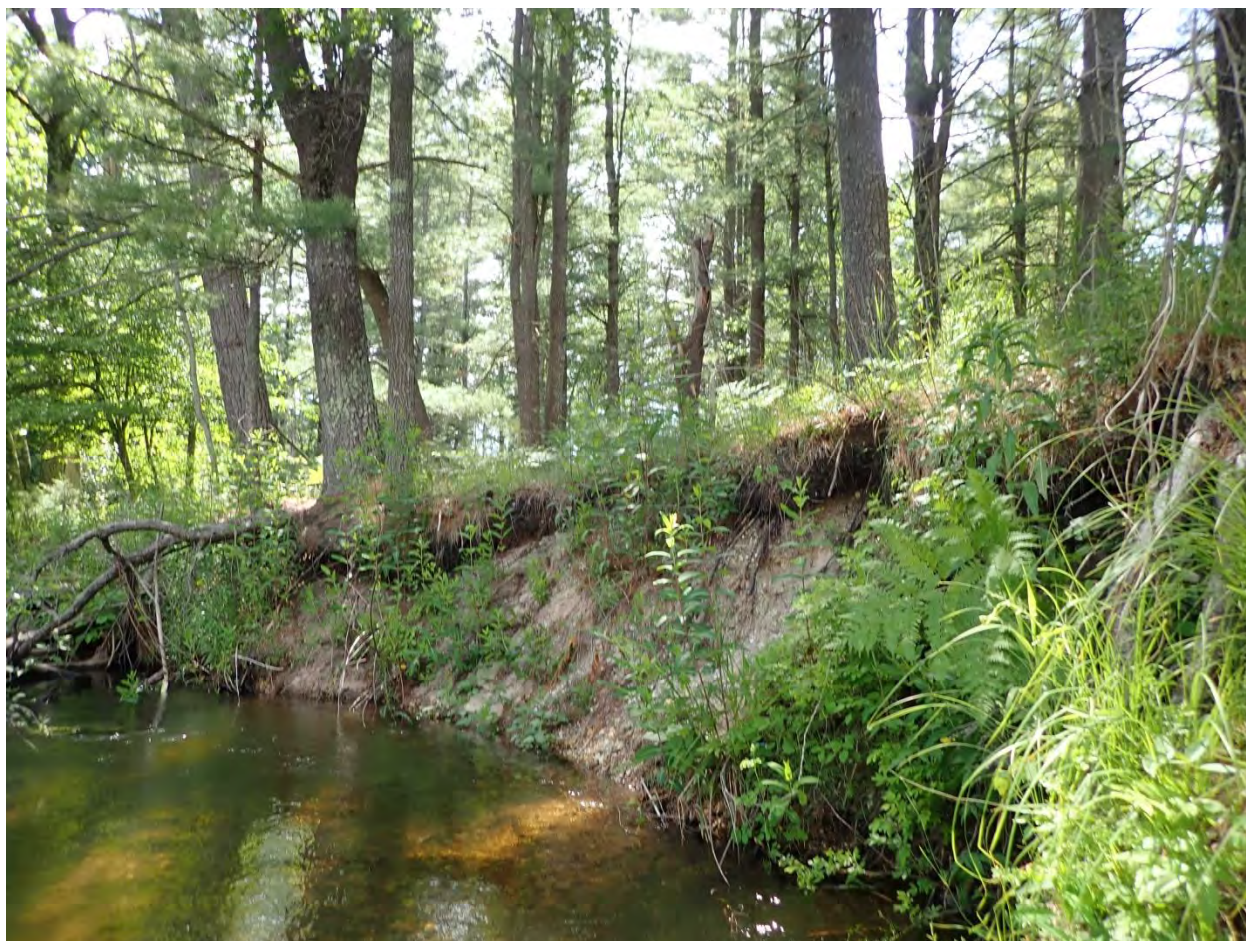
LM#84-2021

44.17476, -86.13882

substrate: sand, gravel

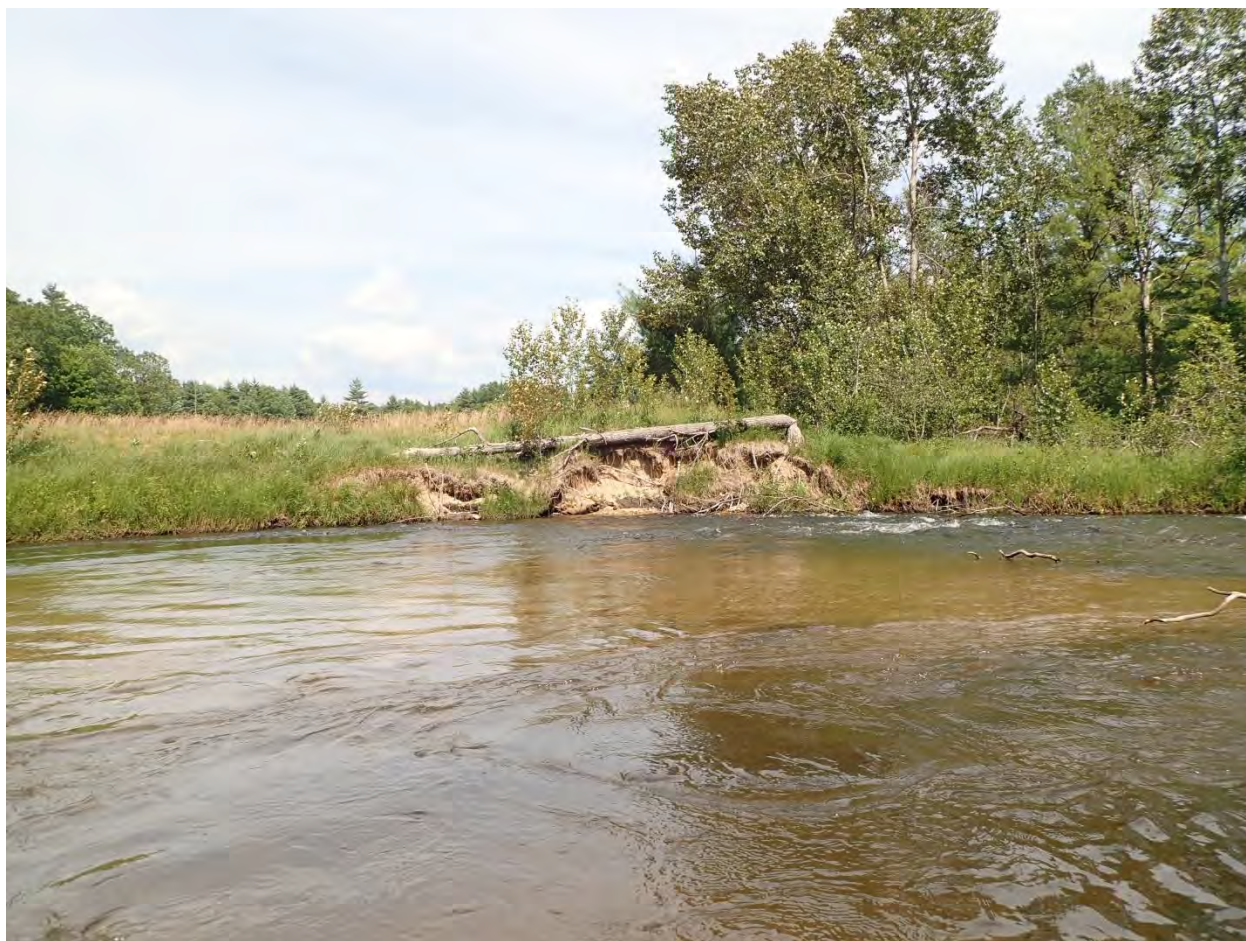
LM#85-2021

44.17503, -86.13828

substrate: sand, gravel

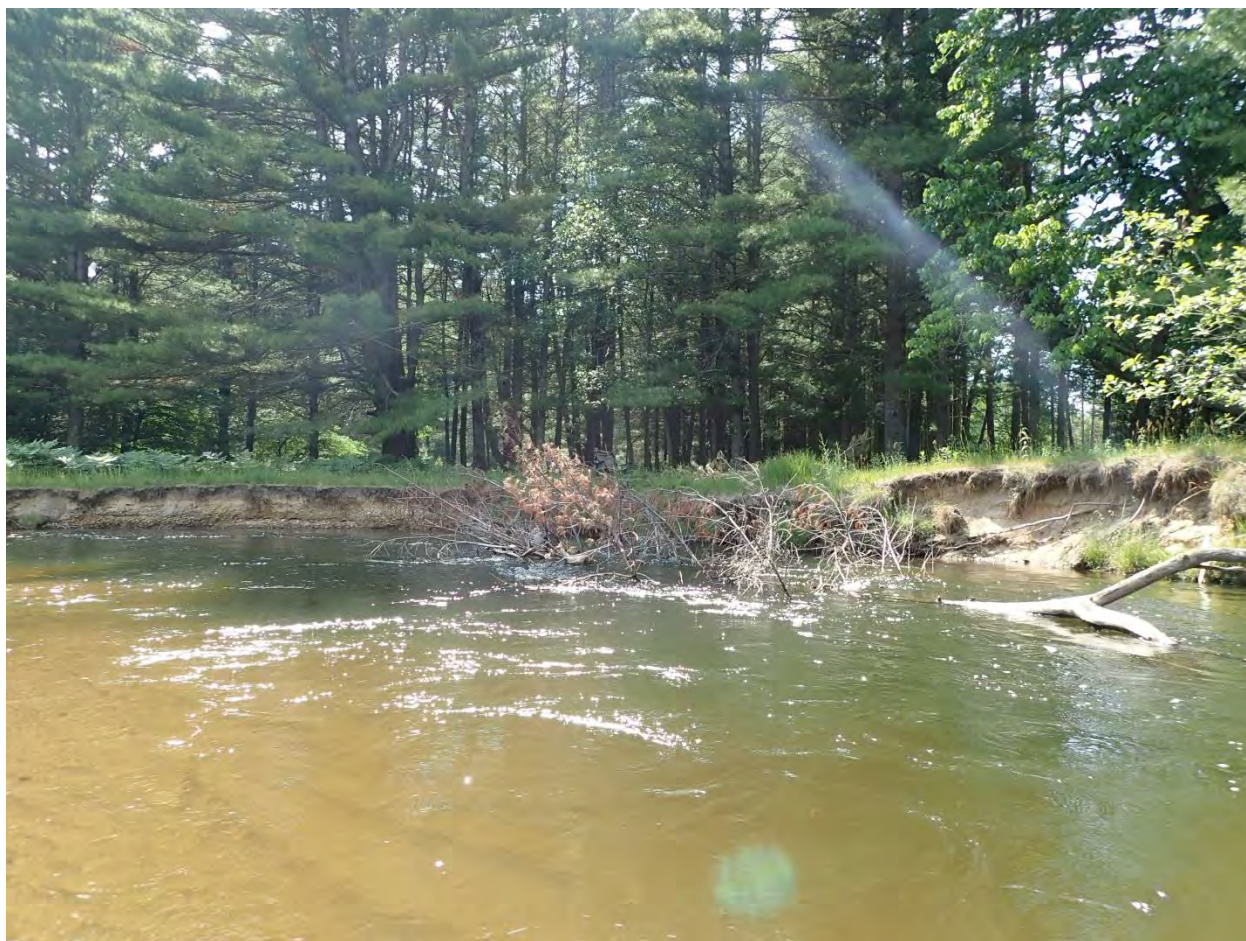
LM#86-2021

44.17566, -86.14111

substrate: sand, gravel

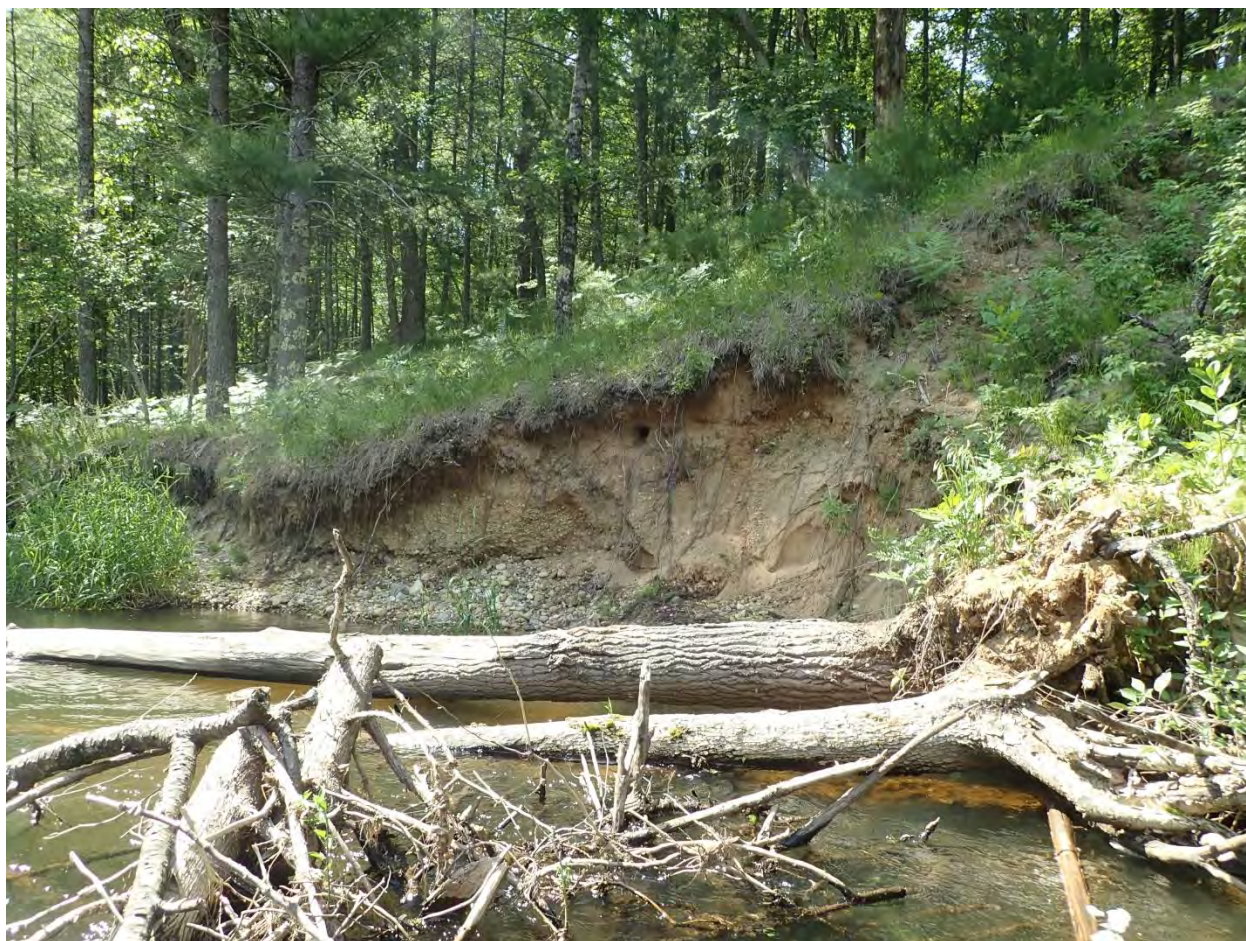
LM#87-2021

44.17735, -86.14570

substrate: gravel, cobble (fieldstone)

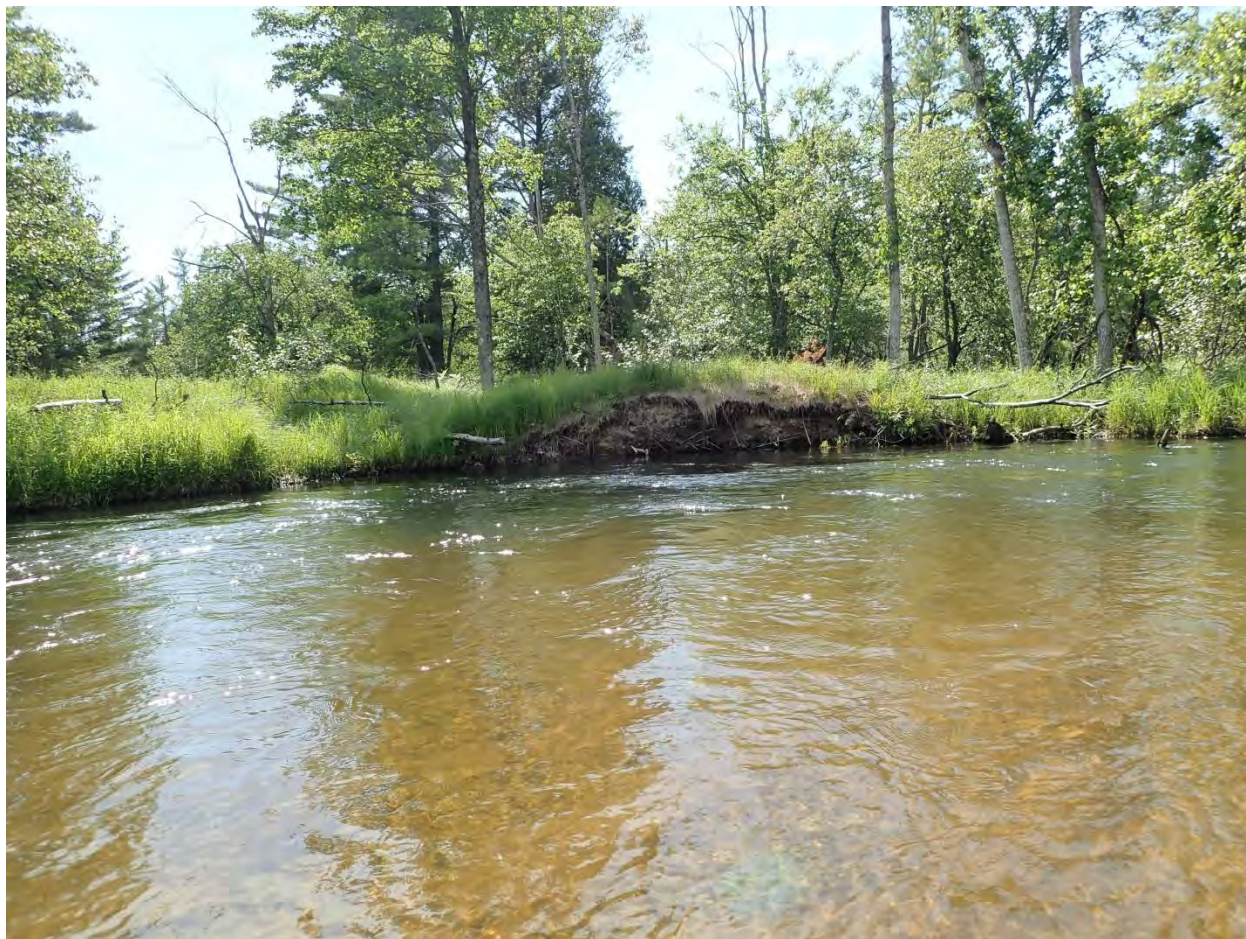
LM#88-2021

44.17735, -86.14850

substrate: sand, gravel

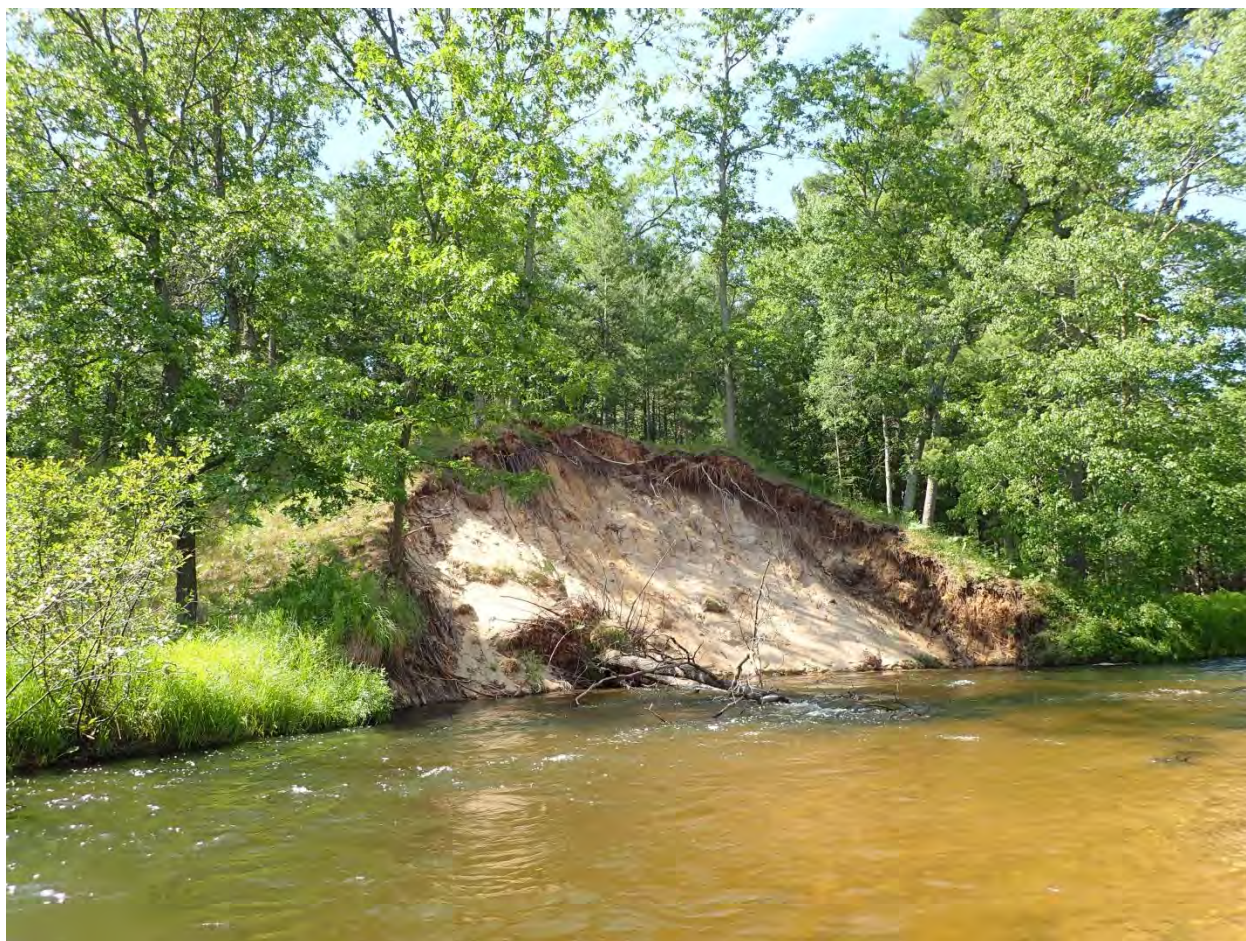
LM#89-2021

44.17673, -86.15128

substrate: sand, gravel

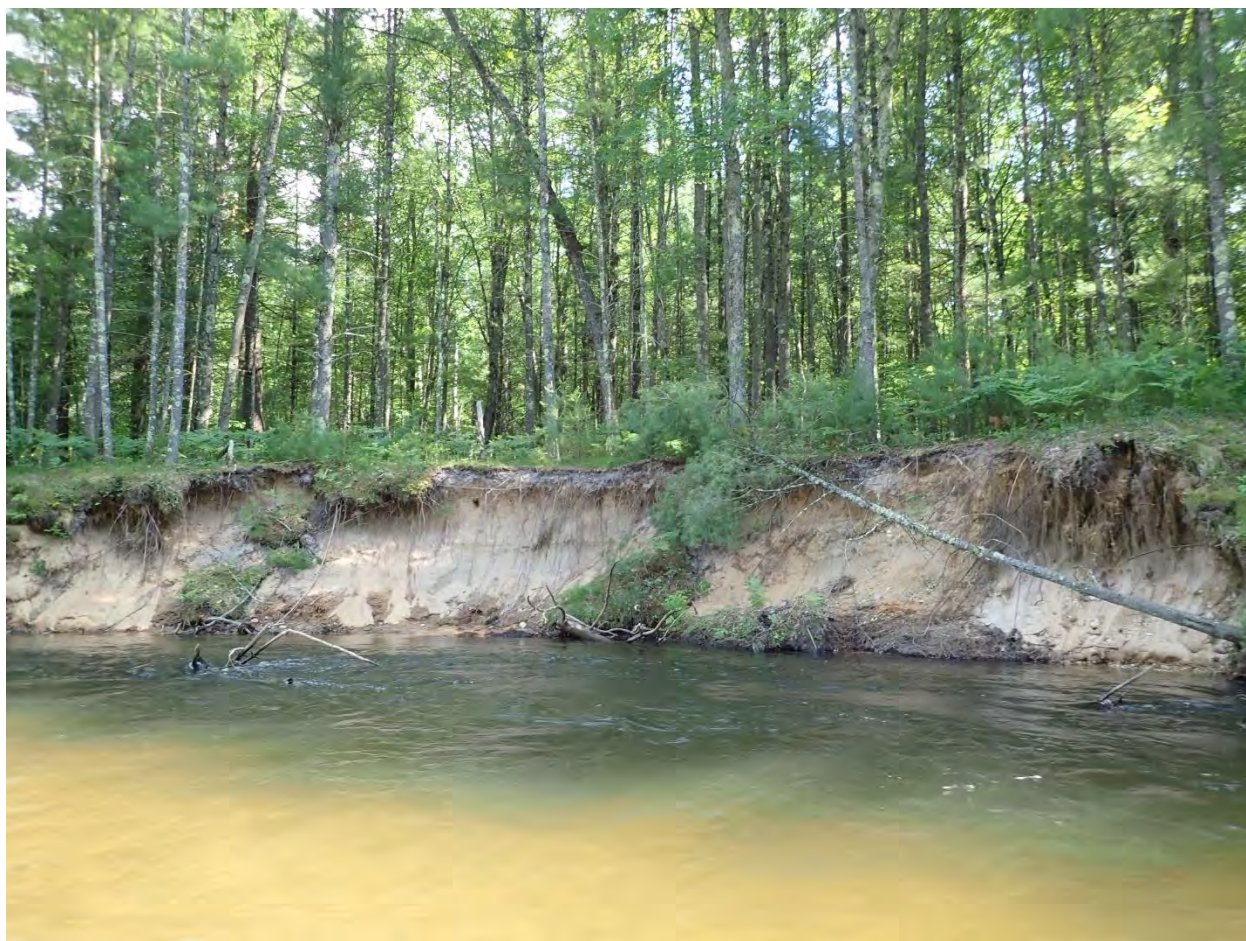
LM#90-2021

44.17615, -86.15361

substrate: sand

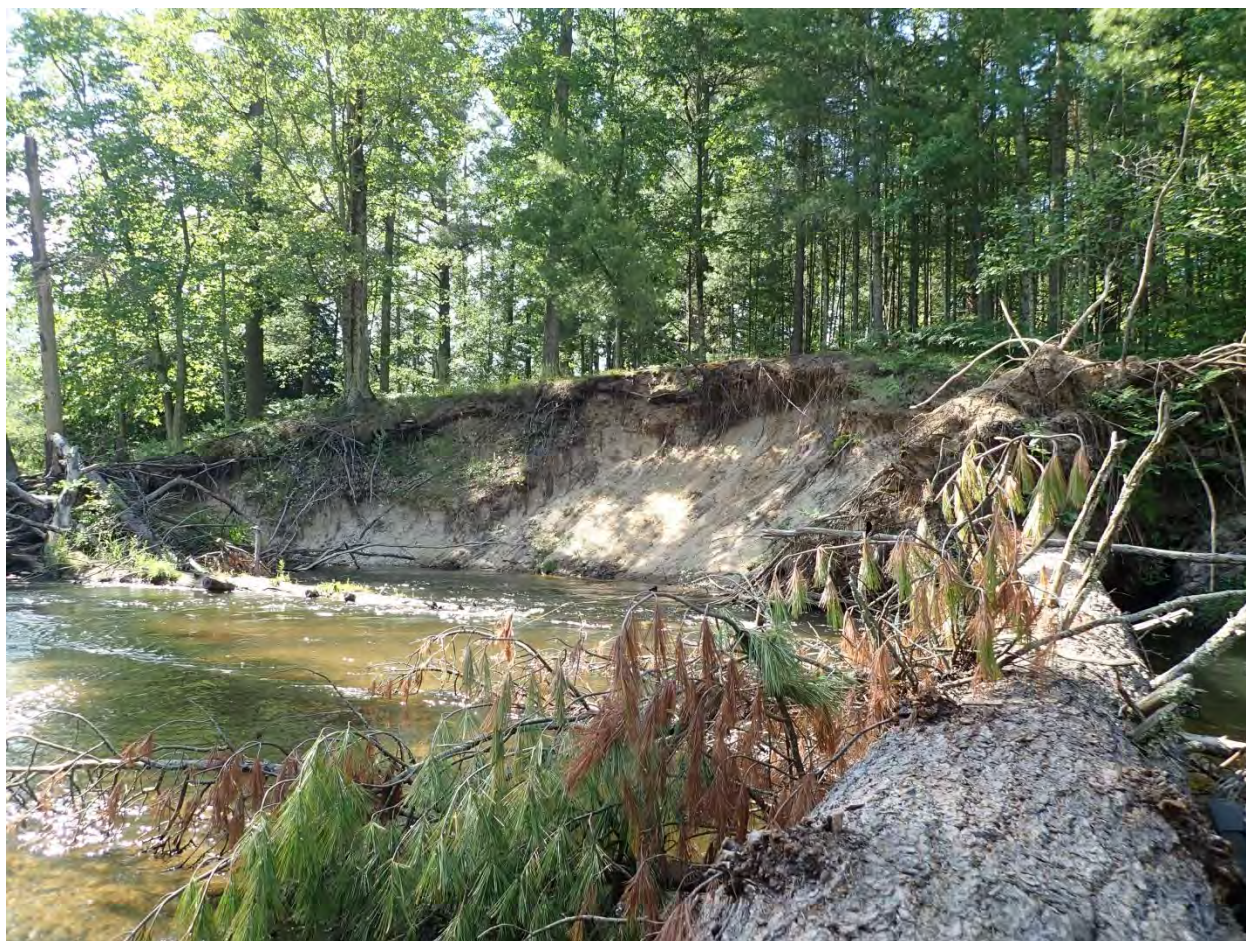
LM#91-2021

44.17911, -86.16132

substrate: sand, gravel

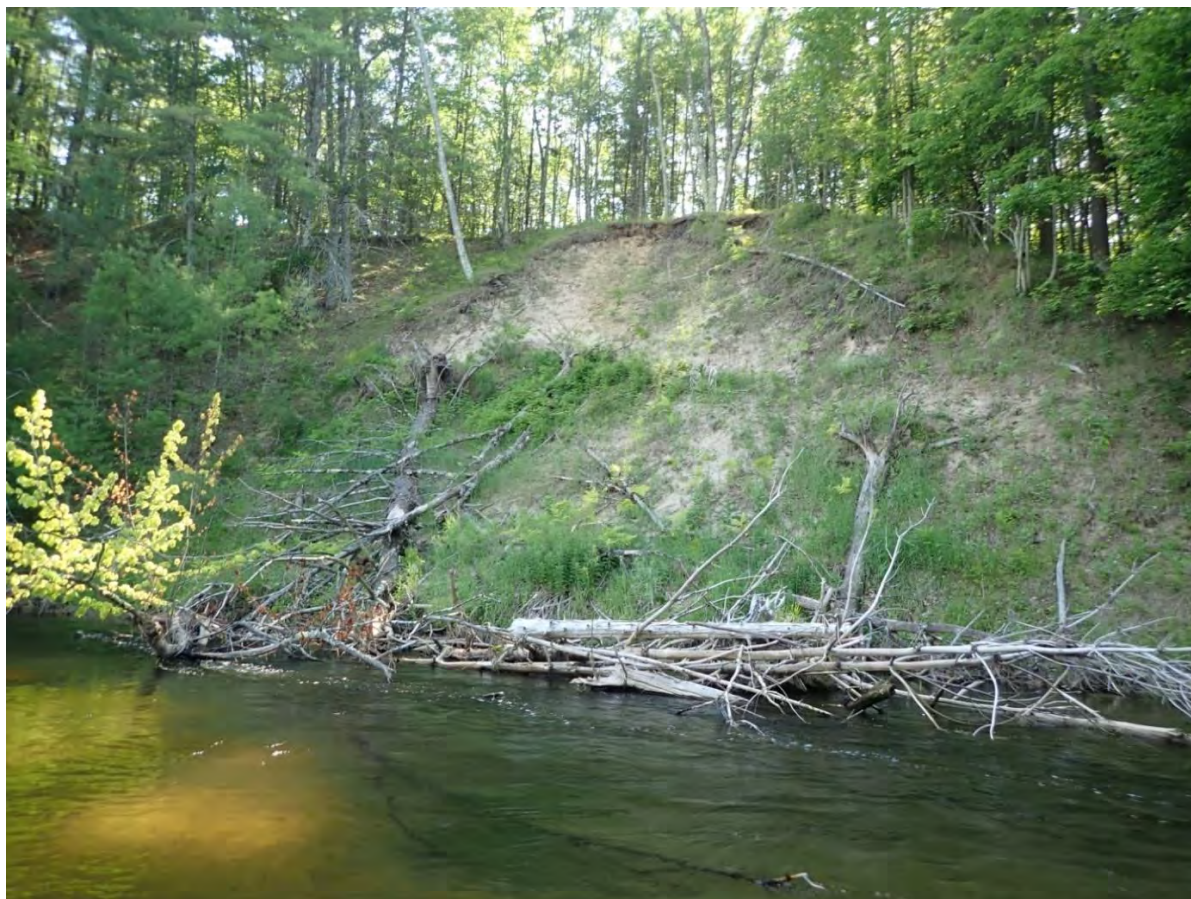
Passive bluff stabilization through benign neglect (Site #79-2011/2014).

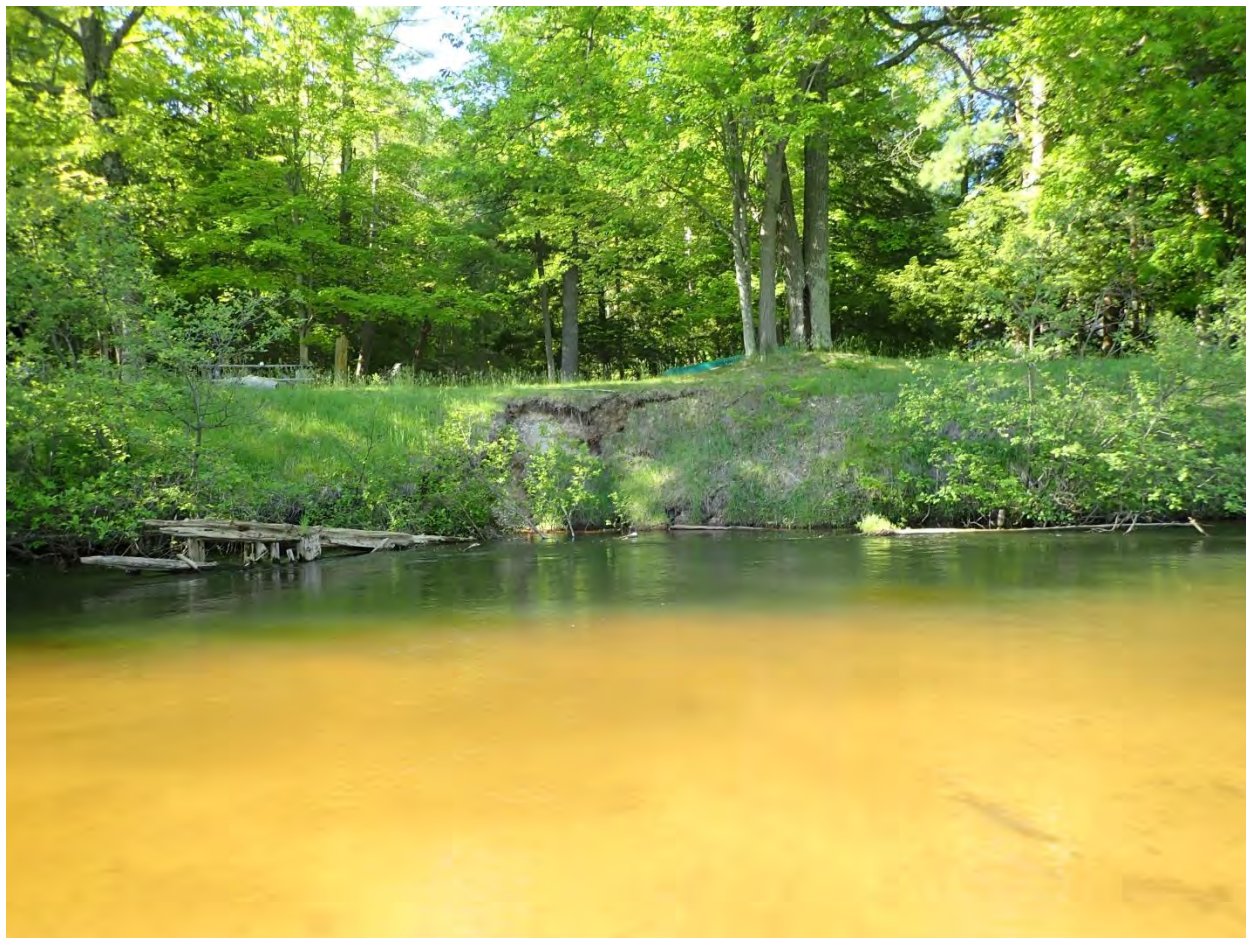
**LM#92-2021**

44.20363, -86.20378

substrate: sand

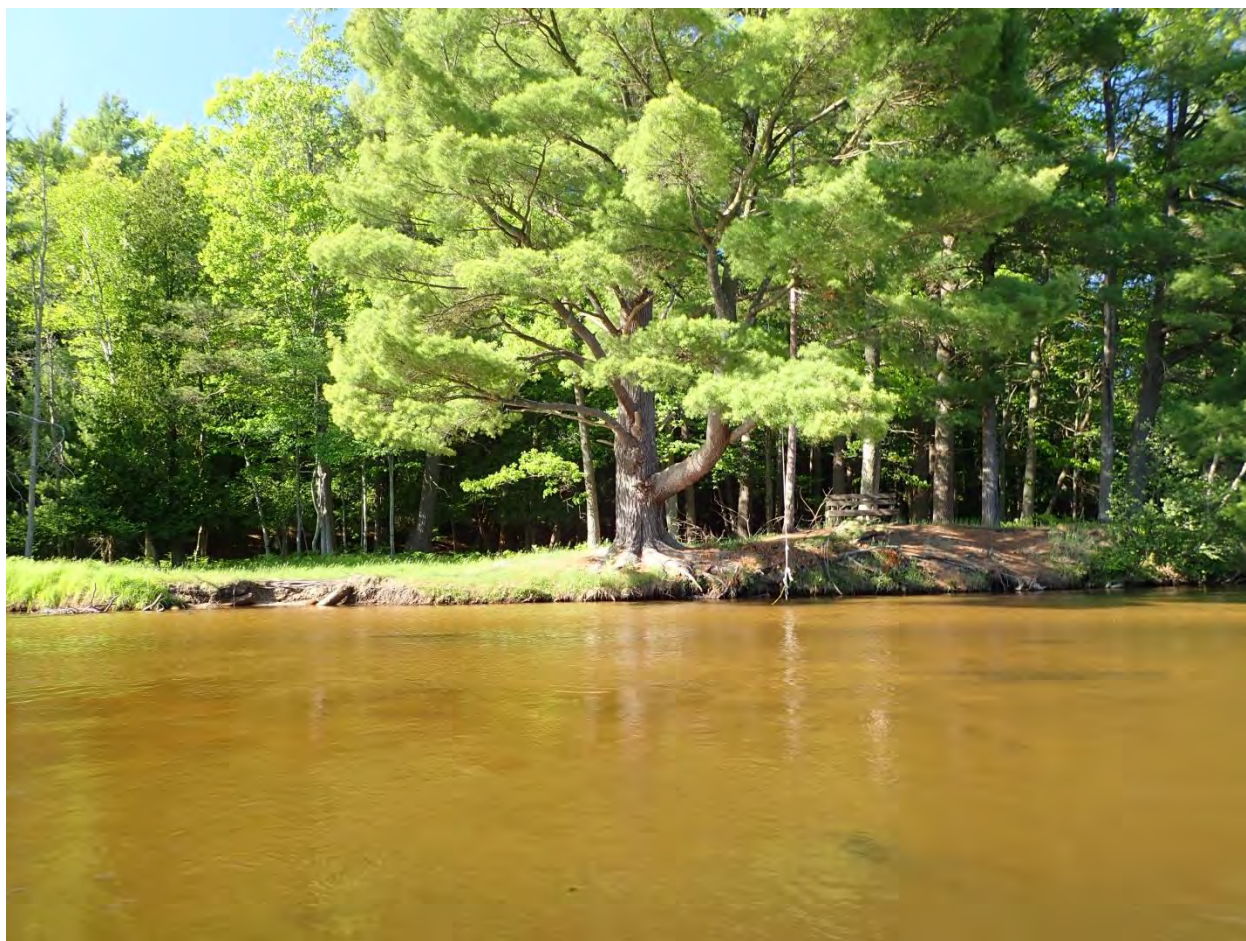
LM #93-2021

44.20692, -86.22277

substrate: sand

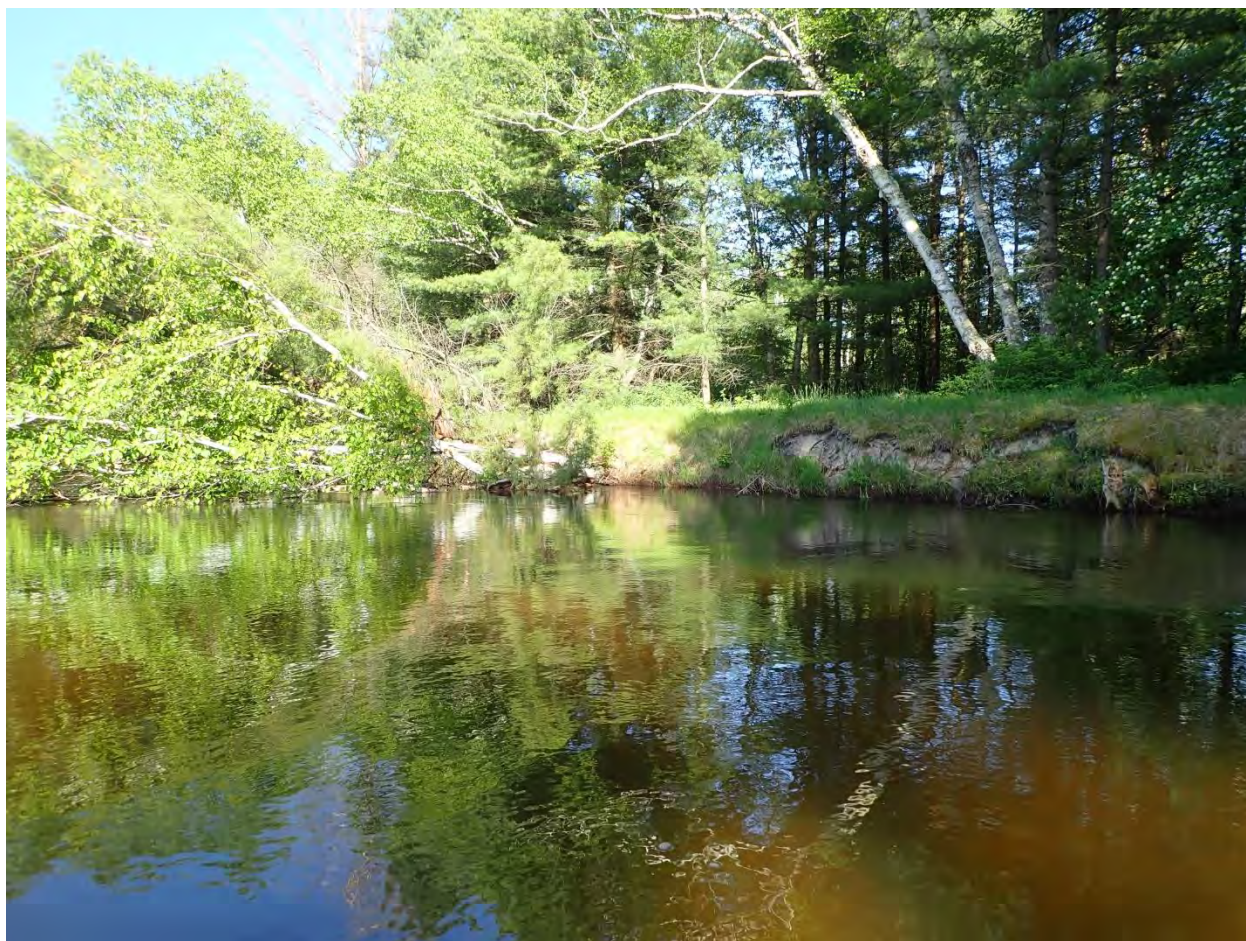
LM#94-2021

44.20821, -86.23972

substrate: sand

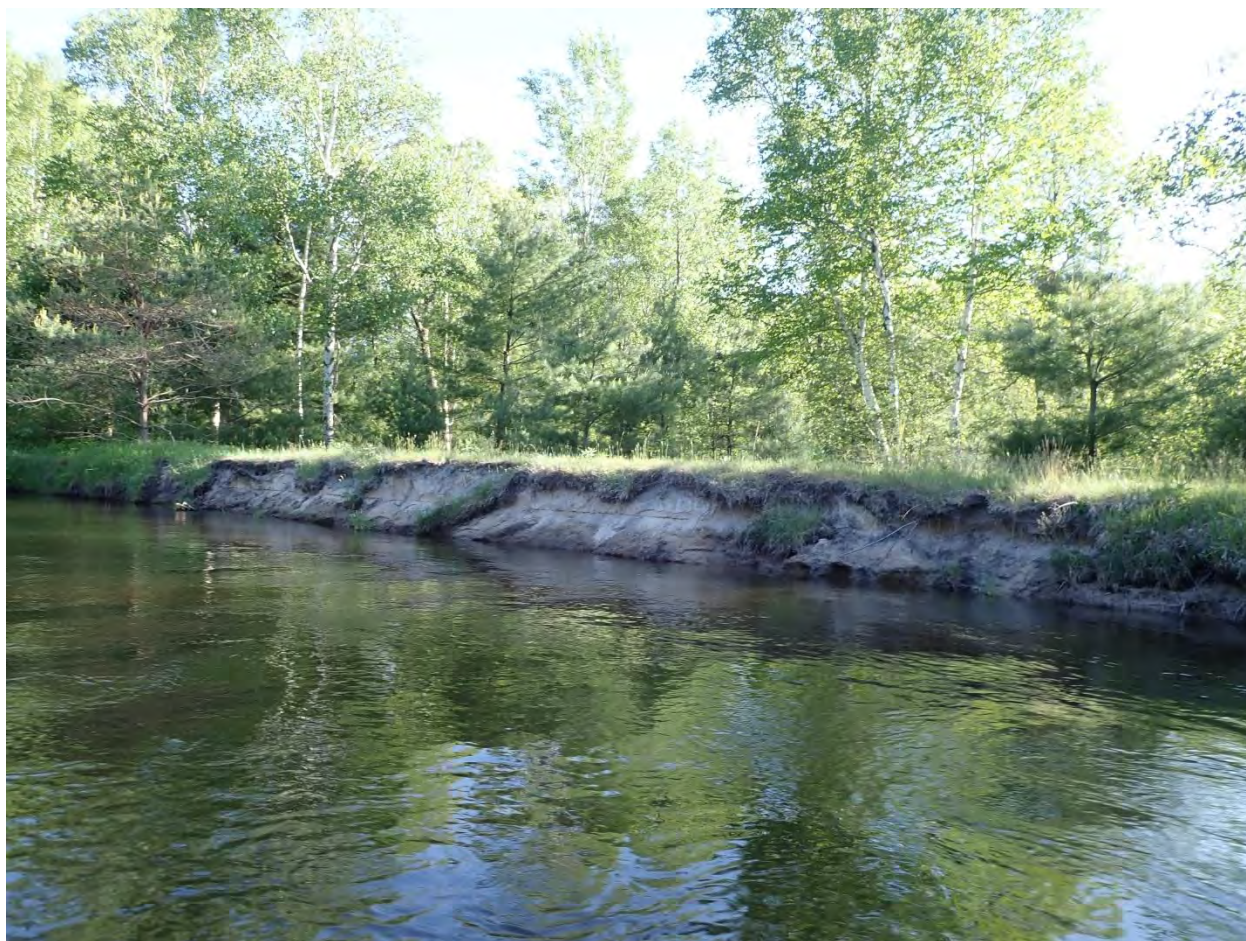
LM#95-2021

44.20850, -86.24171
